#### **DESIGN & ACCESS AND HERITAGE STATEMENT**

BARN STREET BOUNDARY WALL
THE GROVE
5 LADY STREET
LAVENHAM
SUFFOLK

Ref: CJS\EJM\22764~das01\_REV -

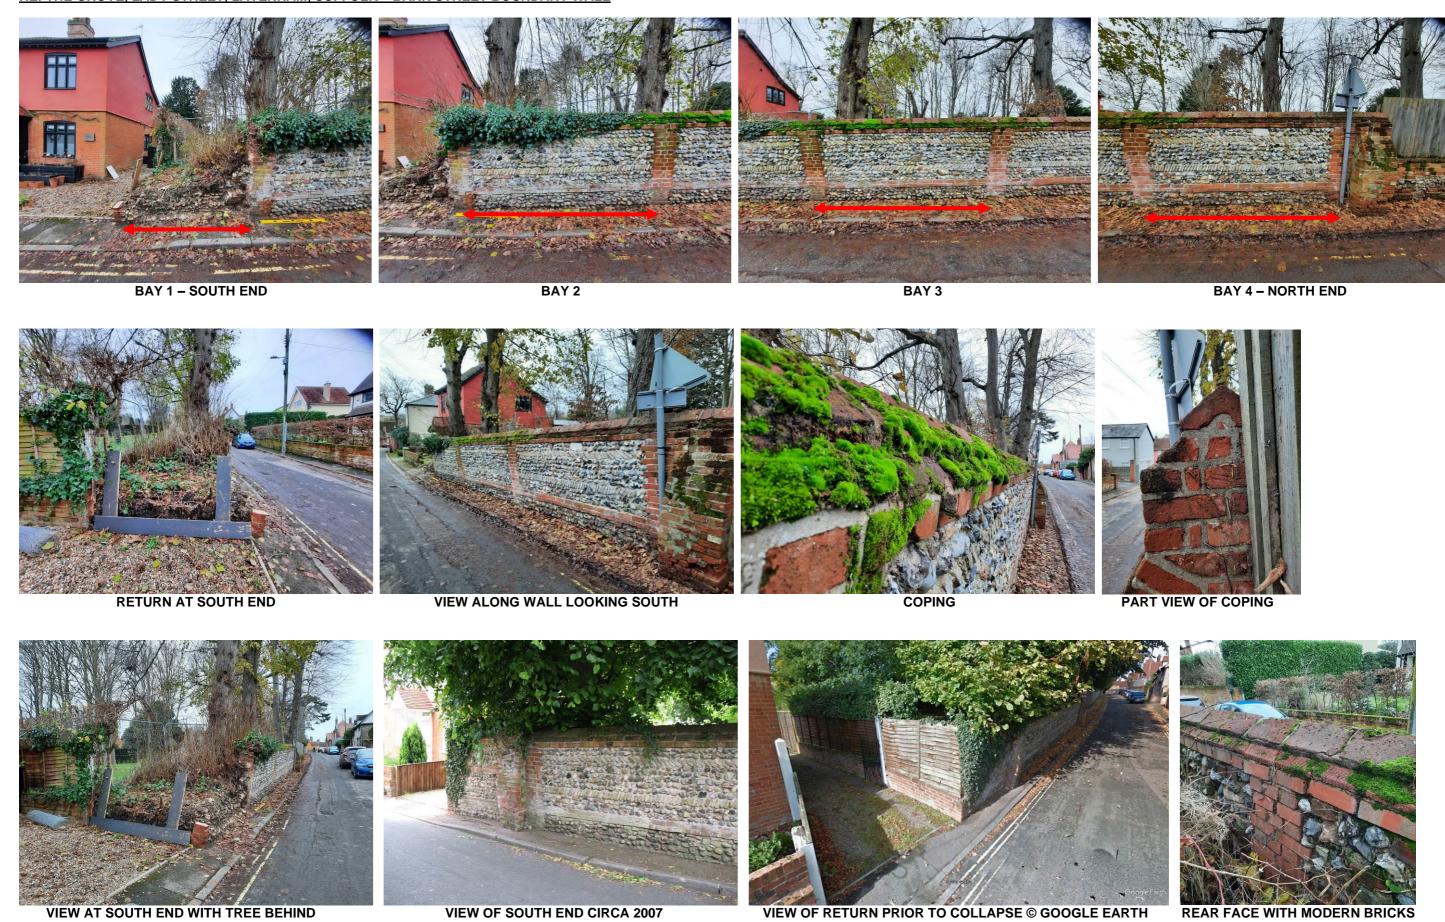
At the south end, one bay, approximately 2.8m long, has collapsed which seems is clearly related to root pressure from the tree behind, acting on the rear face.
