Our Ref: BEK/20771/201023/EG

Land at the north of Rhallt Lane, Welshpool - BRE 365 Percolation Test

BEK Enviro (BEK) have been commissioned by Euro Garages Ltd to determine soil infiltration rates at the above site using the BRE 365 methodology (2016) to assess the viability of disposal of surface water from the site via infiltration.

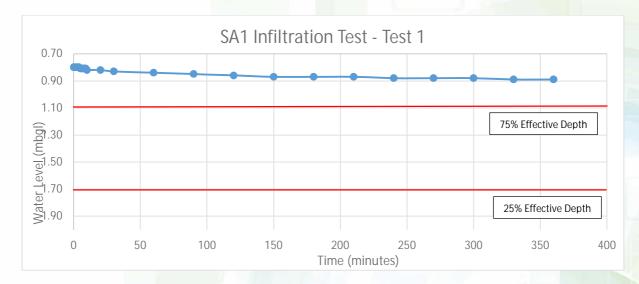
Table 2: SA1 Infiltration Test

It can be seen from the above table that the water did not reach 75% effective depth after 6 hours of the test. Furthermore, 3 tests are required to be undertaken with the slowest infiltration rate used for design purposes therefore the test is considered to have failed.

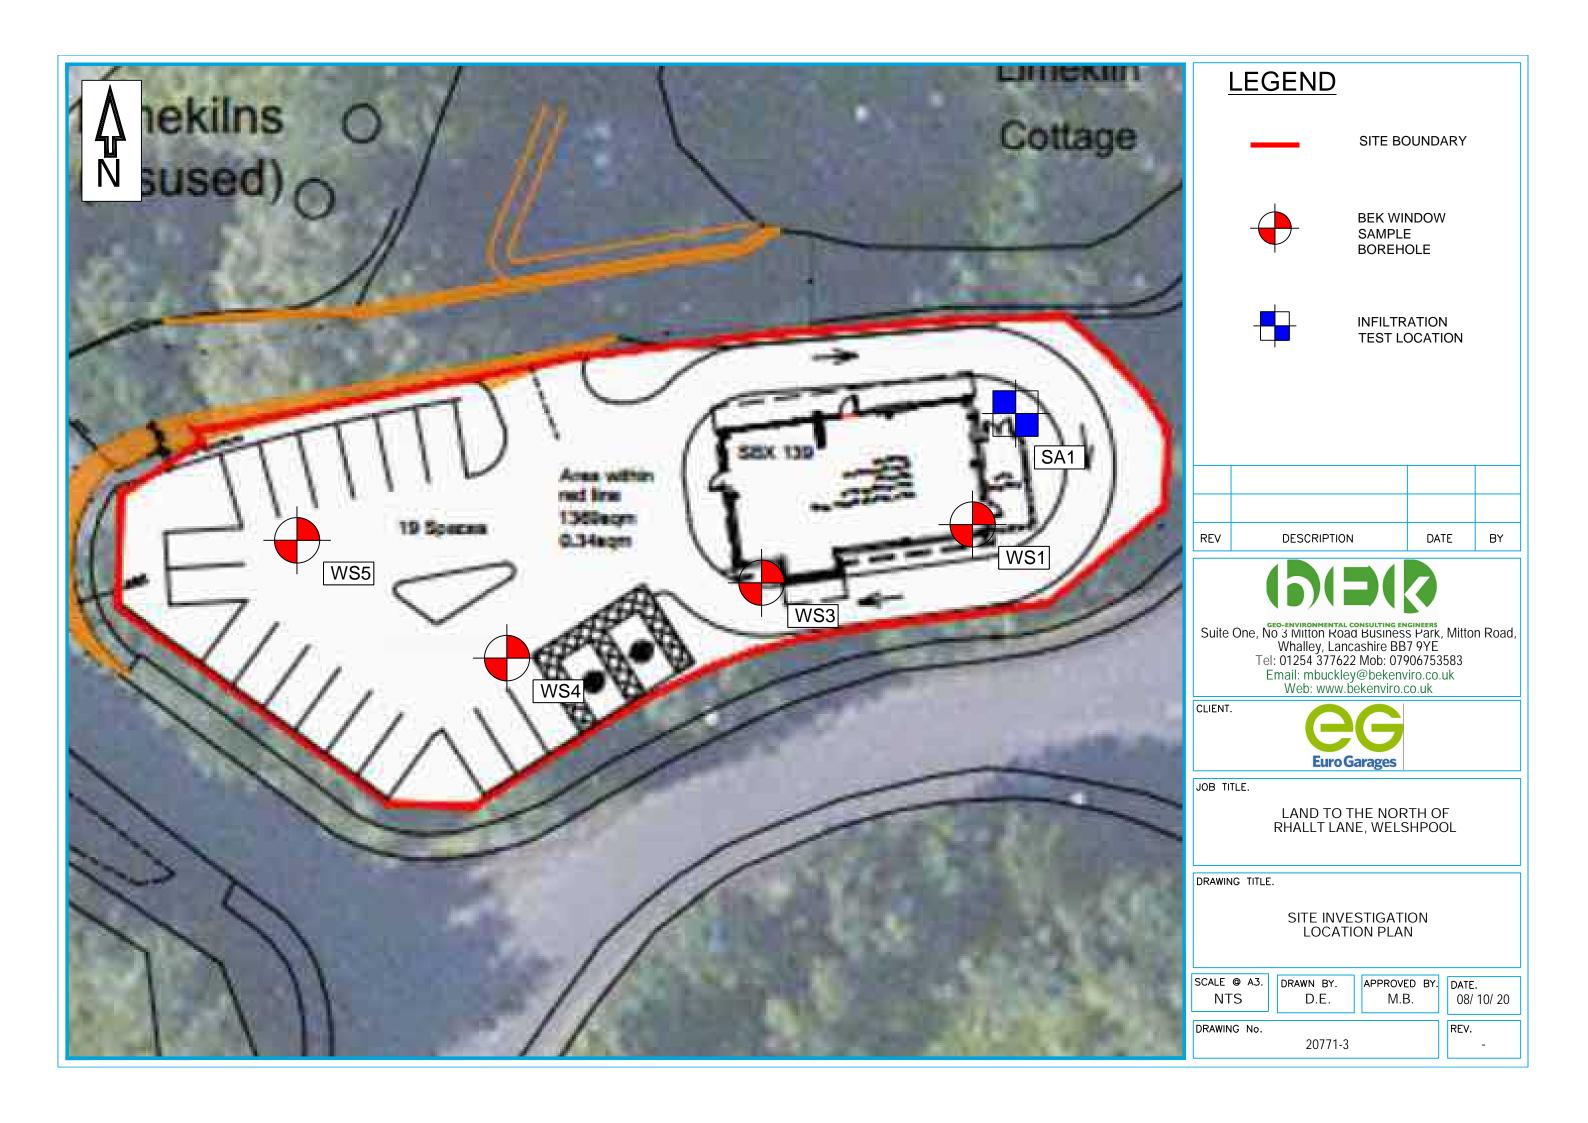
ANNEX B
Site Investigation Location Plan

Percolation testing was undertaken in accordance with the requirements set out in BRE 365 (2016). A test pit was excavated at the site and an infiltration test was undertaken. The test was undertaken on 03<sup>rd</sup> October 2020 with dry conditions. The test location is presented on BEK Drawing No 20771-3, a copy of which is presented in Annex B.
