OMC Associates

BS 5837 Arboricultural Impacts Assessment

CLIENT:	McGregor
SITE:	Land off Denham Road, Denham, IP29 5EW
OUR REF:	01490AIA/CJO/3005
DATE OF REPORT:	4 June 2019

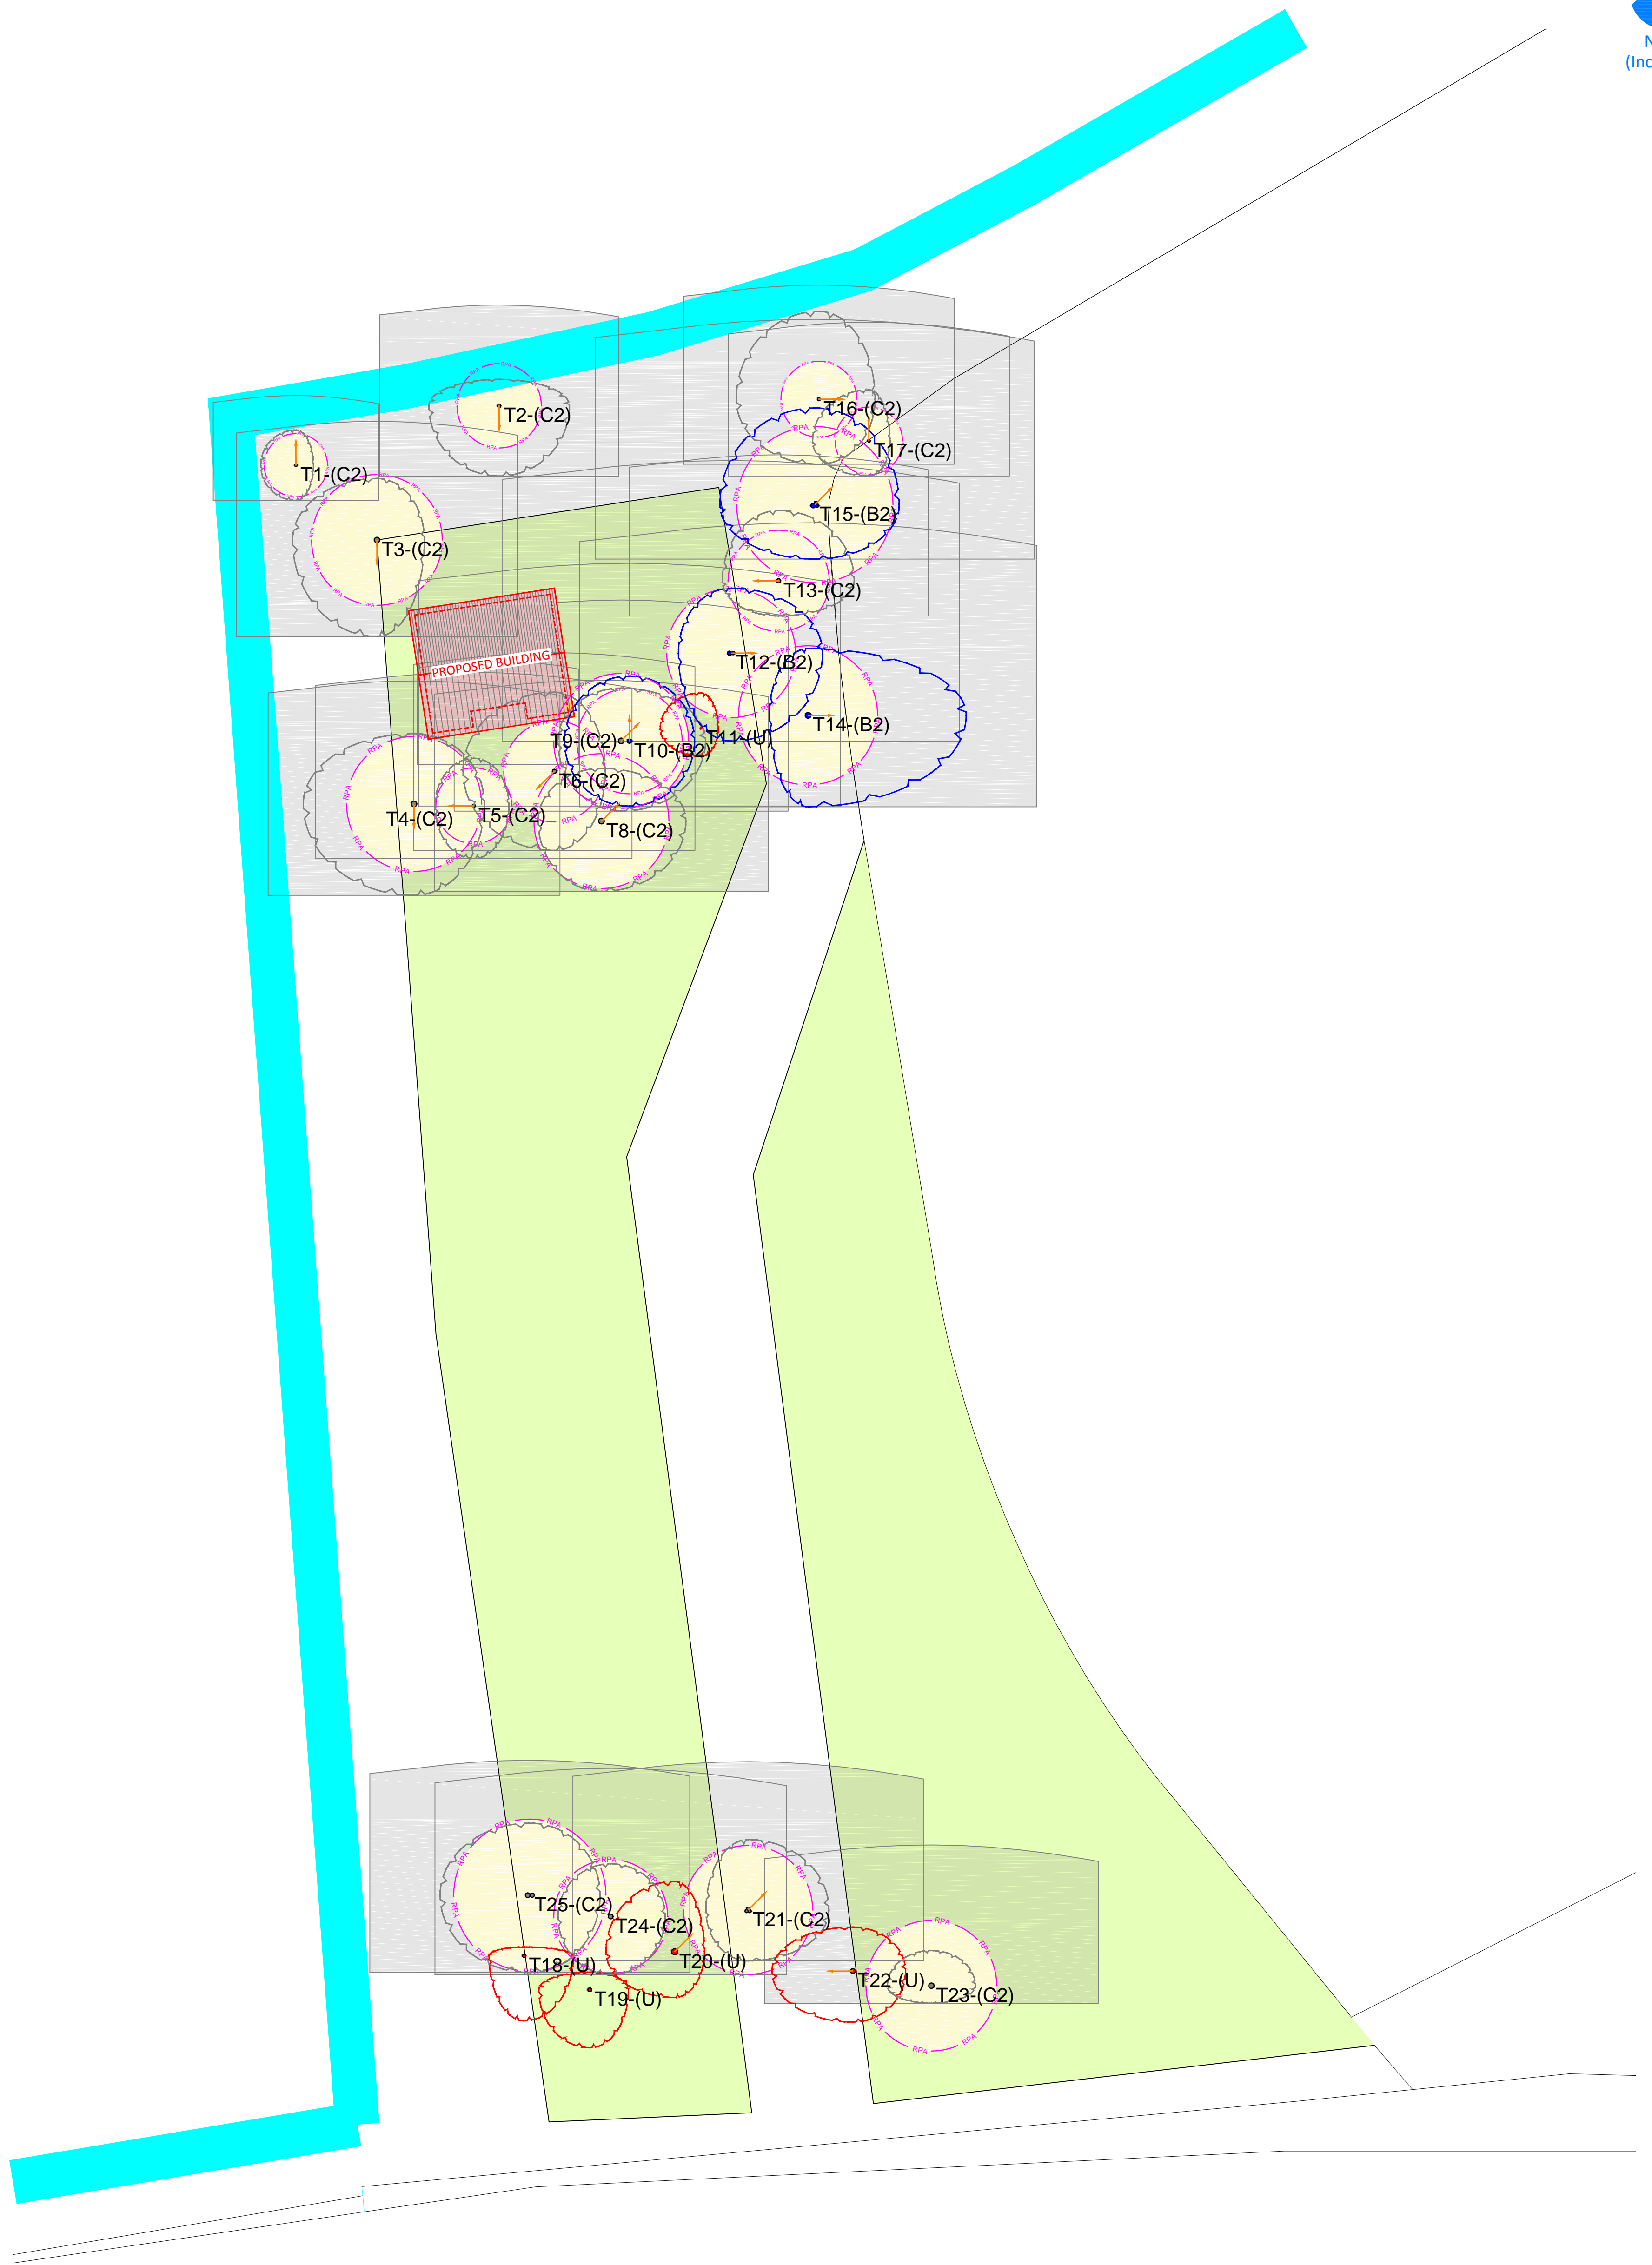
Title
Tree Constraints Plan

The proposed cabin will encroach upon less than 5% of the RPA of T10. This well below the 20% threshold generally advised by the British Standard. The trees are, moreover, early mature trees of high vitality that will tolerate any root loss with negligible impact on health and form. There is, moreover, ample new rooting space to exploit.

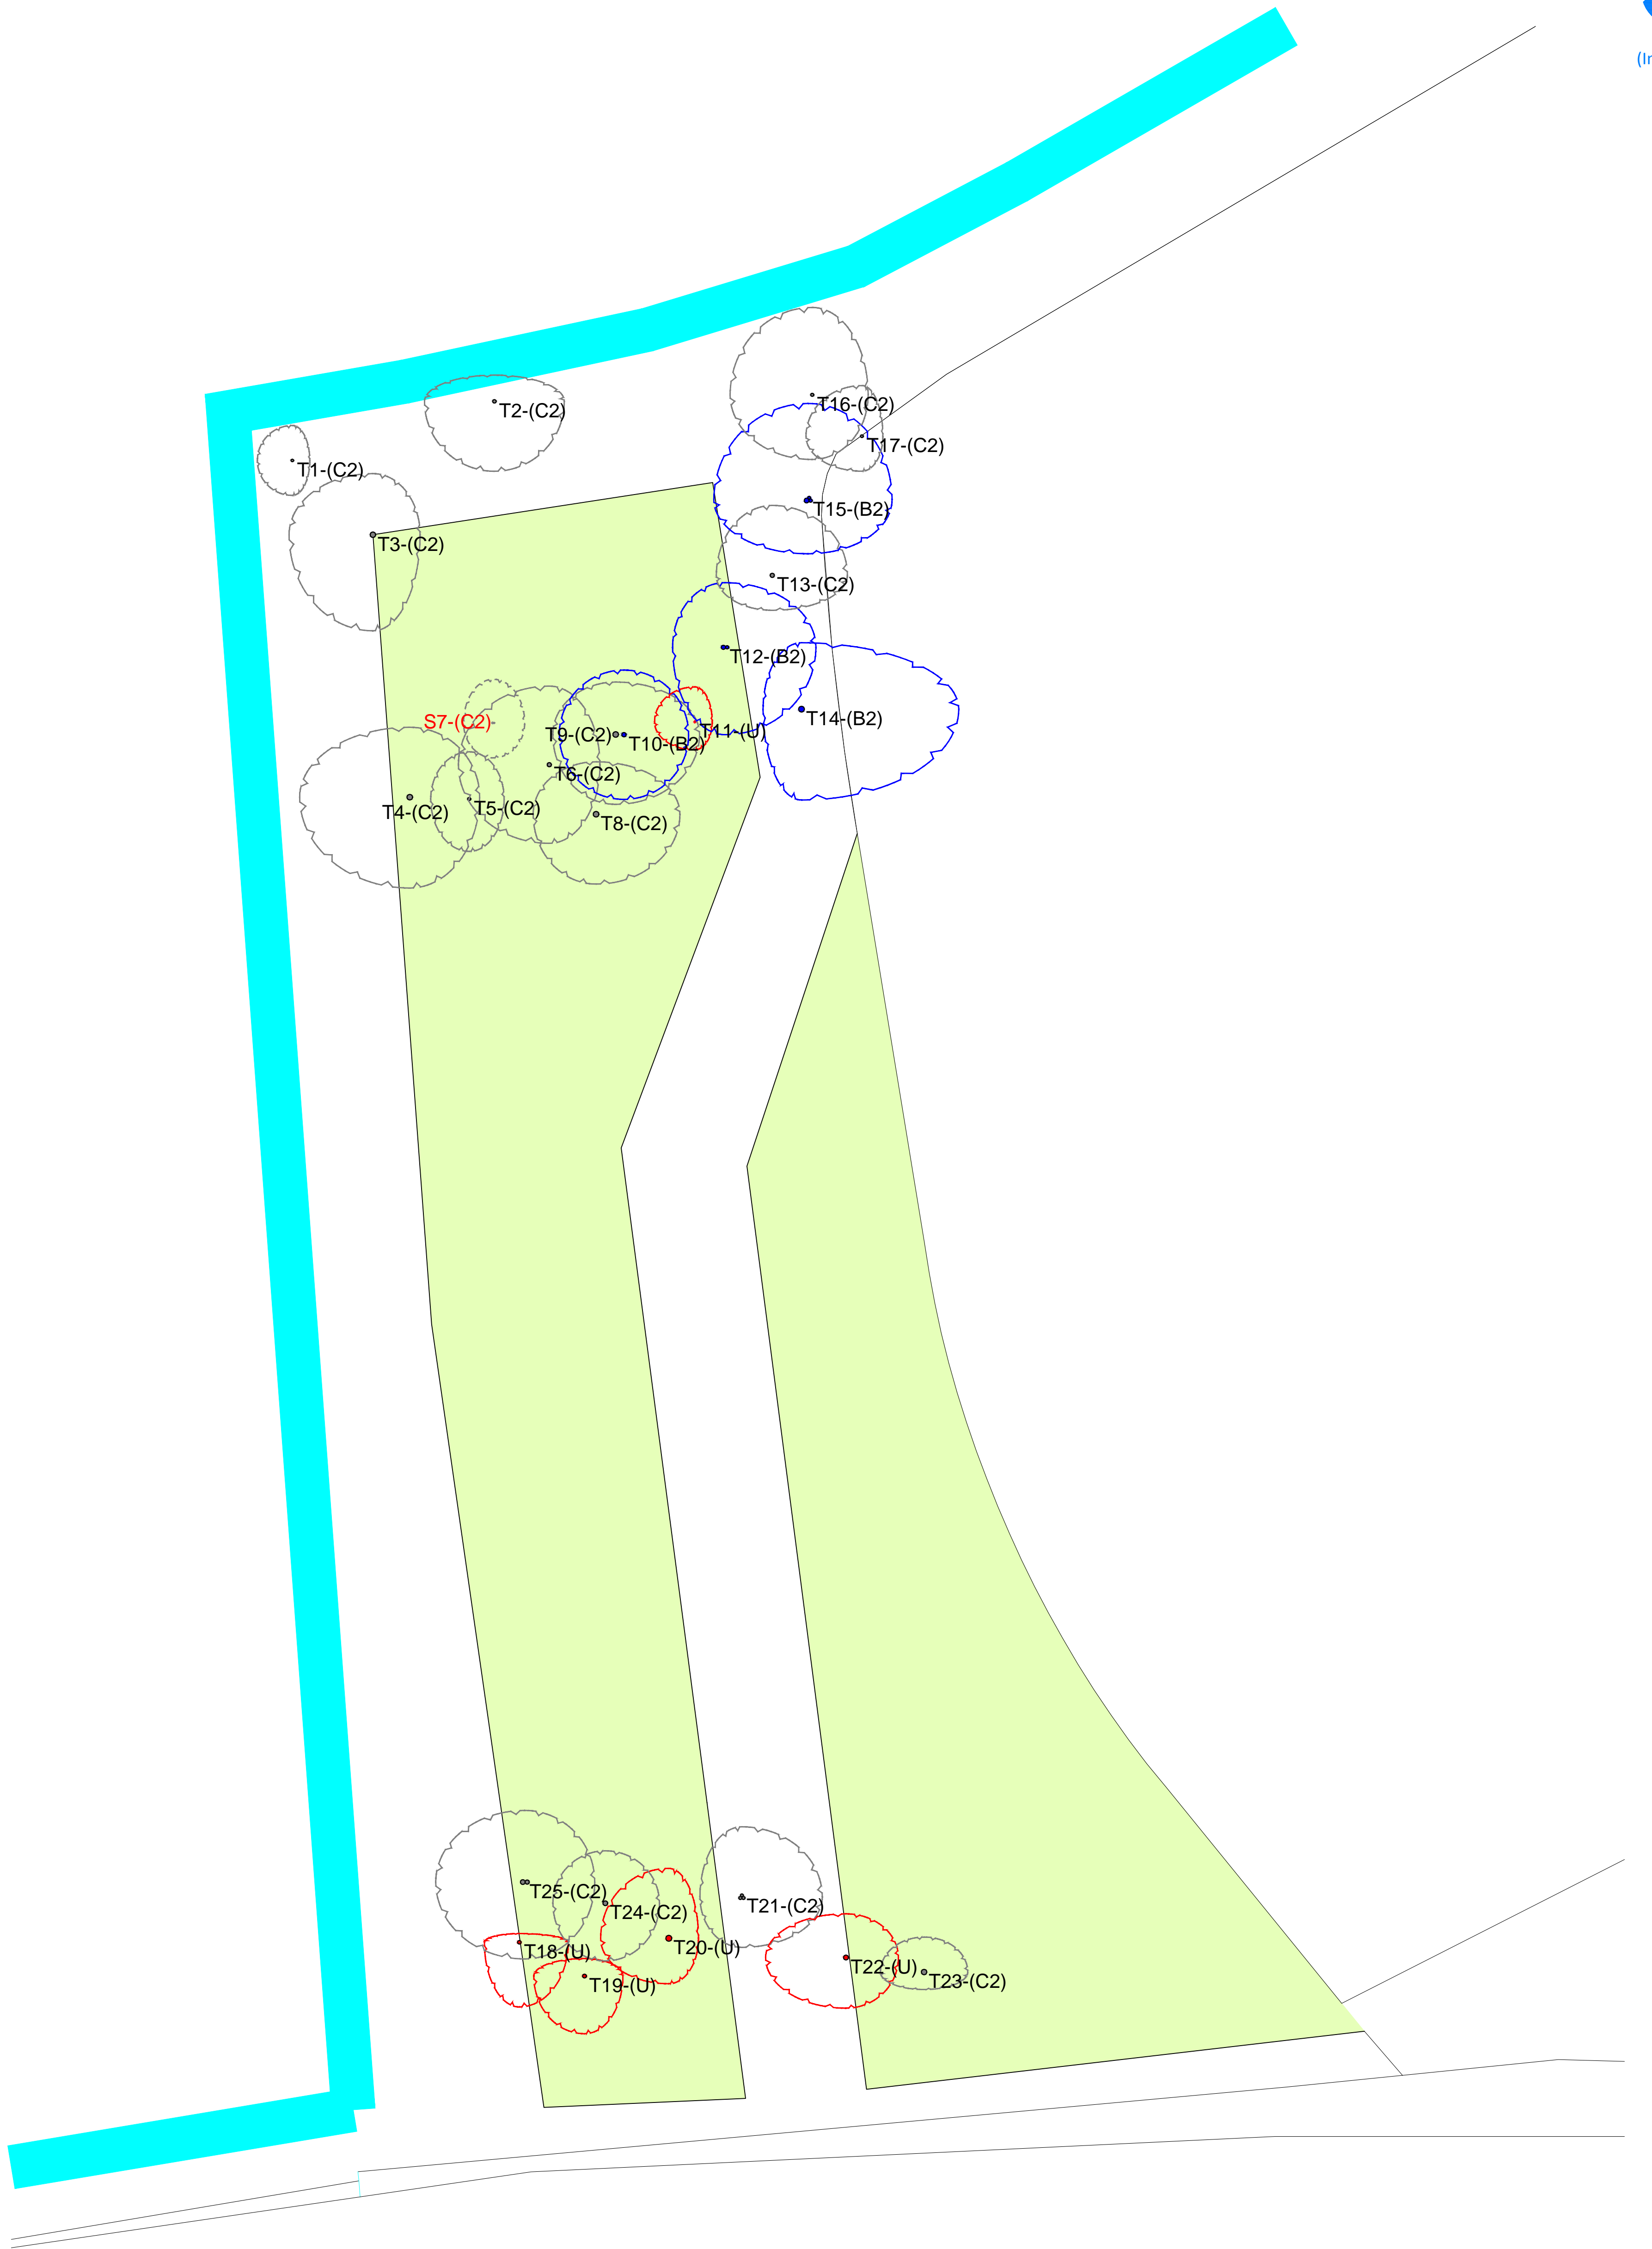
Title
Tree Survey and Proposed Removals Plan

No tree removals are necessitated by the scheme. Removal of the shrub S7, however, is required.

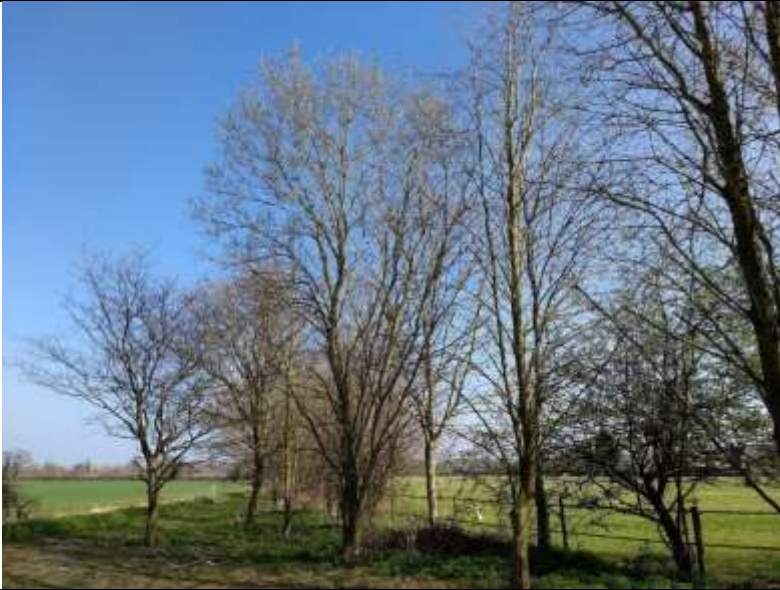
Photo 1

- T12-T16 looking east

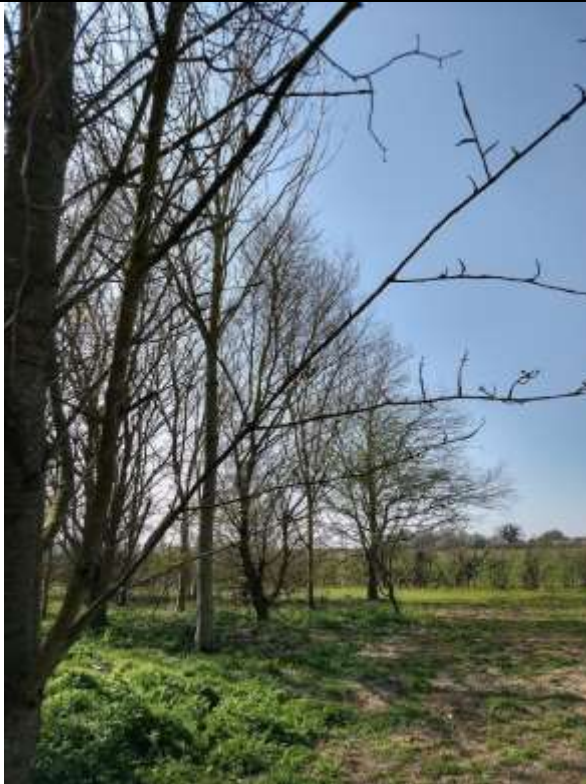
Photo 2

- T4, T6, S7, T10, T12 looking west

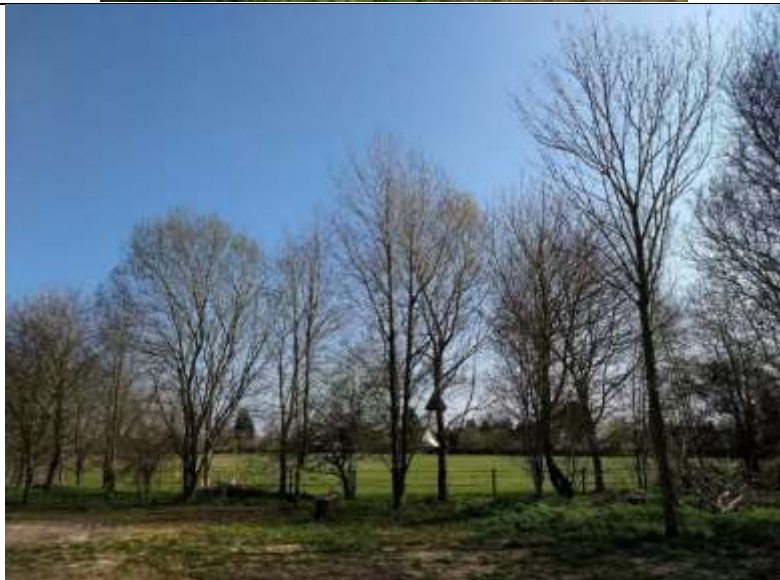
Photo 3

- T10-T15 looking east

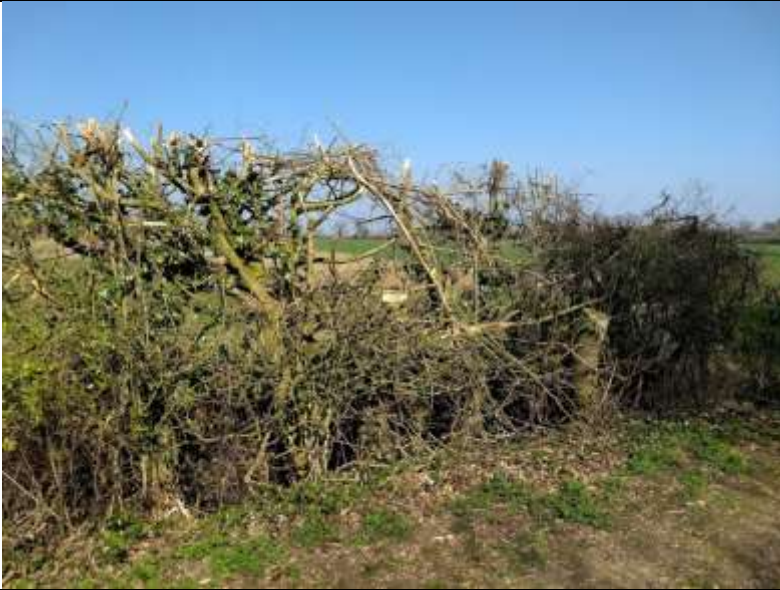
Photo 4

- Harshly cut back hedgerow on northern boundary

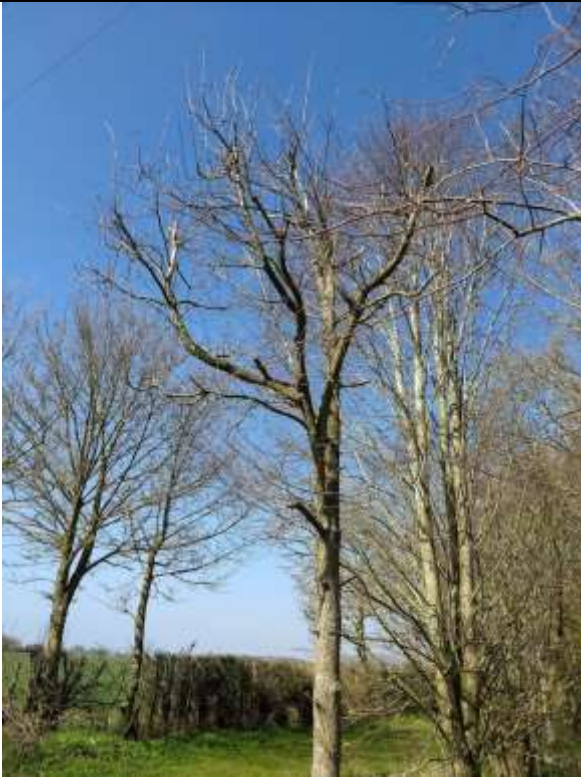
Photo 5

T19	Common lime (<i>Tilia x europaea</i>)	4.6	220	N -1 S -3.3 E -2.2 W -2.9	EM	Phys. -Poor Struct. -Poor	5		10-20	U	Edge of woodland facing highway; seriously disfigured by poor tree work; little potential to redevelop its crown Works: -	2.64
T20	English oak (<i>Quercus robur</i>)	11.6	340	N -4 S -2.6 E -1.7 W -3.9	EM	Phys. -Fair Struct. -Fair	4	1.7 (NE)	10-20	U	Edge of woodland facing highway; seriously disfigured by poor tree work; little potential to redevelop its crown Works: -	4.08
T21	Field maple (<i>Acer campestre</i>)	10	180 170 180	N -4 S -2.9 E -4.6 W -2.4	EM	Phys. -Poor Struct. -Poor	2.5	0.5 (NE)	>40	C2	Within wooded area; established; typical shrubby form Works: -	3.67

- T19 looking north west

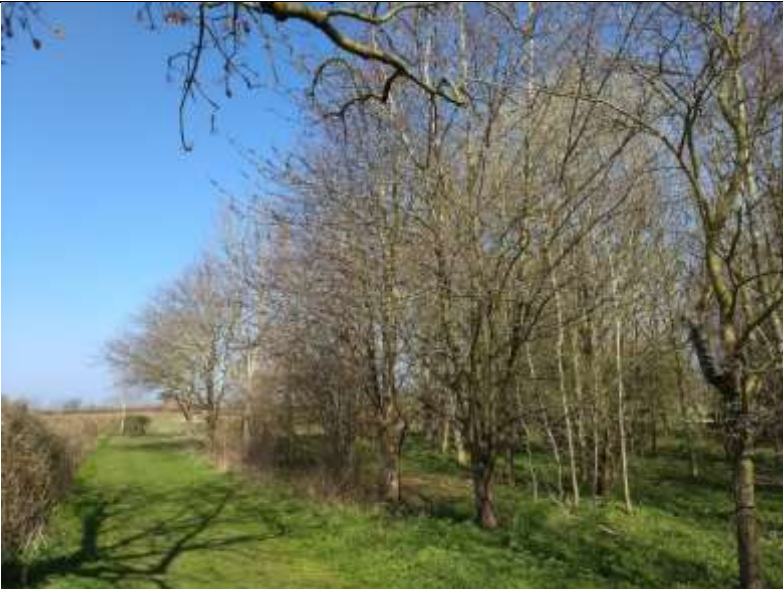
Photo 6

- Grassy access track along west side of woodland

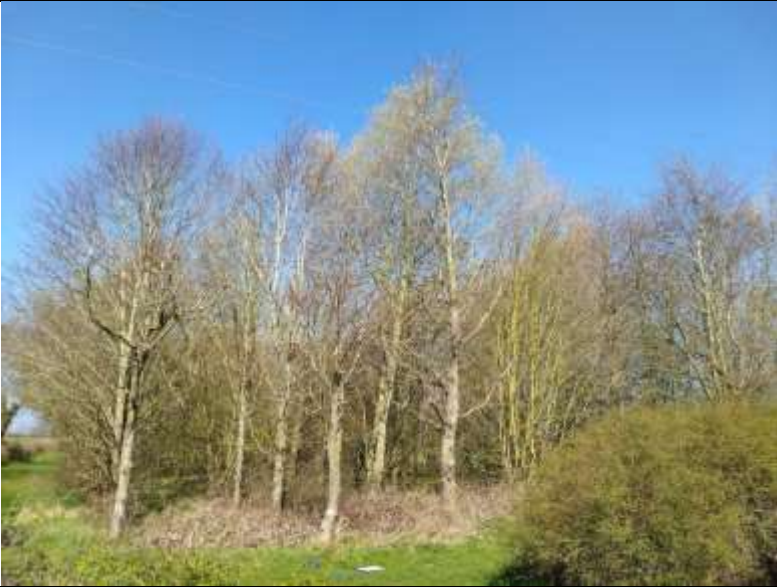
Photo 7

- T18-T22 looking north

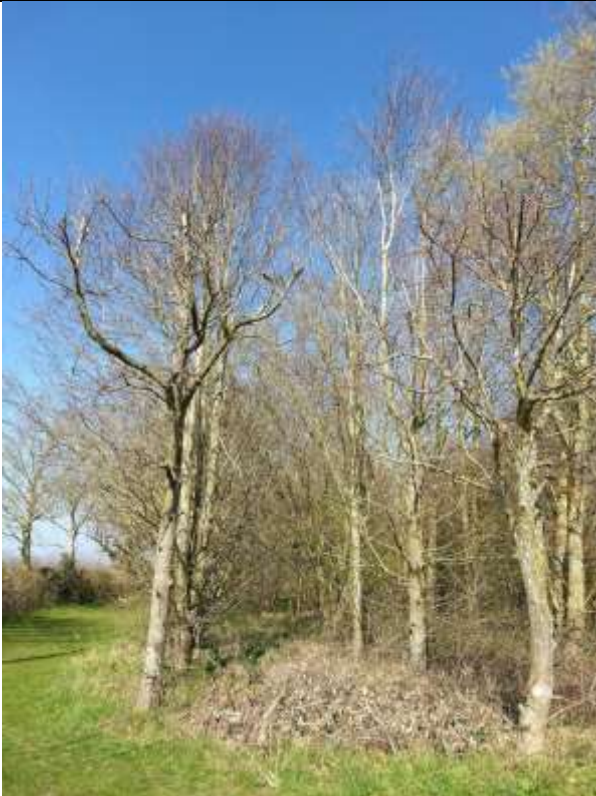
Photo 8

- T18-T20 looking north west

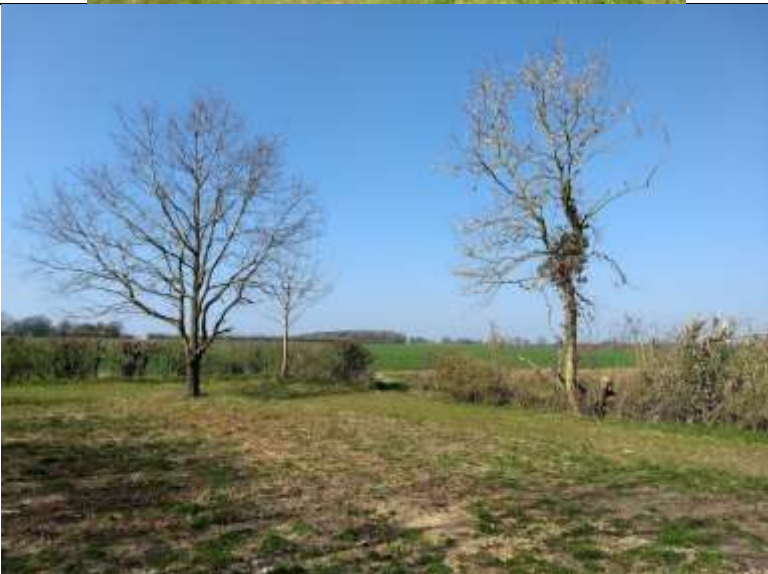
Photo 9

- North west corner of site
- T1-T3
