ARBORICULTURAL IMPACT ASSESSMENT REPORT

Land at Lower Green, Little Whelnetham

Durrants Building Consultancy

DATE: 19th December 2022

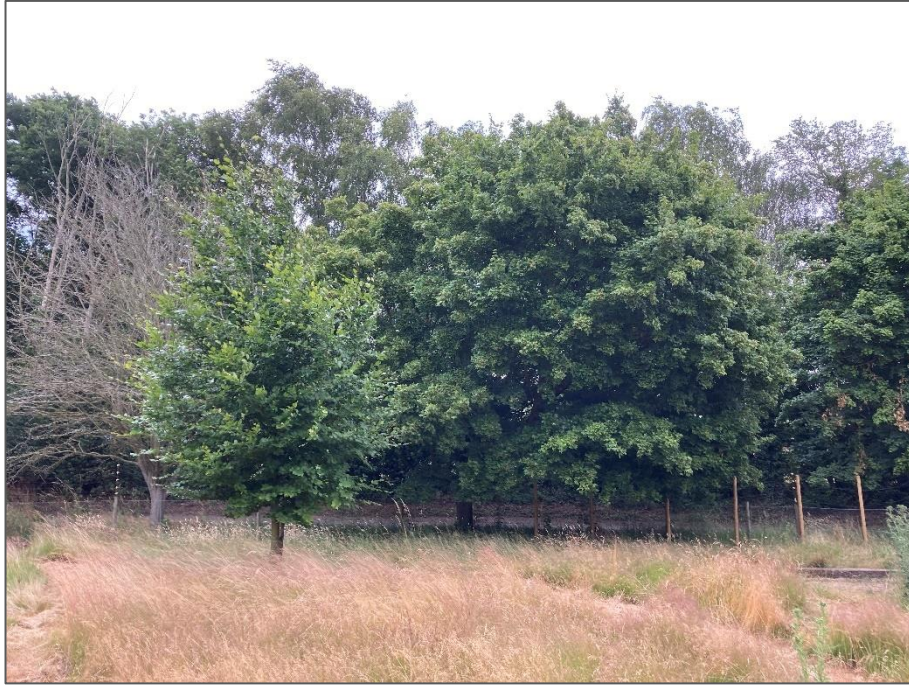
These are roadside trees, most of which are in reasonable condition, with some pruning of lower branches to prevent obstruction with the highway.

Photo 1 -T65 (foreground), T1-T3 (left-right, background), looking east

Arboricultural impact assessment: There are no impacts to these trees from the proposed development

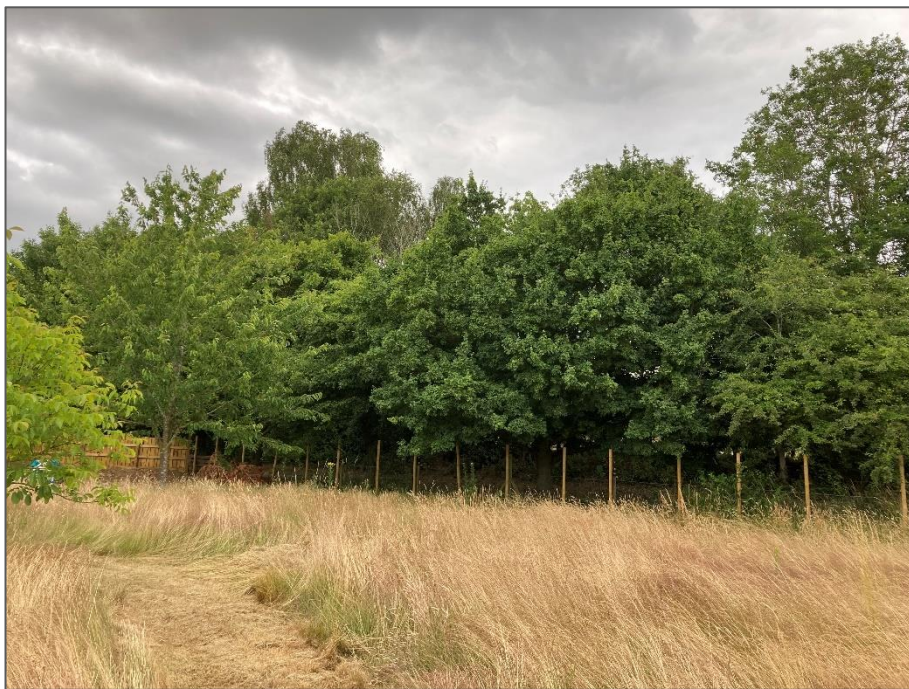
Photo 2 -T6-T9 (left – right), looking north-east

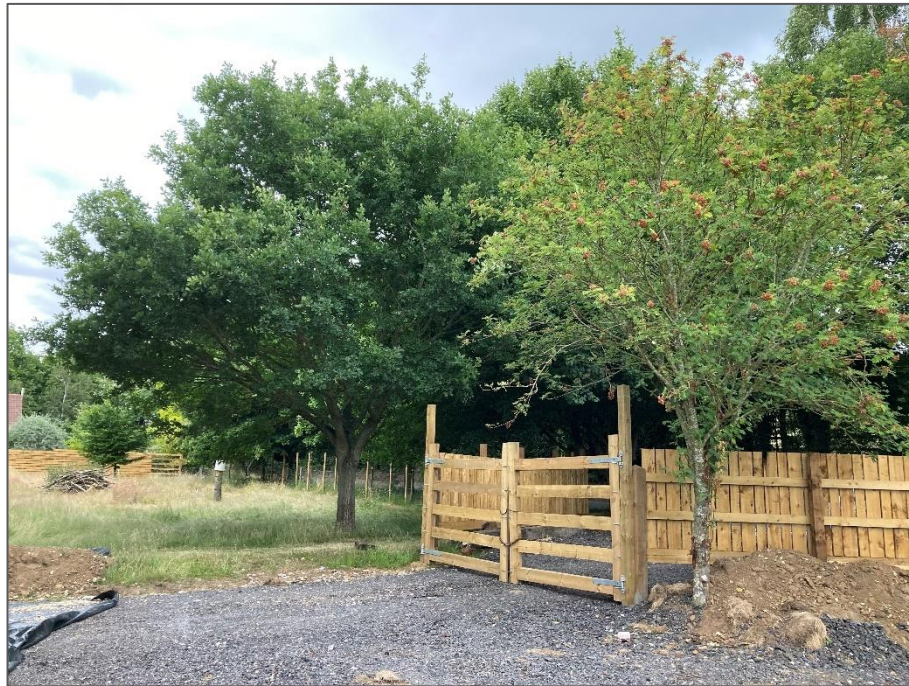
Photo 3 – T65 (left of gate), T66 (right of gate), looking north-east

T66	Sorbus aucuparia (Rowan)	SM	140	1	4(1.5)	3.0	2.5	2.0	2.0	Fair	10+	C1	1.68	8.87	Impact damage at base on west. Base of main stem buried in spoil. No major defects but average form and condition.

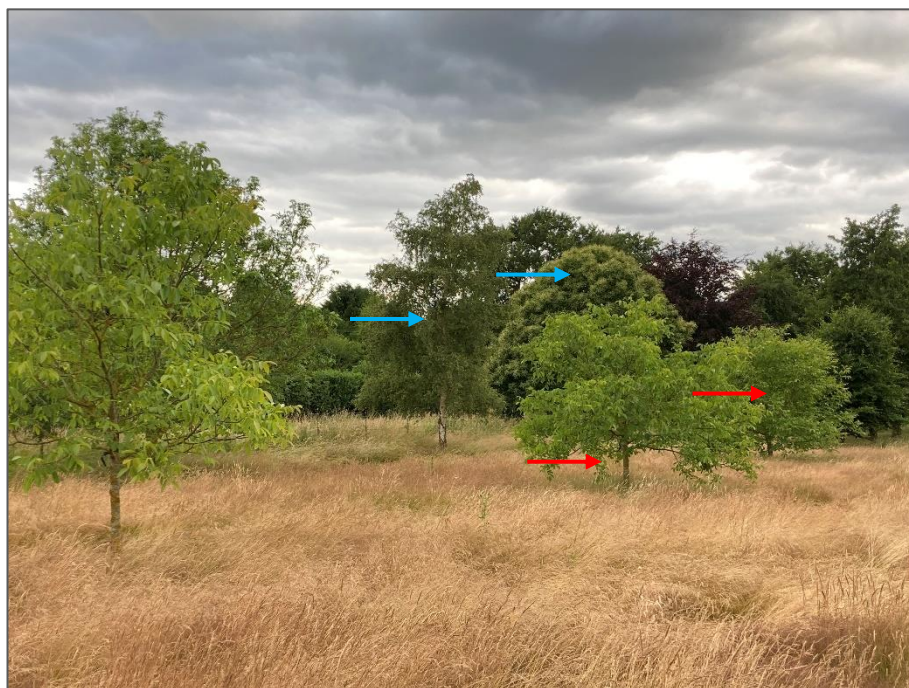
The southern boundary trees and those towards the lower western boundary are well established. There is relatively new planting within the more central section of this area of the site.

Photo 4 -G25 (left), G24 (red arrows), T14 (left background) T15 (right background)

Arboricultural impact assessment: Two small trees conflict with the proposed parking area, and will need to be removed.

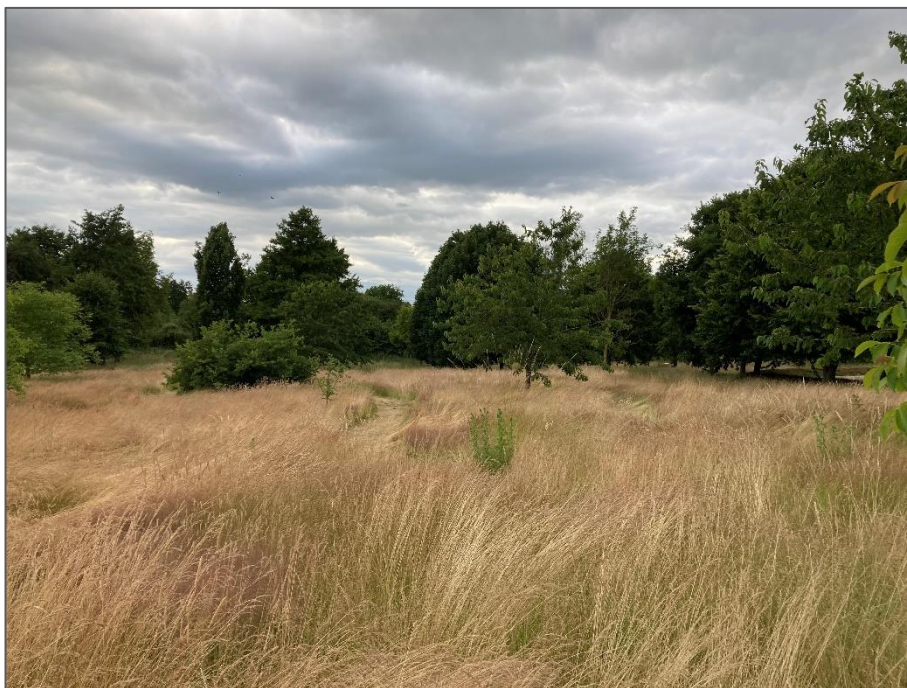
Photo 5 – view towards western boundary, T29-30 (far right), T27-28 (centre), T19,T20& T34 (background), looking west

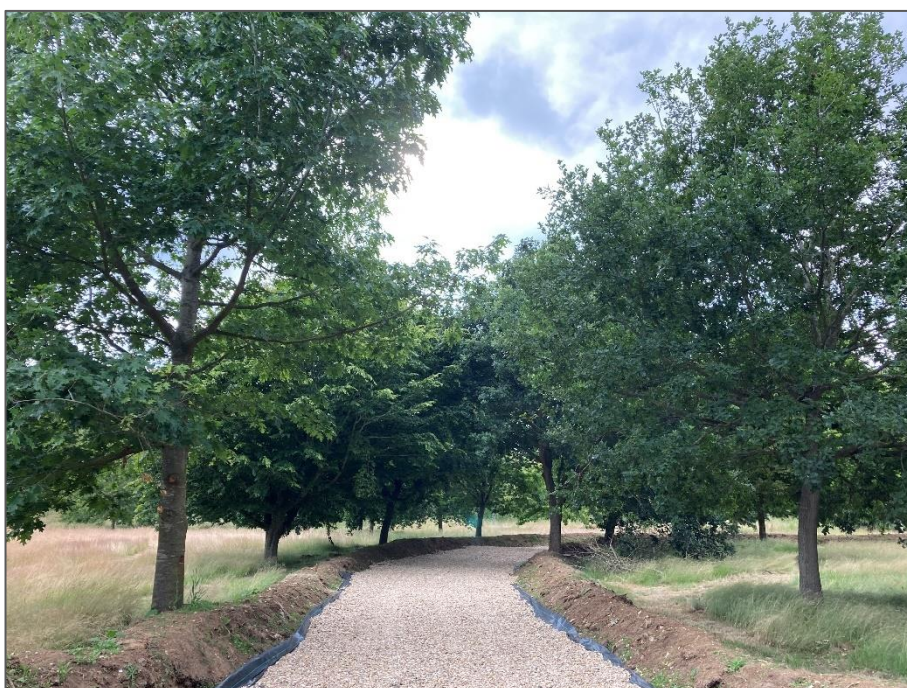
These are relatively well-established trees, there has been some recent disturbance to one aspect of the root area from the installation of the access road, and some of the stem bases have been partially buried by spoil.

Photo 6 - View down access drive T29 (left), T63 (right), looking west

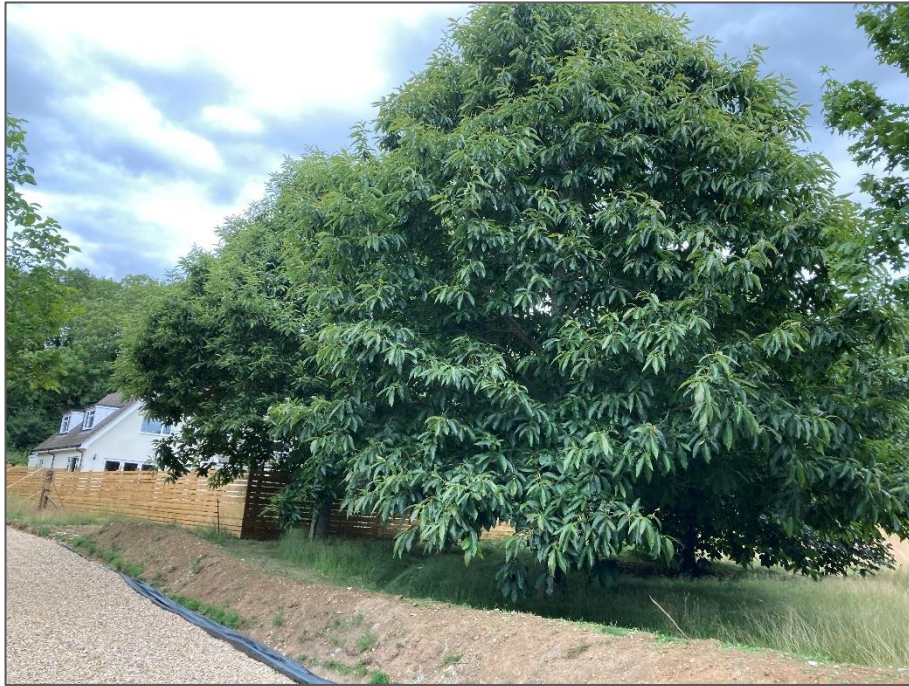
Photo 7 – G58, looking north

Tree Number	Botanical Name (Common name)	Age	Dia (mm)	Stems	Height (crown height)	N	E	S	W	Cond	Life Exp	BS Cat	RPR (m)	RPA (m ²)	Comments	Recommendations
G58	Castanea sativa (Sweet Chestnut)	EM	400	1	7(0.5)	3.0	3.0	3.0	3.0	Fair	20+	B2	4.8	72.39	Two trees set back slightly from access road. Lower branches have been removed on northern-most tree. Both trees are in reasonable condition, relatively small for species but making an attractive feature.	
T59	Aesculus carnea (Red Horse Chestnut)	SM	280	1	7(0)	4.0	4.0	4.5	4.0	Fair	10+	C1	3.36	35.47	Evidence of bacterial bleeding canker, not a heavy infection, but sapwood death from previous years and new areas of bleeding this growing season. Level of infection is tolerable and tree has good potential for recovery.	
T60	Acer platanoides (Norway Maple)	EM	280	1	8.5(1)	4.0	4.0	4.0	3.0	Fair	20+	B2	3.36	35.47	Set back slightly from access road, but spoil mound within RPA. No major defects and reasonable form and condition. Low category B.

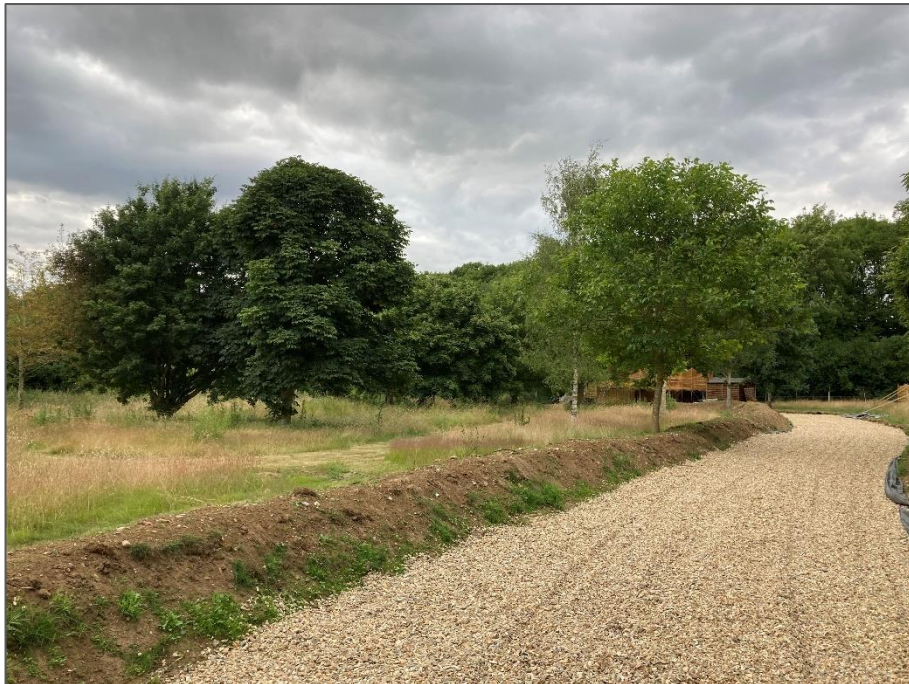
There is some newer planting along the line of the access drive, with more established planting to the west. All trees have relatively squat forms, which is typical across the site.

Photo 8 – T41 & T42 (left), T54-57 (right), looking north-west

Arboricultural impact assessment: there is a small encroachment into the RPA of T43 by a proposed straw bale hut.

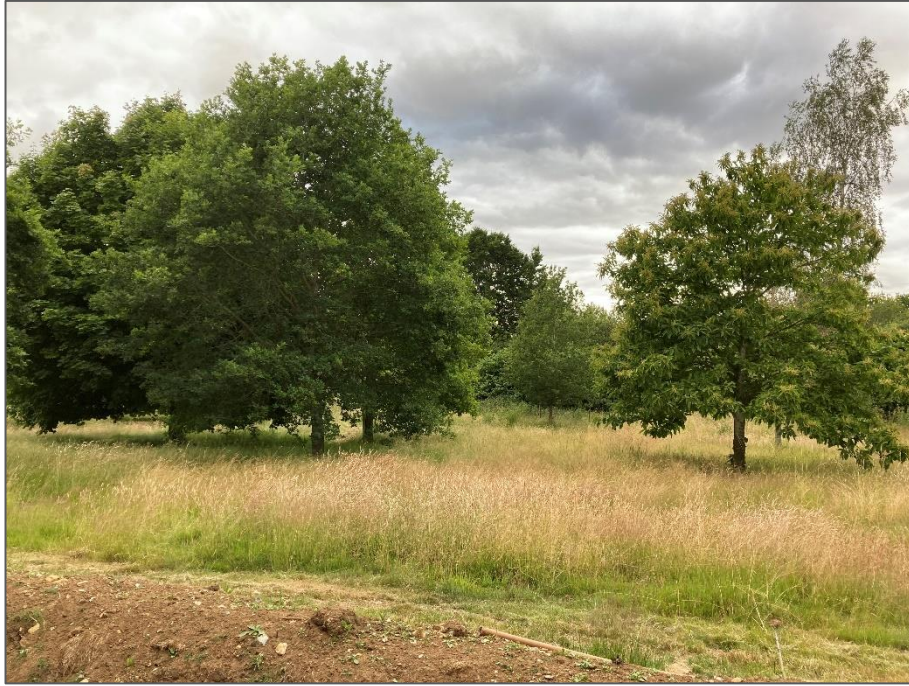
Photo 9 - G31 (left), G33 (right), looking south
