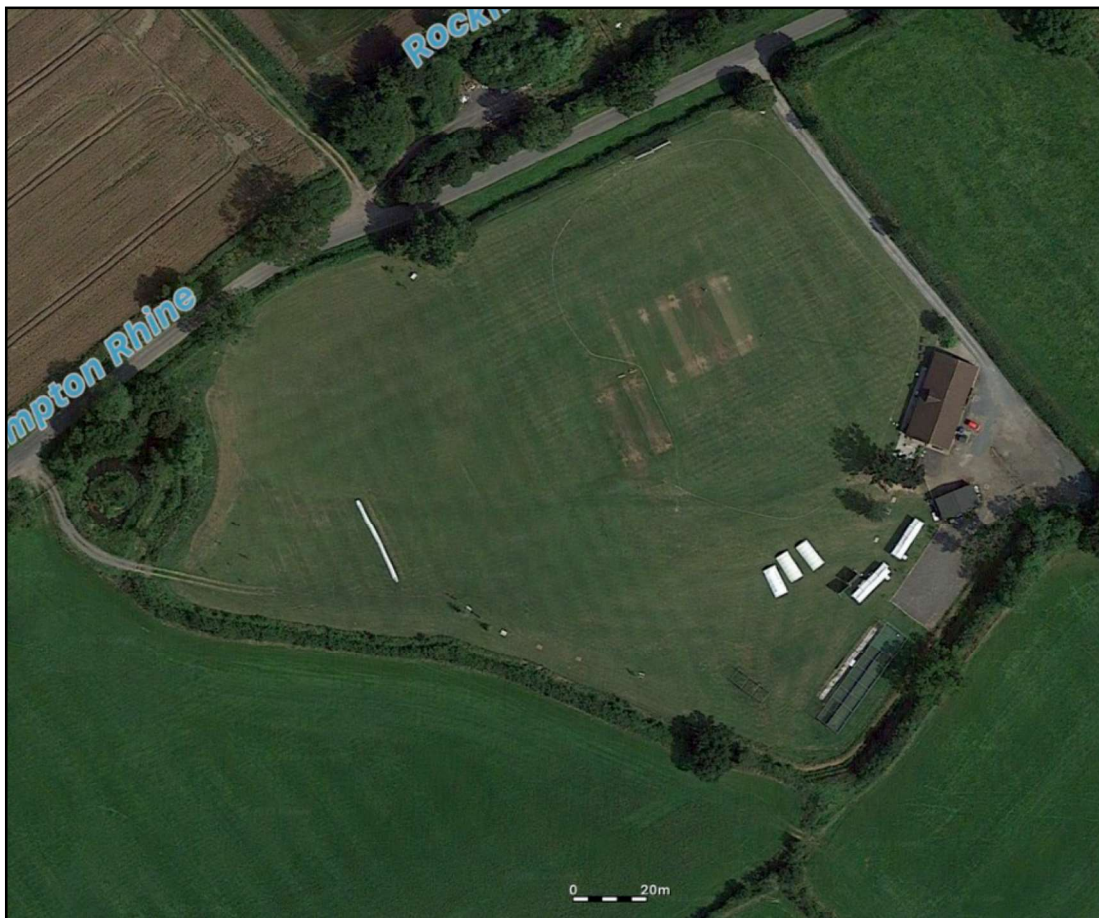
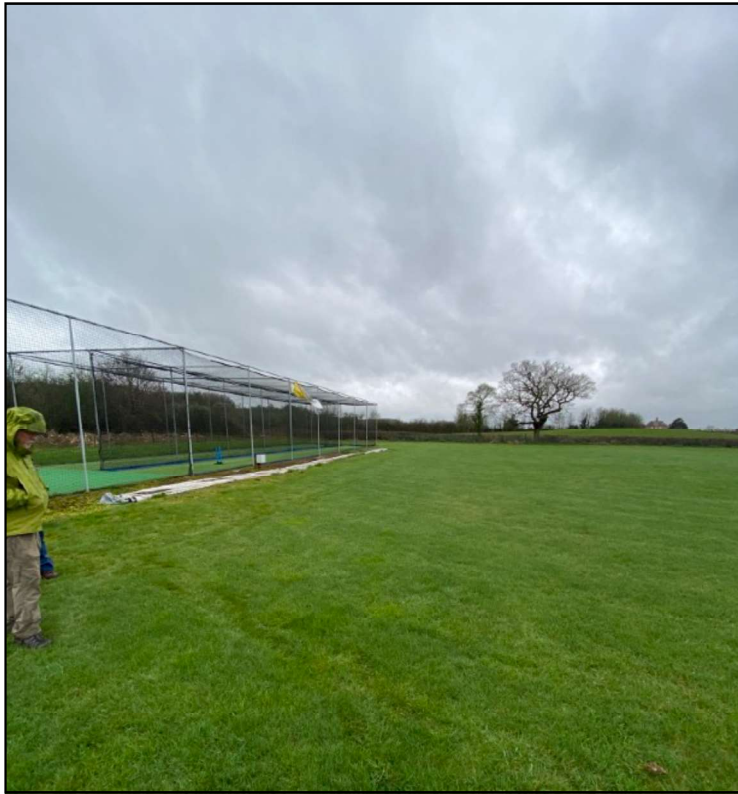
### **IMAGE OF BUILD SITE:**

The area adjacent to the existing net system is natural turf and relatively flat.

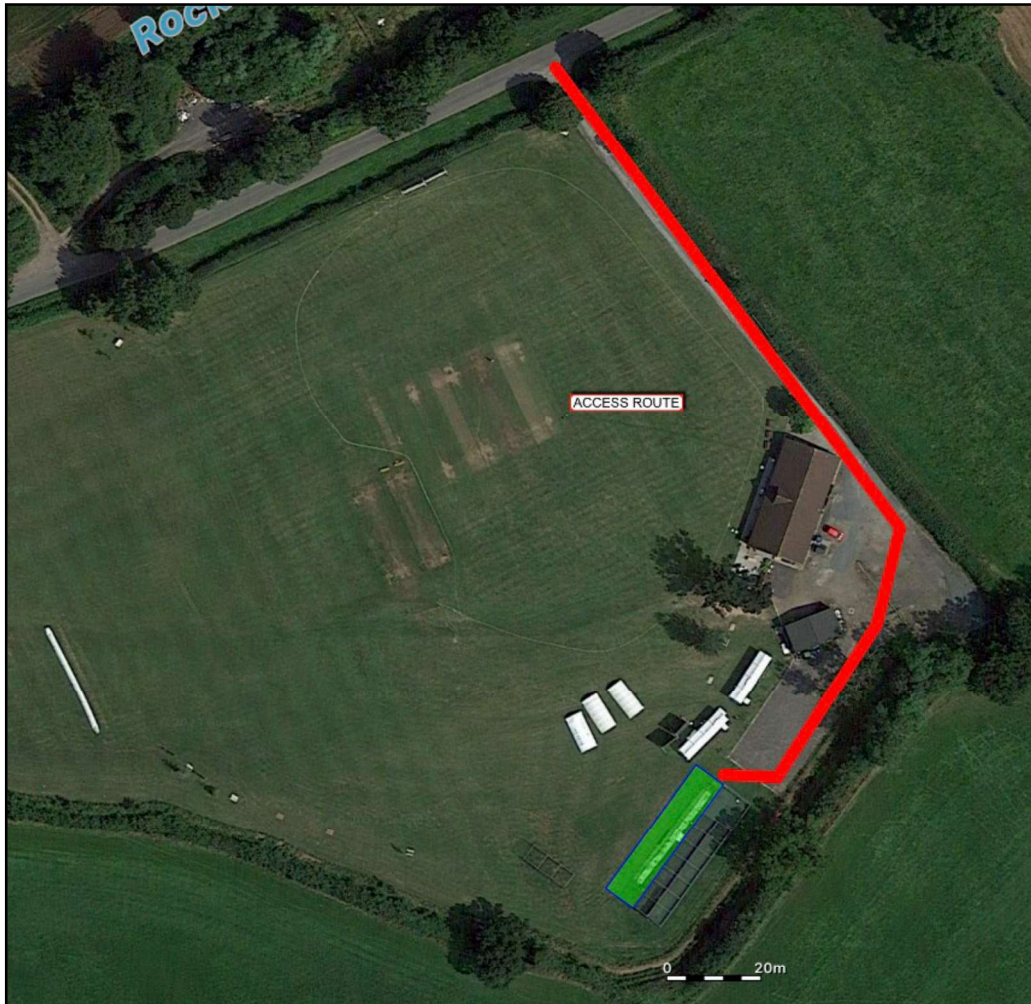
## PLAN OF ACCESS ROUTE:

The proposed works area can be directly accessed off the main car park via the gated entrance situated NE of the cricket field.

If prevailing ground conditions are wet, it would be advisable to approach the build site around the cricket ground, crossing approximately 10 m of natural turf. Although every effort will be made to ensure no damage is caused to the outfield during construction works it was highlighted at the site visit that some damage will be unavoidable if the works take place in wet weather.

total-play propose establishing an unloading area on the car park and using part of the car parking area as a site compound.

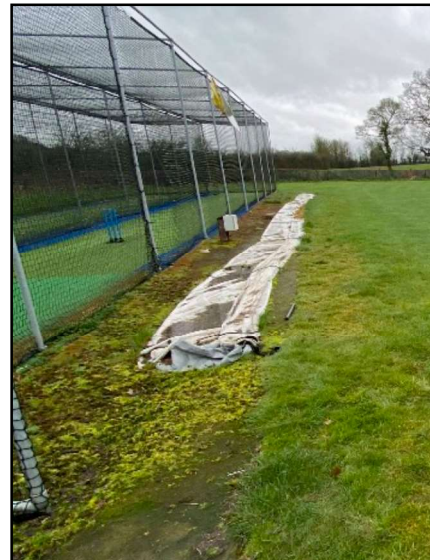
There is a power cable which feeds the existing net system located adjacent to the new system build site and this will need to be included in the plan for the infill area. This will need to be relocated before construction of the new system commences.

The power cable will need to be dug-out and then re-instated to allow for the infill area to be created with weed mesh, base aggregate and carpet.

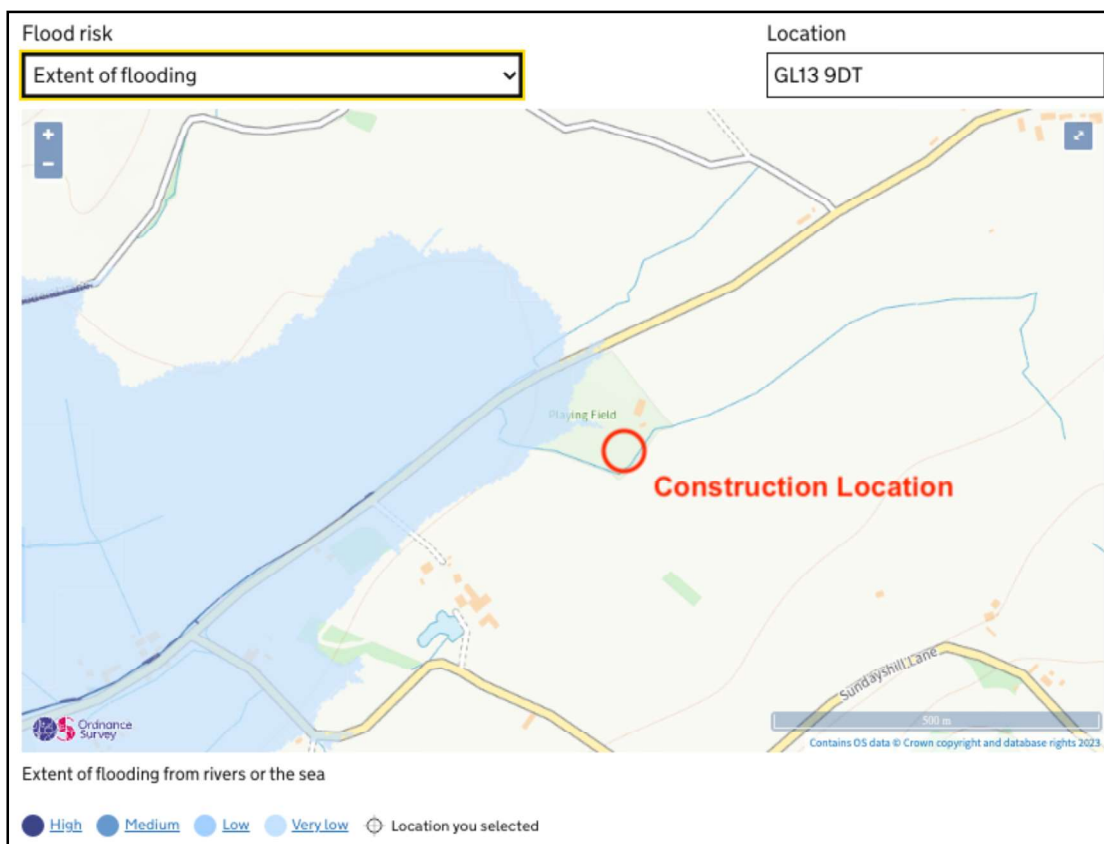
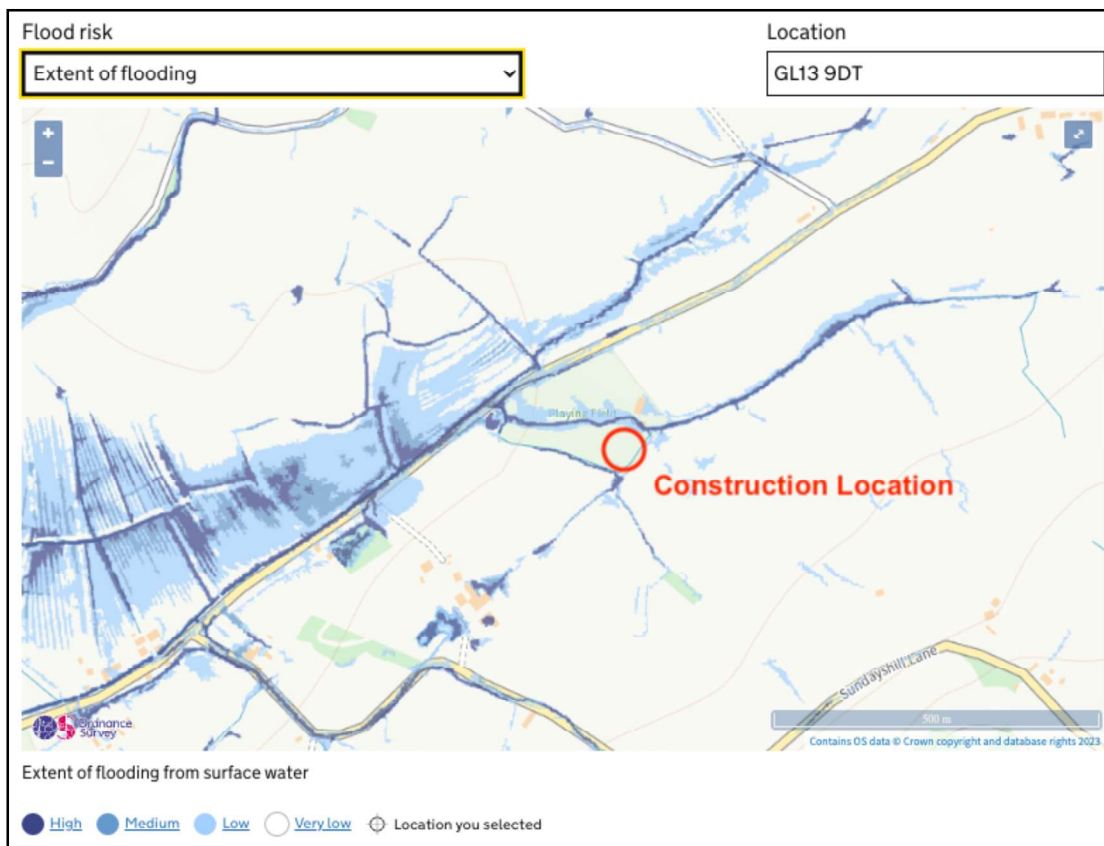
### FLOOD RISK MAP:

The proposed build site is not regarded to be at risk of flooding from either 'Surface Water or 'Rivers or the Sea'.

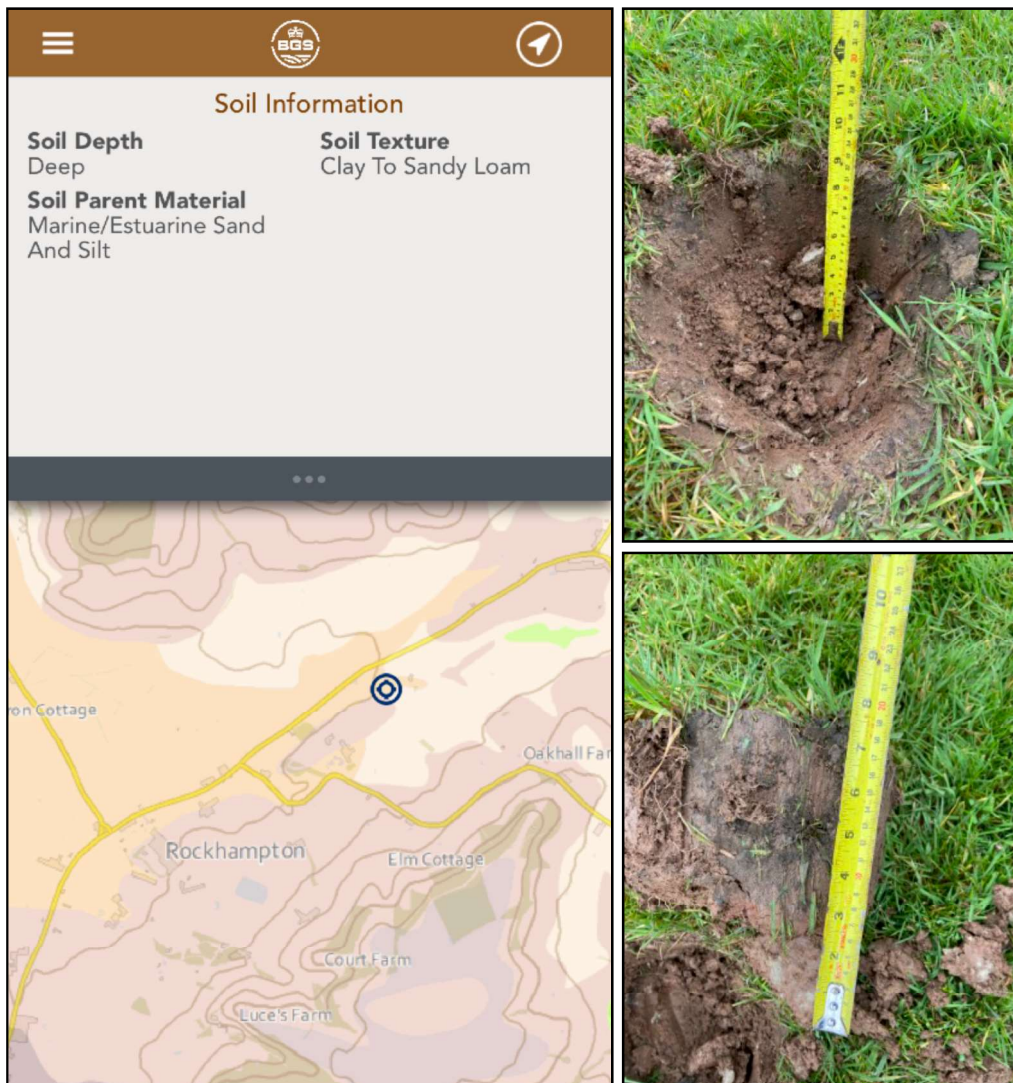
### GEOLOGY INFO & TRIAL HOLE IMAGE:

The depth of this top soil layer was between 150 - 180 mm. The top soil is thought to be a Clay/Sandy Loam soil. The sub base is made up of a Clay/Sandy Loam soil which contains a high volume of flint stones of various dimensions.

The soil profile showed no signs of continual water logging.
