HERITAGE STATEMENT

43-47 HIGH STREET NEWMARKET CB8 8NA

John Johnstone MRICS Keylocks Ltd Chartered Surveyors and Valuers Rothsay House, 124 High Street Newmarket CB8 8JP

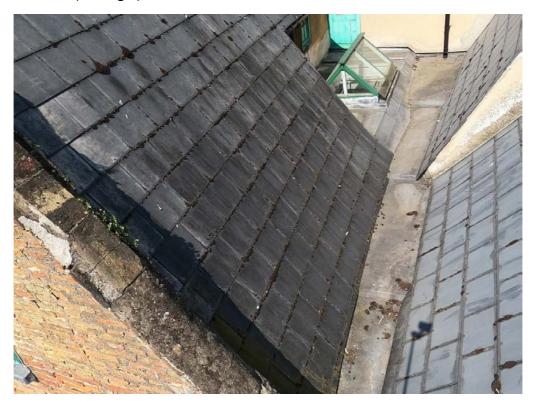
Fig 9. Flat roof area to rear elevation.

The flat roof between the two wings has a roof light and chamfered interior to the eaves. (See Fig 9)

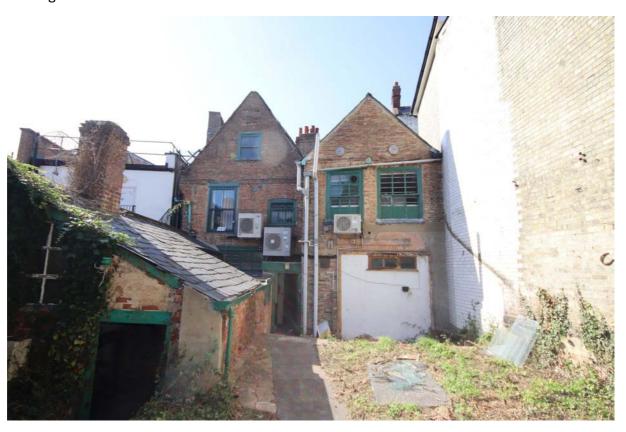
Fig 10.

The rear elevation shows various modifications including soil vent pipes from the two WC's located on this elevation. Fig 10 also shows the attached outbuilding which has a finished floor level below that of the garden and path. Air conditioning units provide cooling and heating to the commercial units both in

43 and 47 High Street. The guttering is generally in poor condition and requires refixing and some renewal.

The outbuilding as shown in the foreground of Fig 10 is cement rendered in places which has deteriorated, and has damaged the bricks beneath. As well as requiring to be re-rendered in a lime finish the building also requires to be re-roofed with the internal ceilings having partially collapsed.

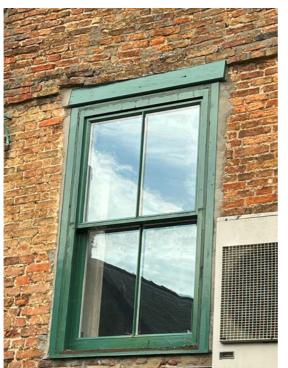
Fig 12.

Modern sash rear window to the landing area.

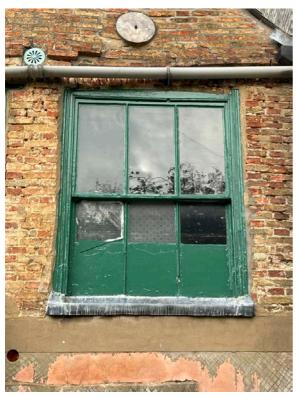
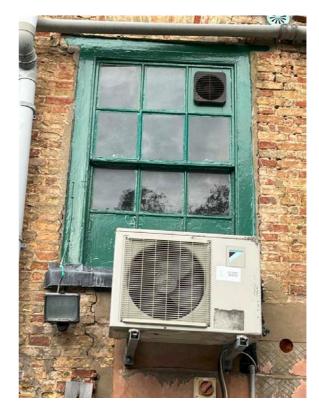
Fig 13 Fig 14

Rear windows over the ground floor shop are modern sash windows with various alterations.

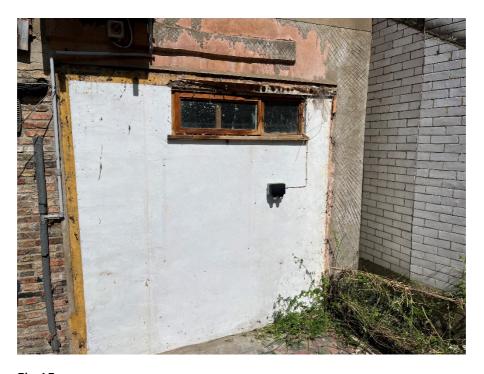
Fig 15.

The alterations in 1987 also involved the bricking up of windows to the rear elevation, as can now be seen from the cement render externally to this area. A lean-to was erected over an area to the rear, probably at this time, where a modern tiled floor can be seen externally. (Fig 15)

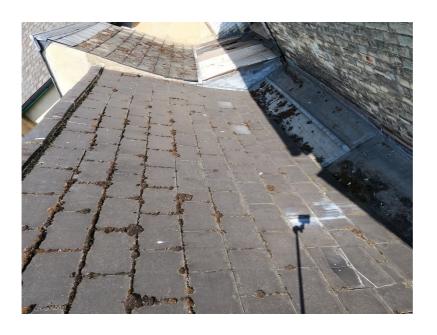
The stairs have been constructed within a space between the original rear wing to this elevation and the adjacent building, with a modern Perspex skylight inserted to the stair well. Fig 16 and Fig 17.

Fig 16. Skylight to stairs below attic pitched roof.

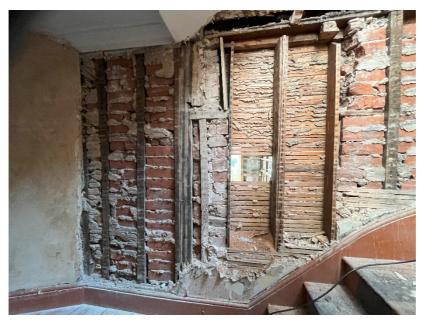
Fig 20

The stairwell in figure 20 shows brick infill to the timber frame either side of a lath and plaster area, possibly originally an opening. A new opening is proposed at the bottom of these stairs to the landing which will be fire rated.

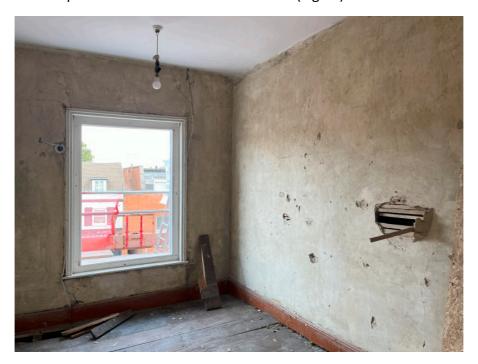
Fig 24

Fig 23
Walls to the upper floor are original lath and plaster and in a reasonable state of repair with most able to be retained. (Fig 24)

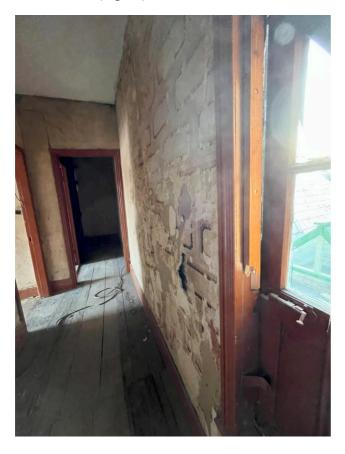
Fig 25

The rear wall is in poor condition and requires strengthening to the inner face. (Fig 25)

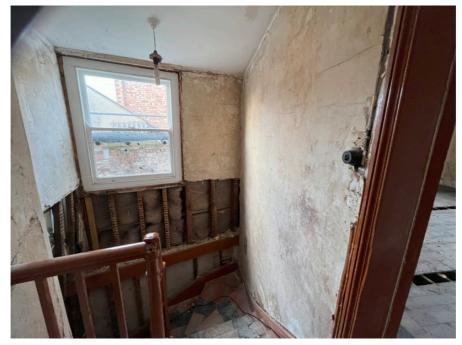
Fig 30

The stairs to second floor will require a side handrail and some modification but are to be retained. (Fig 30). The window to the stairs as above is modern. The timber frame shows to the external wall with some insulation apparent.

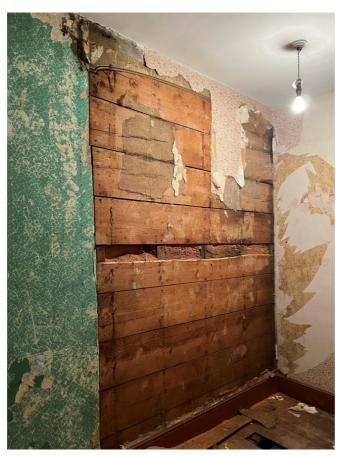
Fig 32.

Some boarding between 2 rooms showing an original arch above, with chimney breast to the left of boards. Proposals are to reinstate this opening (Fig 32).

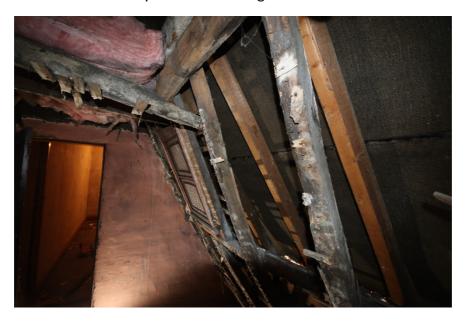
Fig 34

This has been re-roofed from the outside, and the original rafters have been left although these are bowed in places. The structure requires a purlin support to one side and proposals include the reinstating of a roof light which has been blocked by the new roof. Fig 34.

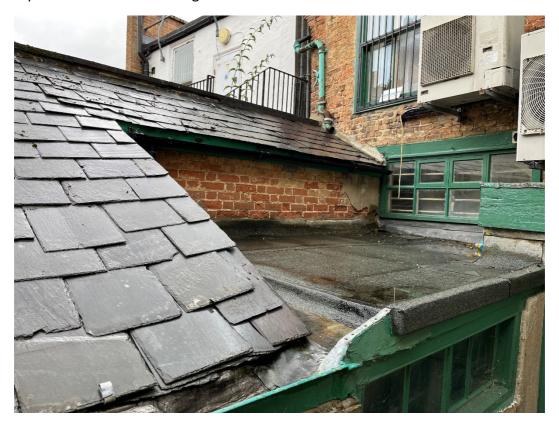
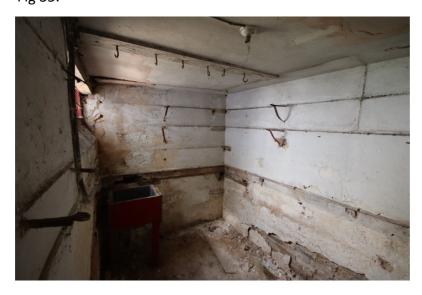
The outbuildings to the rear are attached to the main building with two internal areas. These have not been used for many years and it is proposed to renovate the buildings. The outside has been cement rendered in places which will be replaced with a lime mix. Fig 35 and 36.

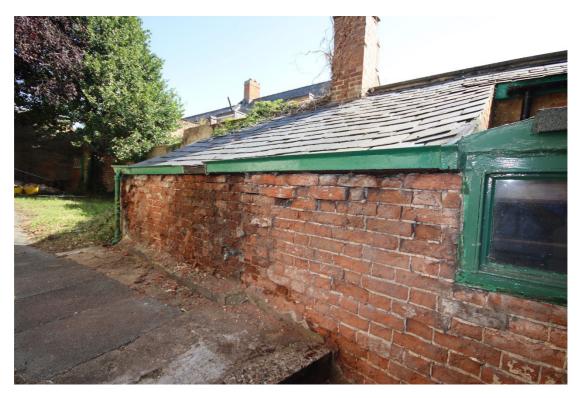
The rear outbuilding is in poor condition. The brickwork has been damaged by cement render and the roof is poor. Fig 37

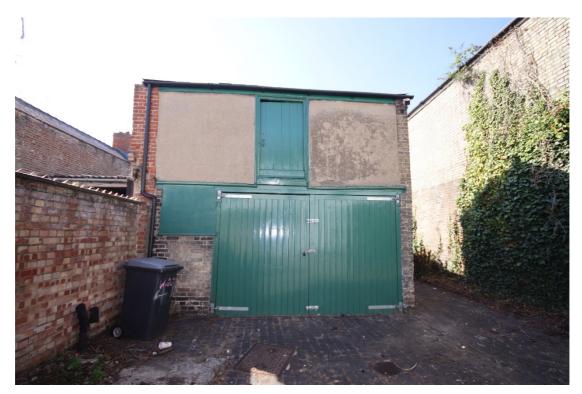
Fig 40

The buildings to the end of the curtilage comprise a brick built structure used in recent times as a garage, with a storage building adjacent. The building originally spanned an adjacent plot belonging to the adjacent property, and the brickwork outline can be seen to the walls at either side of this former building. A wall abuts Palace Street giving limited vehicular access from the rear. The construction is of mid to late 19th century solid brick with a slate roof. Internally the front of the building has been used as a garage with a loft above. The building is not considered to be of historic interest, with part of the original footprint now demolished.

The front elevation is partly cement rendered with double garage doors, and areas where windows were present and now boarded over. There is an external timber door to the hayloft area.

Proposals would be to remove the cement render and lime render the walls depending on the condition of the brickwork below and whether repair is possible. The garage door would form a large window with the loft external door made into a ½ window.

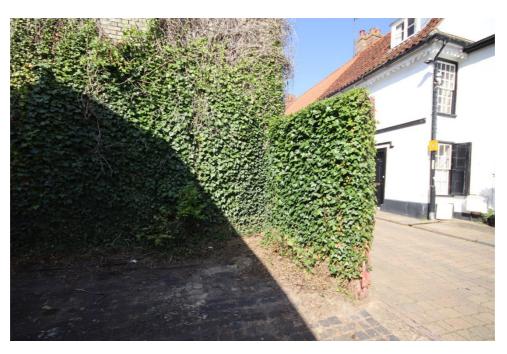
Fig 41
Rear wall to be taken down to allow access.
