Arboricultural Impact Assessment

For Trees At

St. Cuthbert's Hospice,

Durham

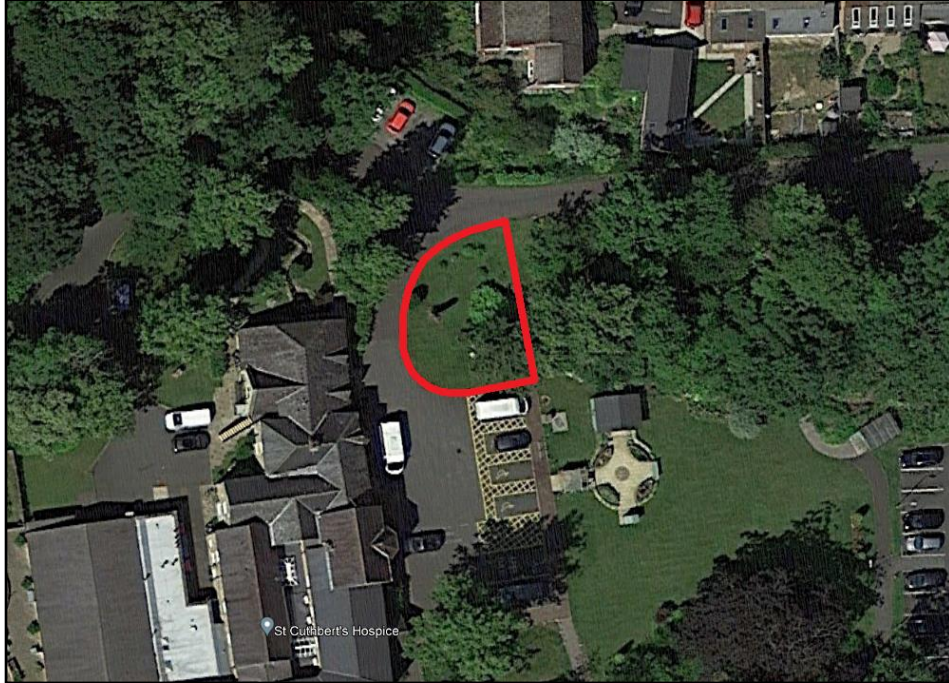
Figure 1 - The location of the proposed parking bays are indicated by the red line in the above image.

4.4.1 It will be necessary to remove some of the existing trees to facilitate the proposed development:

- Trees 1-6, 9
- Groups 1 & 2

will need to be removed to facilitate the formation of the new parking bays.

- The new parking bays are in direct conflict with the case of trees 1-6 and groups 1-2 necessitating their removal.
- In the case of tree 9 the conflict is indirect though considered severe enough to warrant removal of the tree. Disabled access is a requirement of the project, necessitating level ground. The use of above ground systems will not work with the existing levels. Consequently excavation is required. To do so would compromise around 25% of tree 9's RPA which far exceeds acceptable tolerances. The line of excavation start approximately 3.0m from the tree stem where potential exists for striking roots which contribute to structural stability. Lime is known to have relatively soft wood with limited ability to compartmentalise decay; this work is likely to invite future issues. The tree is a mature individual and unlikely to tolerate this level of disturbance. Consequently its removal is recommended.
