# Bat Survey Report

**Lancaster House, Thornbury**

Client: Michael Brownrigg  
Document No.: NPA 11375 0400  
Revision: PO1  
Status: Info  
Print Size: A4  
Date: 06/12/2023

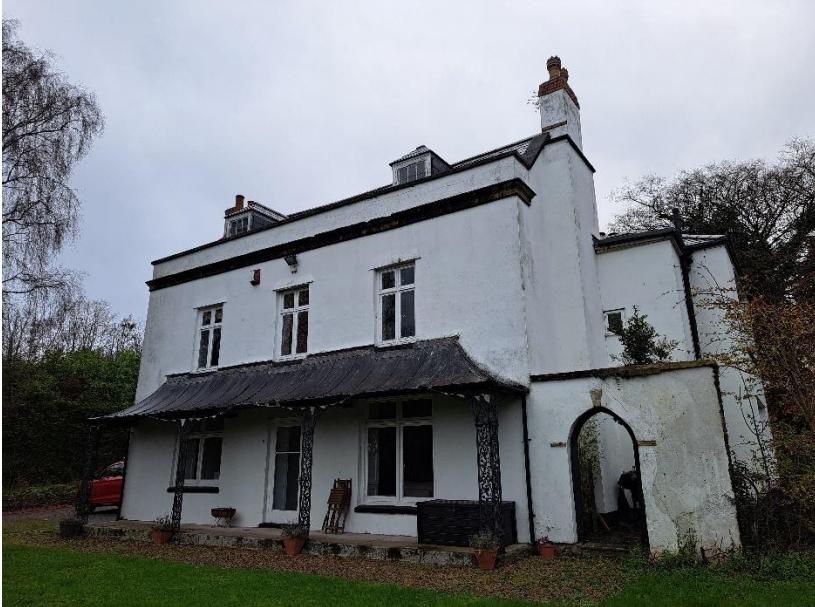
Photo No.	
1

West elevation	Gaps between lead flashing and slate tile cladding on west elevation dormers. Gap between south chimney unit render and roof tiles. Several raised roof tiles. Linear gaps between render and lead flashing above and below cast-iron veranda. Gaps below lead flashing on veranda. Small gap in corner of stone cornice on south-west shoulder of building. Large gap between exposed stonework and render. Linear gaps between facia board and brickwork. Gaps under lead flashing on stone cornice.
Rear outhouse		The rear outhouse has been constructed from stone, with an open extension built from a mix of breeze block, stone and brick. The roof of the outhouse has been constructed from clay pantiles over a timber frame. The frame comprises timber rafters with bitumen felt overlay, and a single

View of west elevation
2

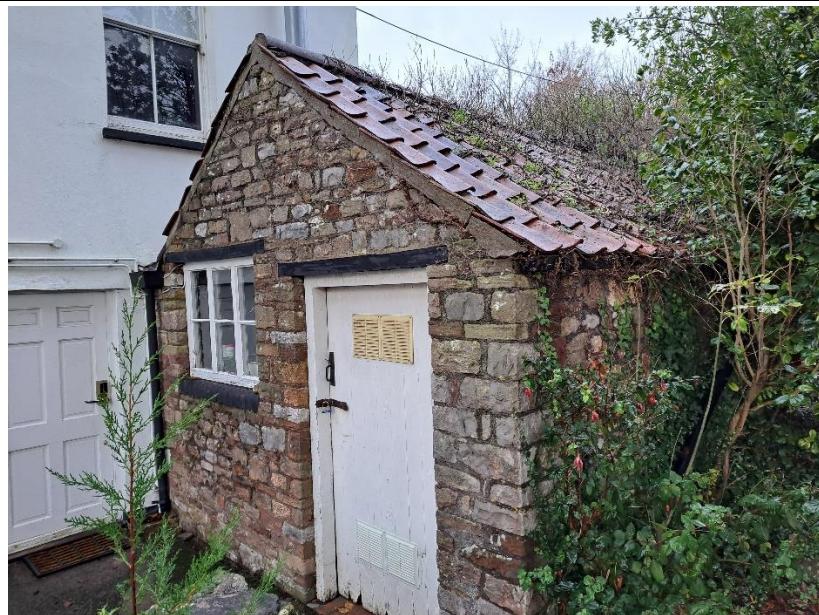
5

purlin on each slope. The open extension has been covered with corrugated asbestos cement sheets.	
	Rear outhouse	Hole behind lead flashing on south-west shoulder of outhouse. Linear opening between entrance door lintel and timber door frame. Uneven/loose pantiles across outhouse roof, particularly where ivy has encroached and colonised. Cracks in fillet of cement on south elevation where ivy has rooted. Gaps below corrugated asbestos roofing sheets on extension, yet most are sealed with cement. Gaps under lead flashing below flue pipe.
<b>Internal</b>	The internal elements comprised 4 No. roof voids and a basement with 3 No. cellar rooms.	
Roof void 1	Small, timber framed roof above kitchen element. Approx. temperature 12.1°C.	
Roof void 2	Double hipped roof on western element of building (above master bedroom). Approx. temperature 10.4°C. This roof void features 3 No. king posts with principal rafters and brace beams, and timber purlins on each face. The floor is insulated with a combination of soft insulation and Celotex insulation board. A plastic style roofing membrane was used to line the roof. A suspected bat dropping was collected from the floor of the roof void.

North-west facing view of rear outhouse

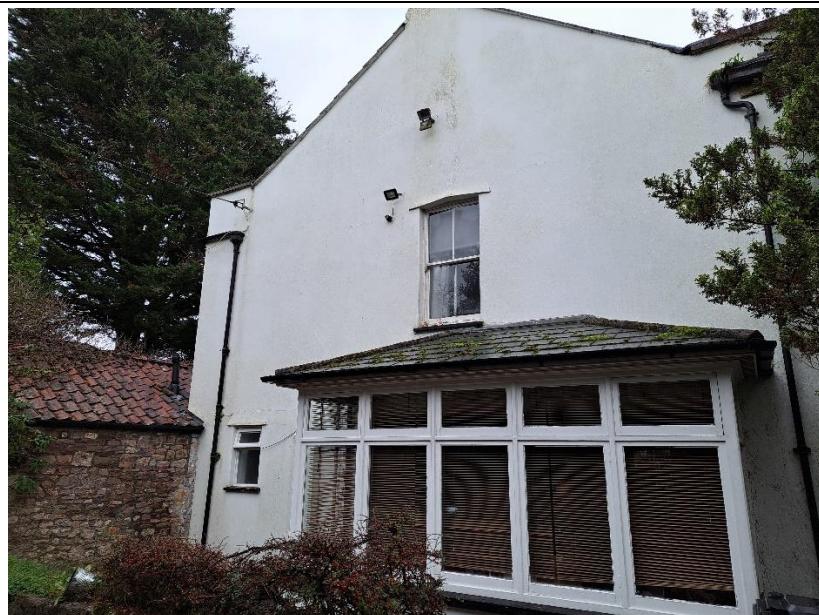
6

North elevation	Gap below lead flashing at chimney base. Gaps below lead flashing on small single story extension element on north elevation. Gap below lead flashing between roof tiles and parapet coping stones on northern edge of building. Large hole behind downpipe tray.
	East elevation	Uneven lead flashing below parapet on two-story element. Gaps below lead flashing on north elevation chimney unit. Linear aperture where mortar has fallen out/been removed on ridge tile near chimney unit on north elevation. Uneven roof tiles providing gaps for crevice dwelling bats. Gap behind lead flashing around irrigation hole in east facing parapet. Linear opening between facia board and render. Large open ventilation hole in external wall.
	South elevation	Linear gaps between facia board and brickwork. Linear aperture behind soffit board above large, high-level casement window. Gaps under lifted roof tiles. Large gap behind downpipe tray. Raised asbestos roof tiles. Linear gap under ridge tile where roof tile is missing. Possible access to cellar through metal grill with c. 7 cm spacings. Two holes within exposed breeze blocks above window (soffit board missing). Linear gaps between facia board and render. Double roman tiles of single-story element appear sealed and covered by moss, so unlikely suitable for bats.

View of eastern section of north elevation

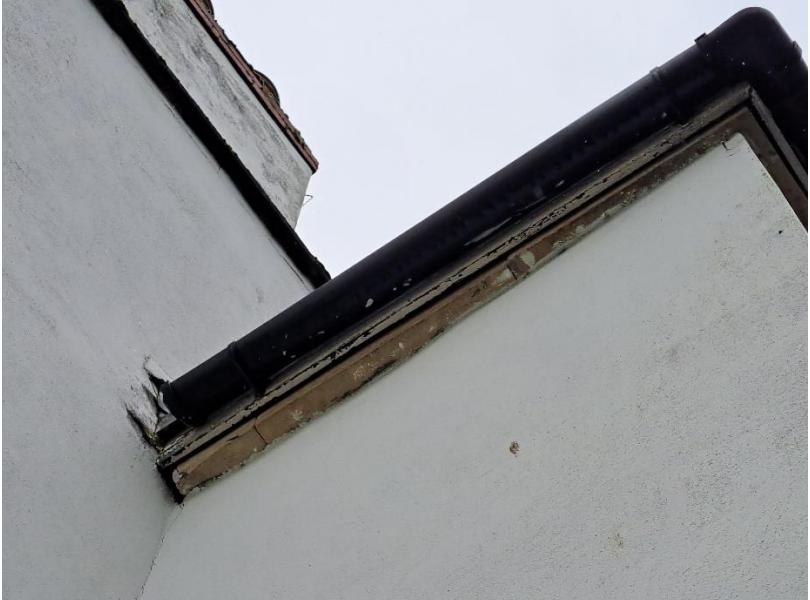
Large hole at junction of external wall and linear gaps between fascia board and stonework on west elevation

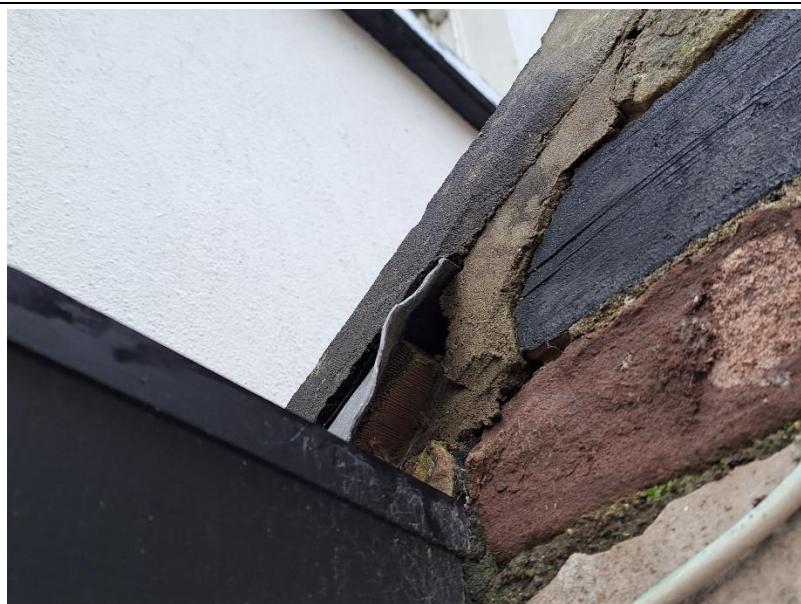
Gap behind lead flashing on rear outhouse

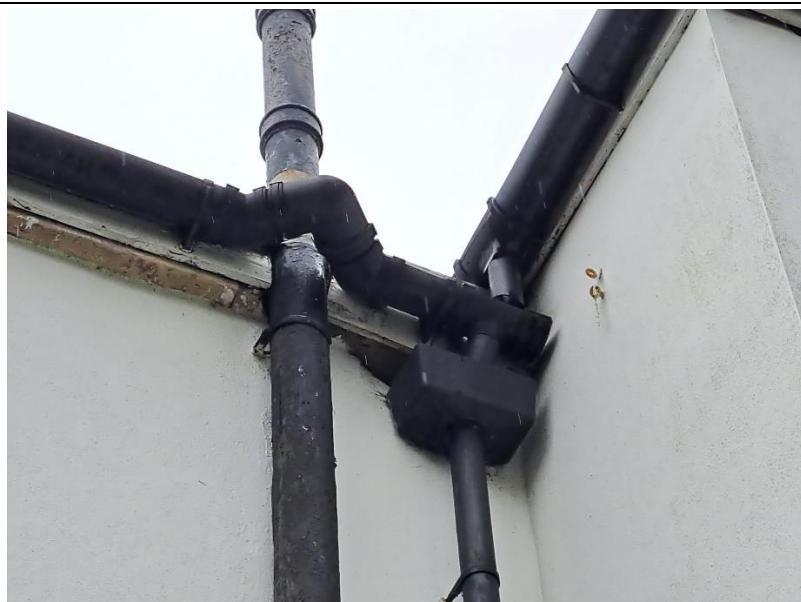
Large hole behing downpipe tray on south elevation
