METHOD STATEMENT

Willow Cottage, The Green Dinton, HP17 8UP

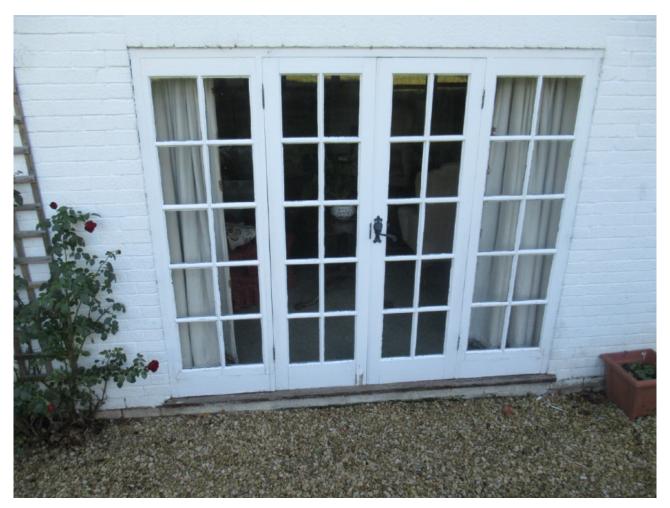
The single glazed French doors to the 1970's thatched extension have failed, with notable decay to the base of the doors and side light. The units are also significantly draughty. The door set is therefore considered to be past economic repair.

Existing French Door glazing bars- doors and side lights.

Existing French doors, with side lights.

We propose to replace them with flush closing single glazed units to match existing. The units will be in sapele hardwood and factory spray painted. The glazing bar configuration and design to match existing.
