Willow Cottage, The Green,  
Dinton, HP17 8UP

APPLICANT: Mr & Mrs Rimell

# HERITAGE STATEMENT

## 3. INVESTIGATIVE PHOTOGRAPHS

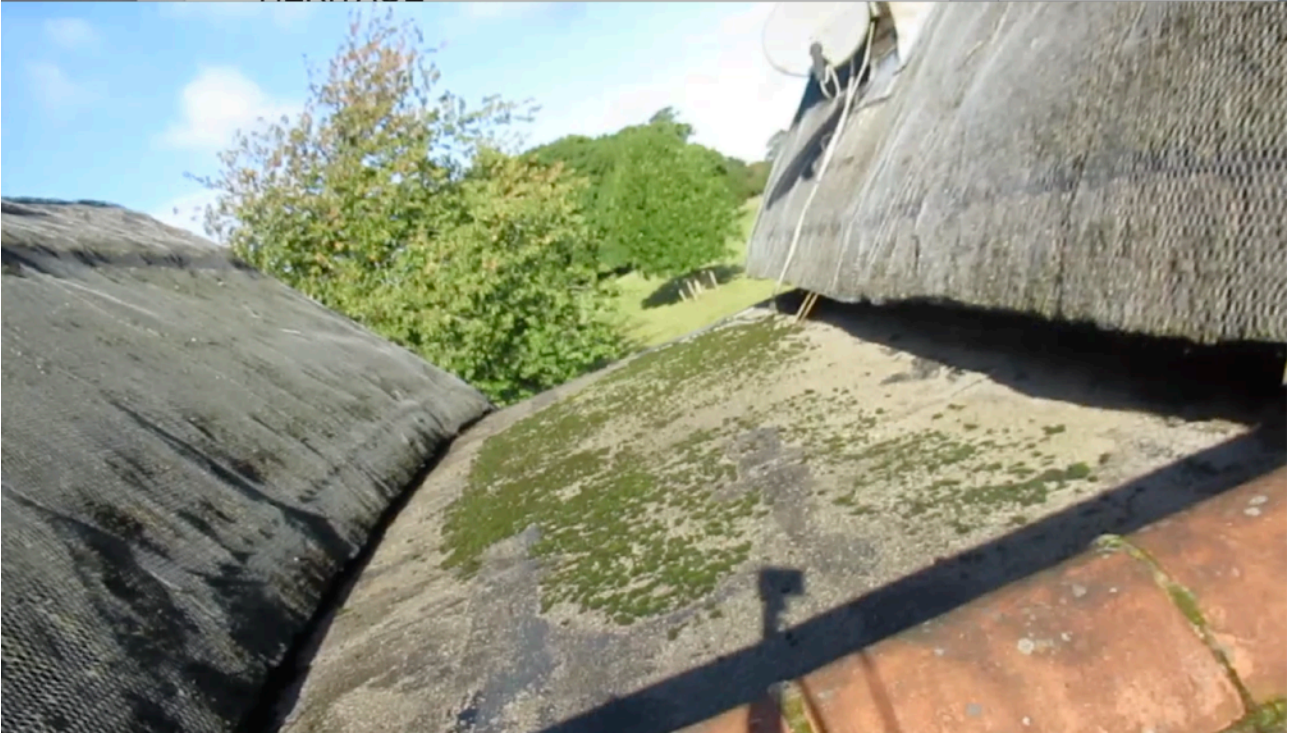
View across flat roof. Viewing from front to rear.  
Thatch to left slope sits on flat roof. Thatch to 1979 extension clear of flat roof.

To get at the flat roof covering, the thatch sitting on the flat roof needs to be stripped back to let the roofing contractor work on the flat roof covering. Once done, the thatch can be redressed, but kept clear of the flat roof covering, as is the case with the thatched eaves opposite. It makes no sense to reinstate the thatch back onto the flat roof covering.

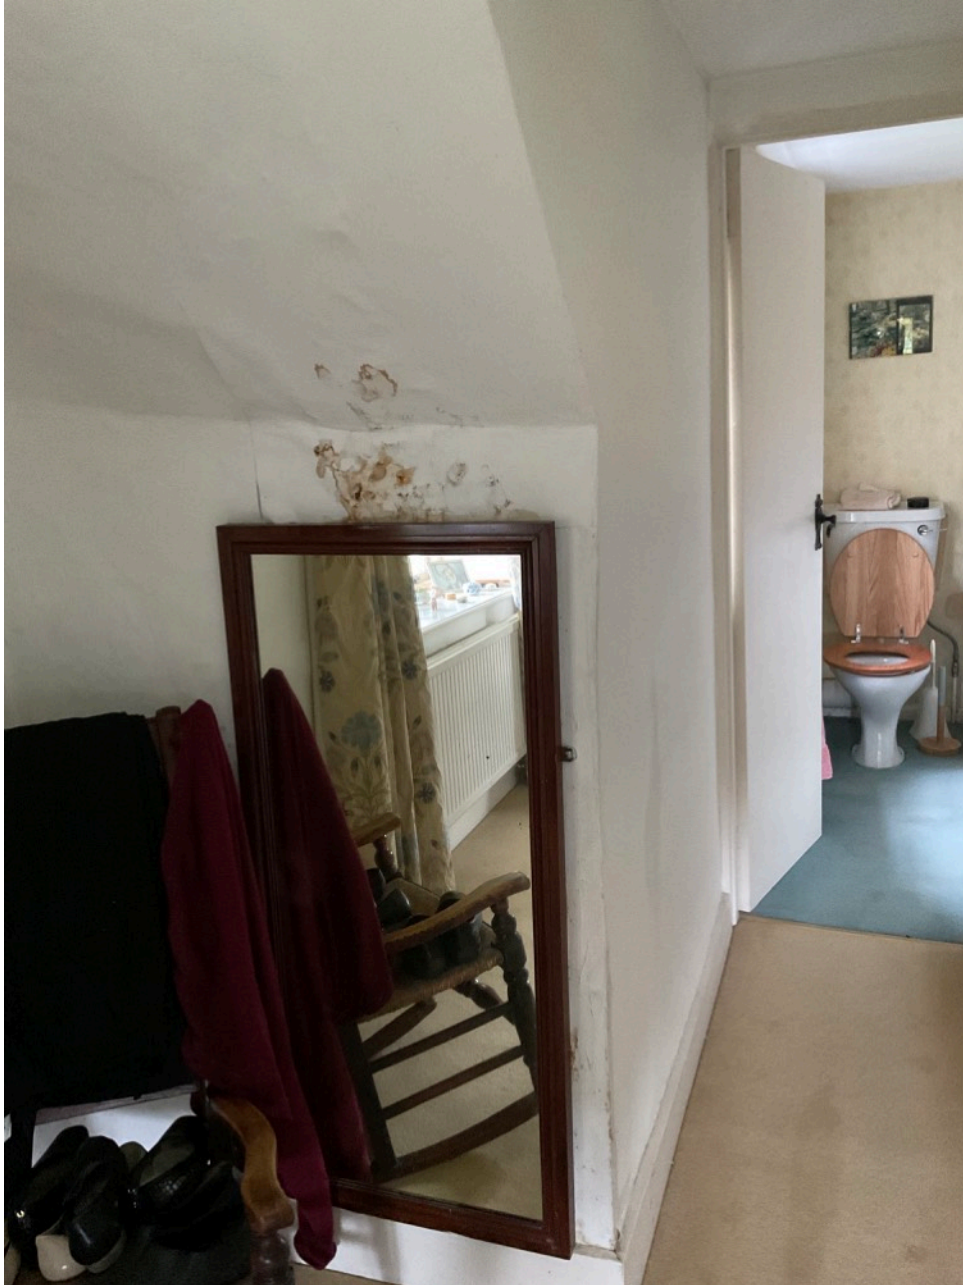
The combined result of these awkward details is rainwater ingress below the back left corner of the flat roof, wetting the wickert wall fabric below, to its detriment.

Water ingress under back left corner of flat roof, wetting roof frame and witchert wall fabric.

To resolve the problem junction area to the back left corner of the flat roof, we propose to introduce a baffle detail, comprising an angle fillet kerb, approximately 50mm tall, set on an angle to direct flat roof rainwater run off away from the problem corner and into the gutter.
