## Design & Access Statement

Boundary Wall to Barnet Grange Care Home,  
59 Wood Street,  
Barnet,  
EN5 4BS

January 2024

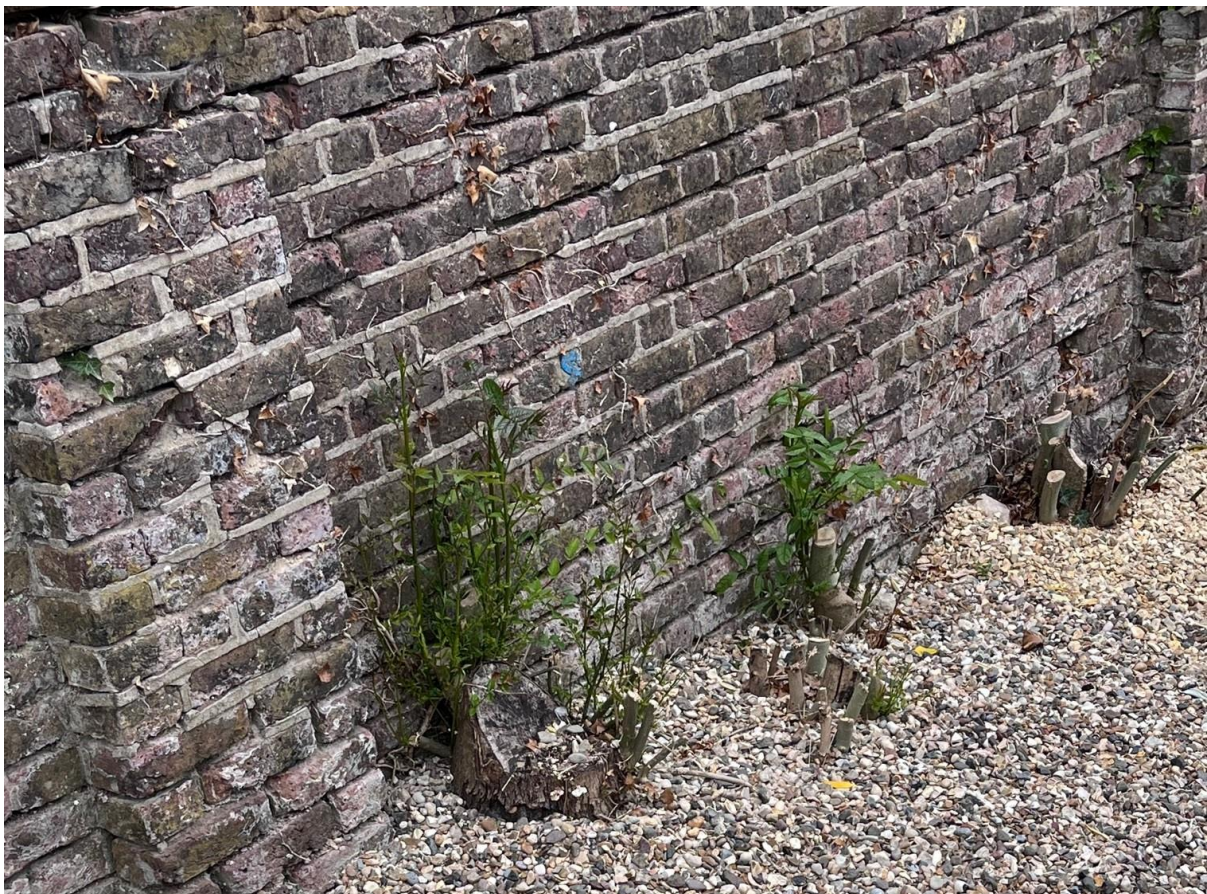
This 60m stretch of wall is in poor condition as seen in the image below. The wall is a traditional masonry built with red brick in Flemish bond and masonry piers at regular intervals of 3.5m width.

The wall is currently in a state of disrepair and is in need of rebuilding. Stratigraphic analysis shows that the wall has seen modern intervention, particularly at upper courses. These interventions have reduced its historic and architectural significance owing to the loss of original fabric and form.

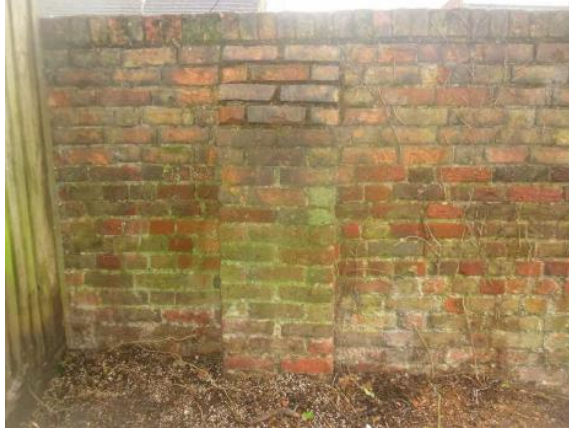
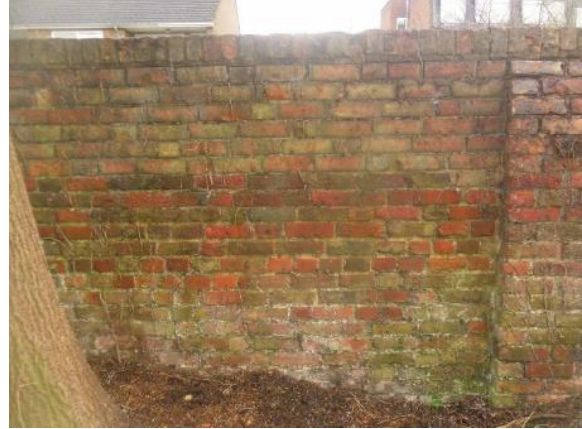
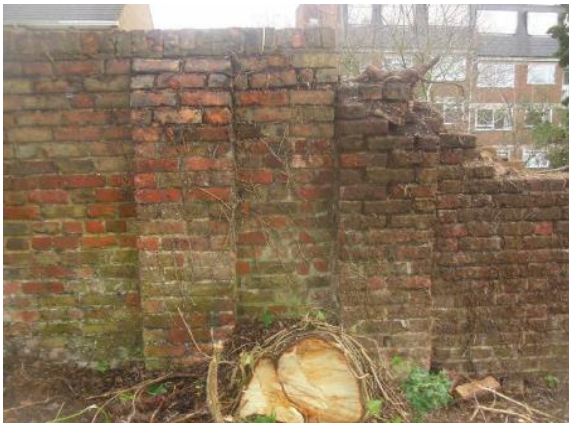
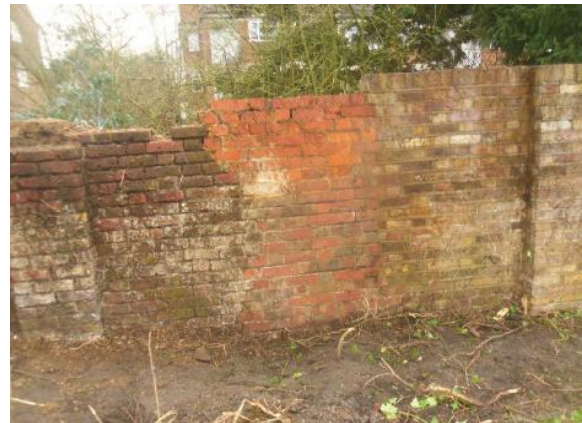
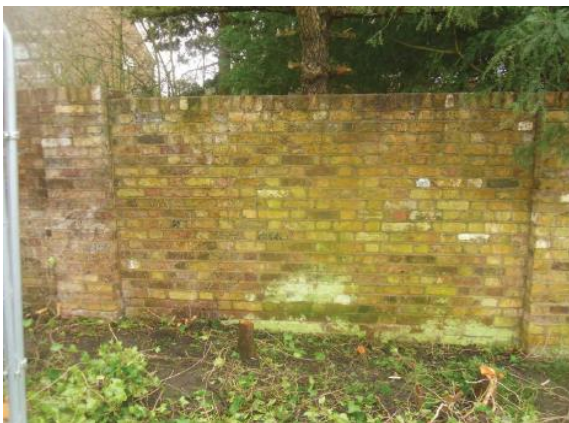
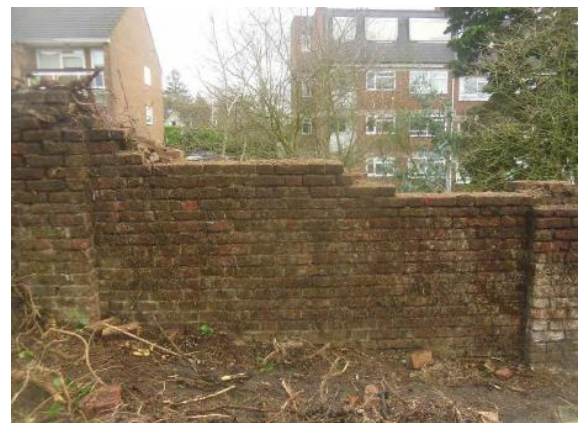
Significant and extensive deterioration of the mortar and brick faces was noted throughout probably because of frost action arising from rainwater and water drawn up the wall due to a lack of DPC. The presence of ivy, algal and moss growth will have exacerbated the deterioration. As a result, the pointing of the brickwork has failed extensively, and some bricks are loose. This deterioration was found on both faces of the wall but was more severe on the site side and in the top half of the wall. In places the depth of missing mortar was as much as 75mm. The mortar in the newer section of wall between piers 5 and 8 was found to be still intact.

Loose bricks were observed throughout the length of the wall in localized areas such as at the top of the wall between piers 3 and 5 and at pier 12 from the neighbouring side. The bricks in the middle section of the pier 10 were absent. A section of wall between pier 17 and the corner of the site has collapsed to ground level. It is currently boarded up with plywood.

The plumb line survey shows the lean of the wall to be most severe between pier 4 and 5, and between pier 8 and the corner of the site. The wall leans between 90mm and 210mm. Causes of the distortion include the close proximity of trees and their growth together with the lateral earth pressures on the wall.

Generally, the walls had very few cracks probably due to the weak mortar of the wall which would naturally allow the wall to distort without showing obvious signs of cracking. Cracks that were observed are noted below. A large crack up to 75mm wide was observed on the southern boundary wall (photograph 31) which appears to be due to movement of foundations. Several trees are in proximity of the wall and foundations can be affected by tree roots or moisture change in the soil

due to tree transpiration. Smaller cracks were noted on the southern boundary which appears to be related to foundation movement. Cracks were noted in the wall panel between pier 10 & 11 most likely due to the growth of the tree pushing against the wall.

See images below for evidence of the state of the wall upon recent inspection.

The Boundary Wall is not in a fit state or form to be repaired without significant intervention and rework to the current fabric, the most appropriate course of action is for the wall to be carefully taken down and rebuilt using the existing bricks and substituted with new salvaged bricks and repointed in its entirety.
