Contaminated Land Phase One Desk Study for proposed change of use from public house to convenience store and residential apartments at Shakespeare Hotel, Wytham Street, Padiham, B12 7DX.

December 2023

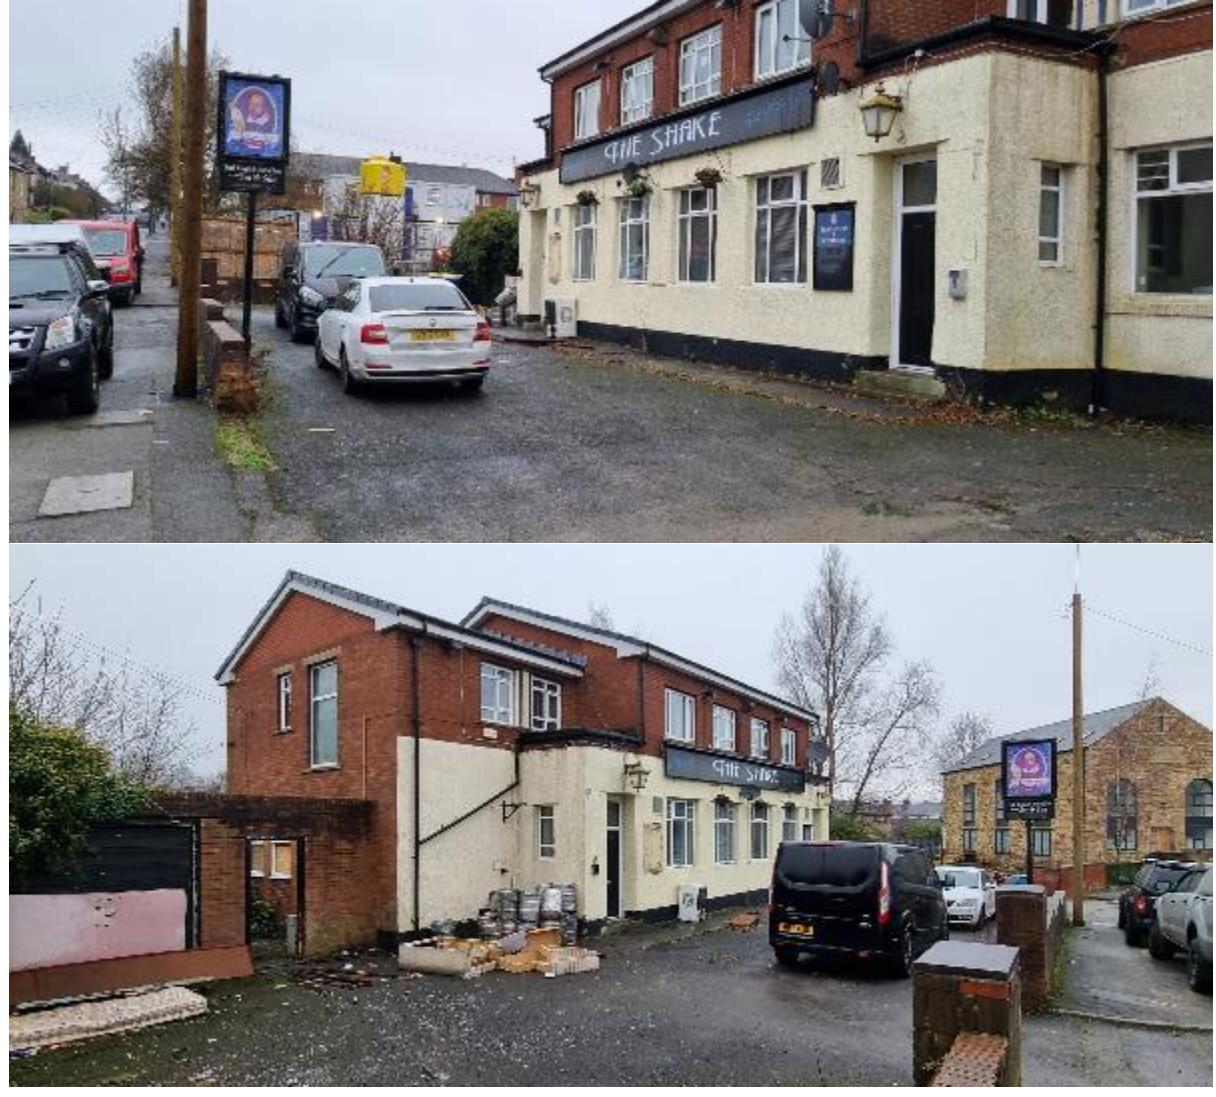
The front eastern section of the site, looking from the north an then the south

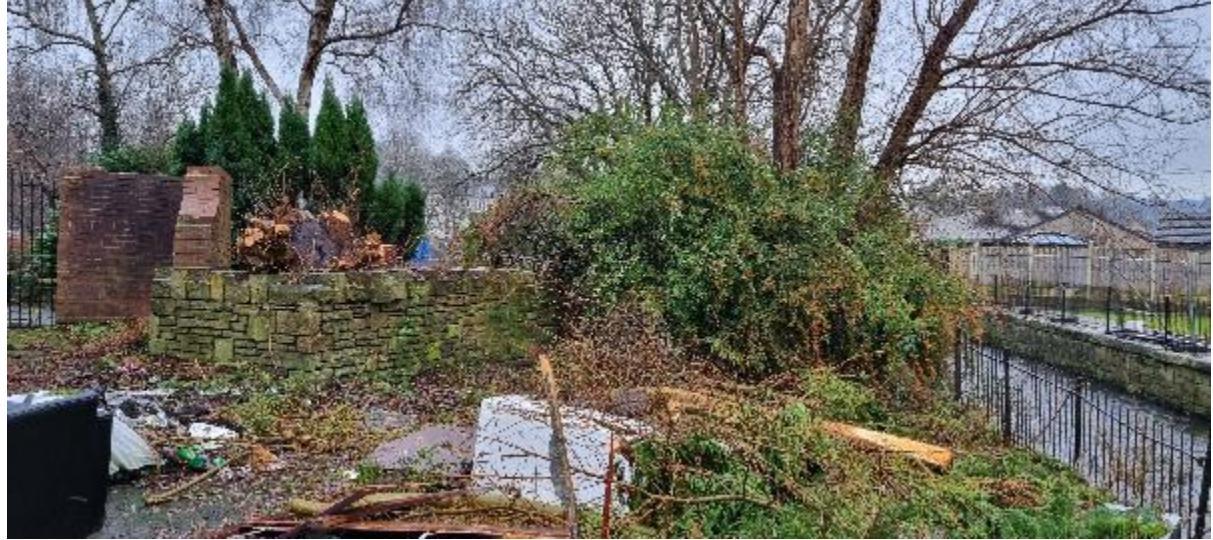
northeast corner by the road

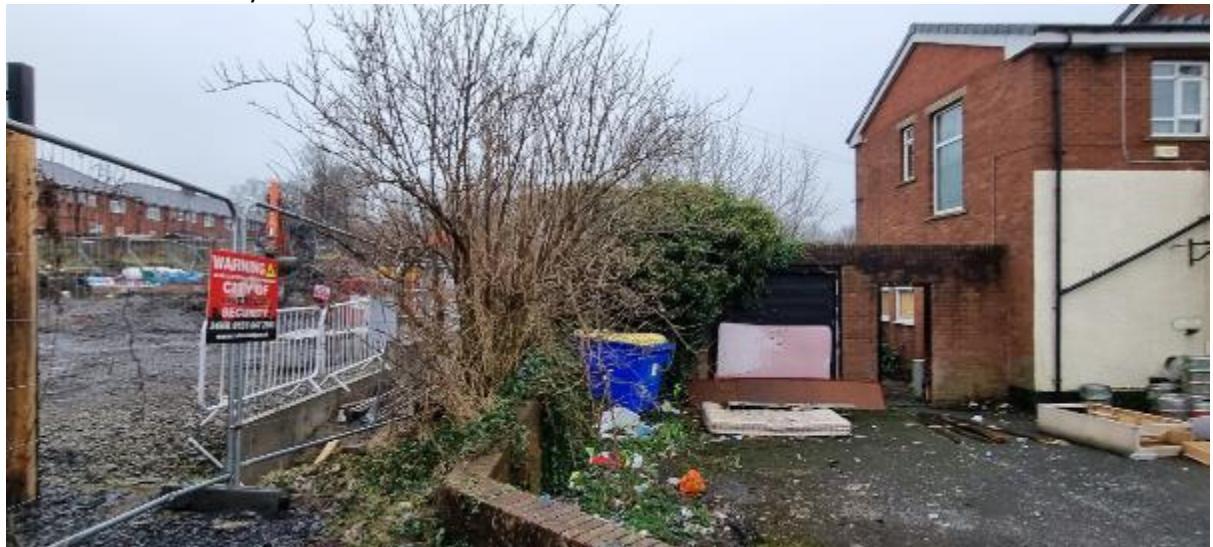
Southeeast corner by the road.

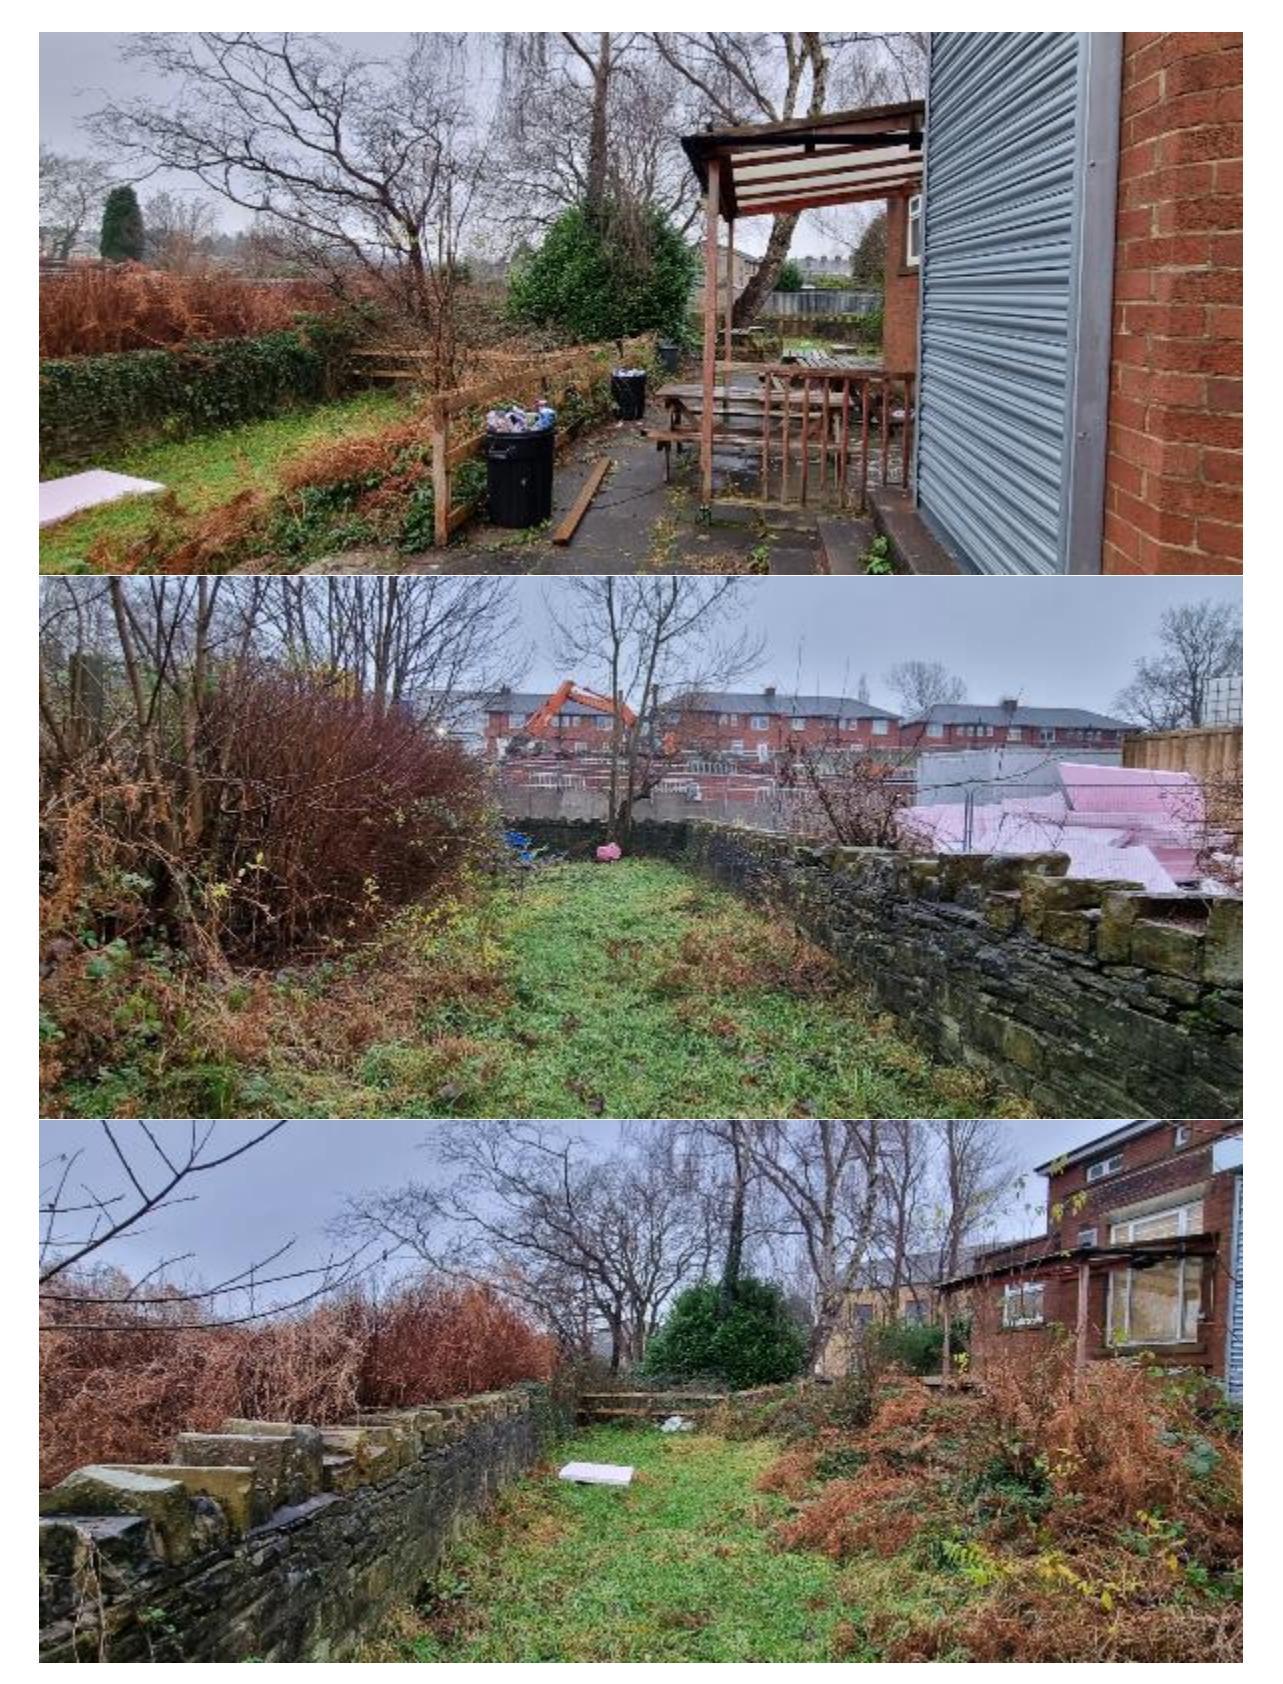
The rear of the building

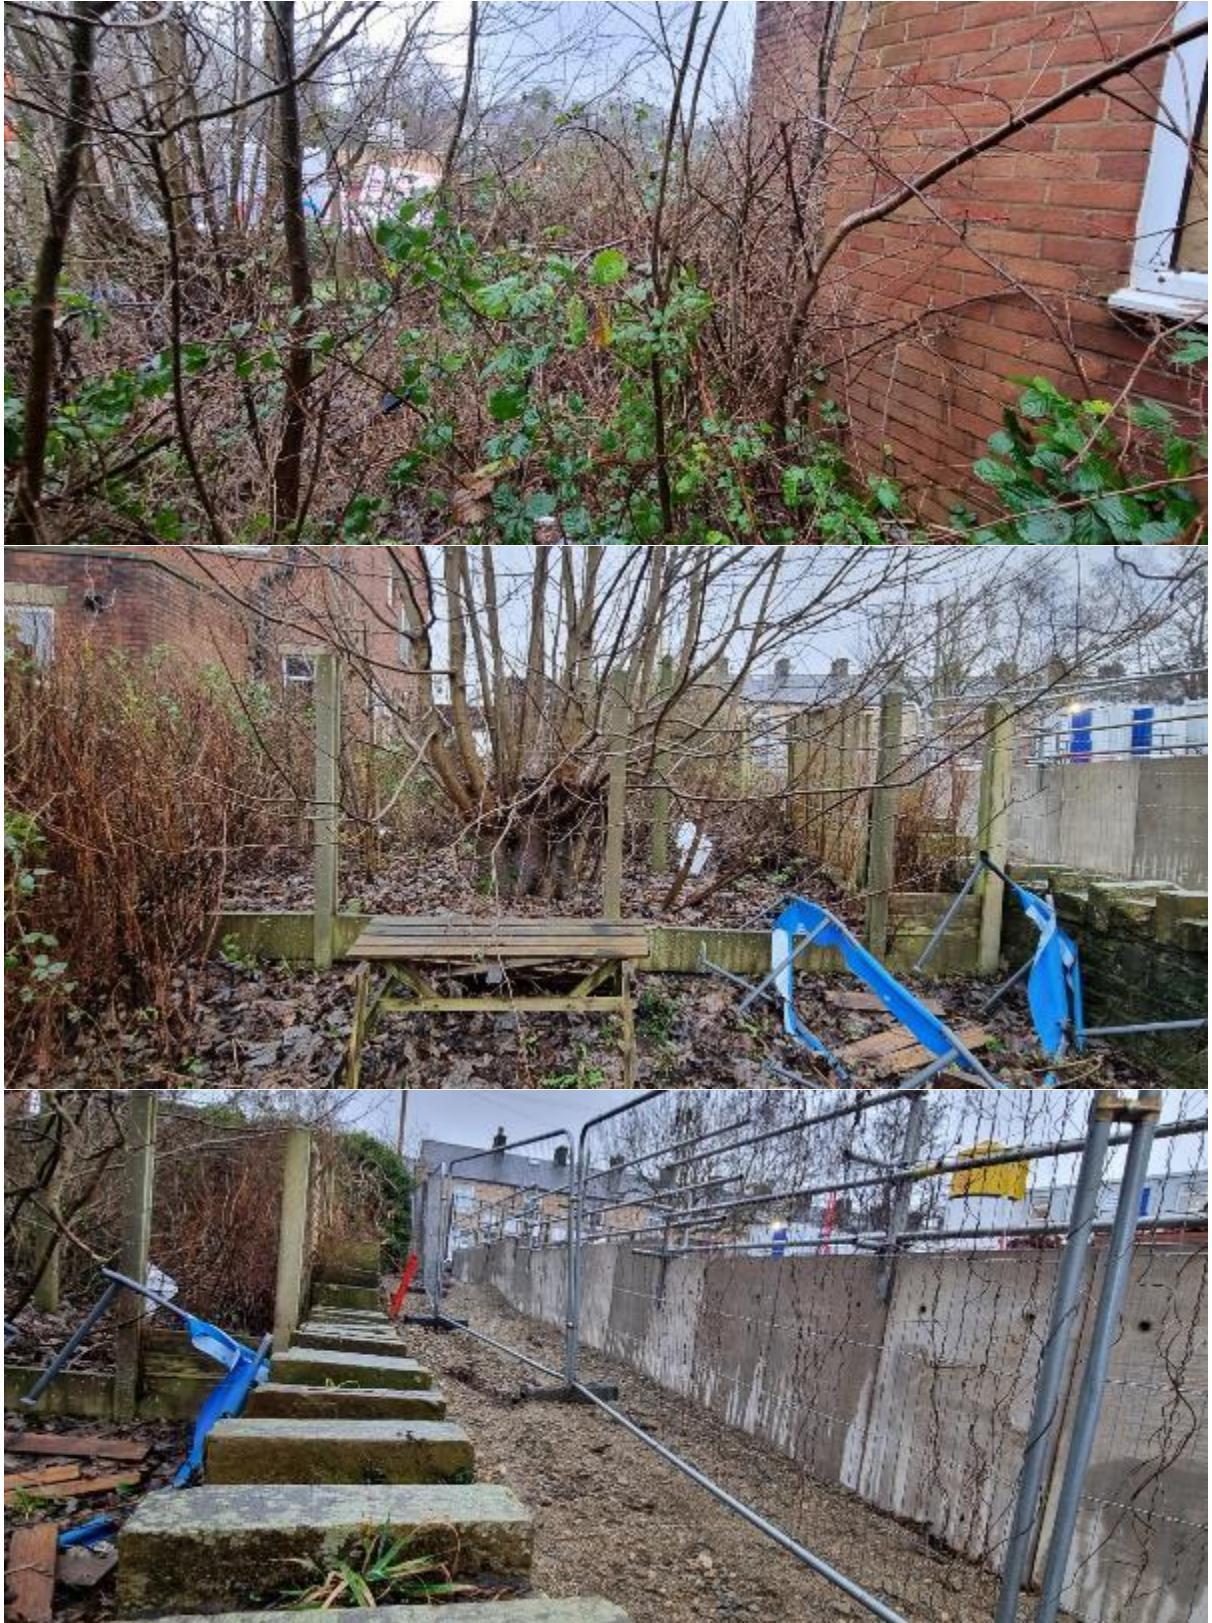
The northern boundary looking west and then east

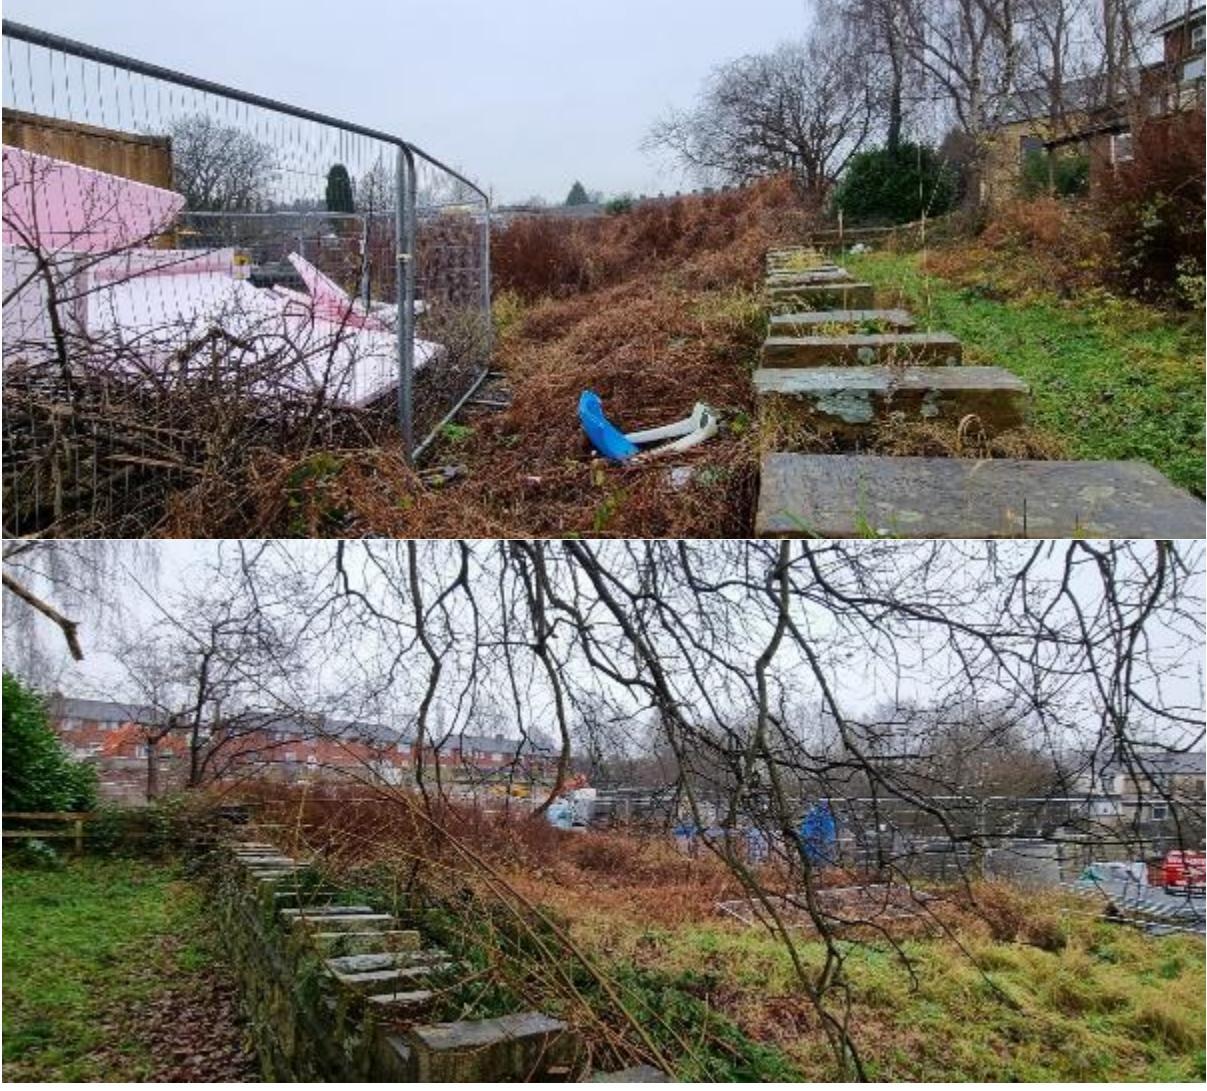
The far western boundary into the construction site (construction material to be removed)

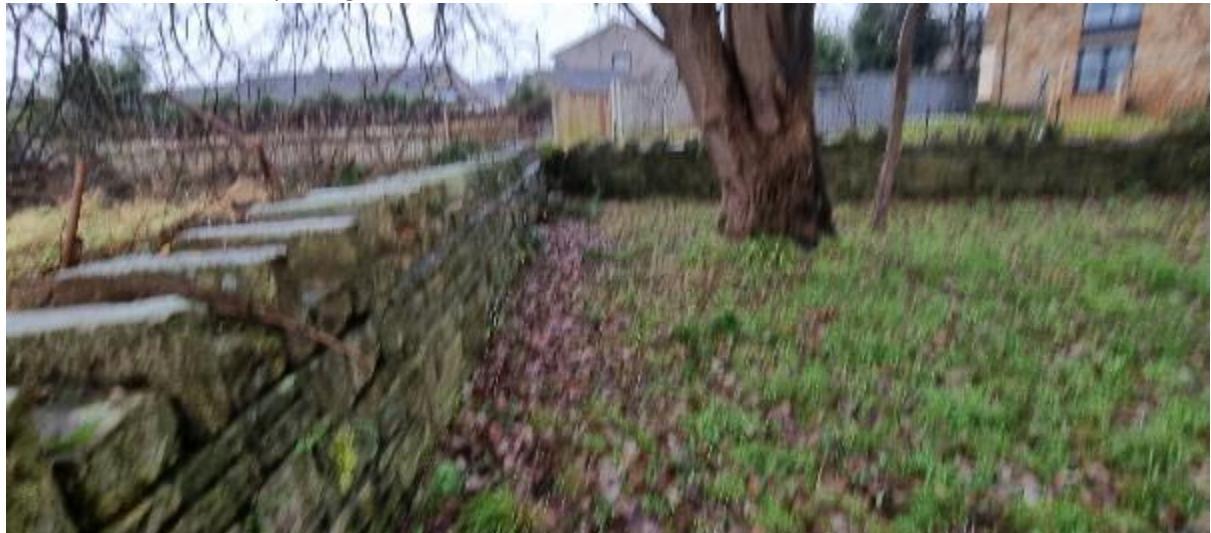
The northern boundary and garden area

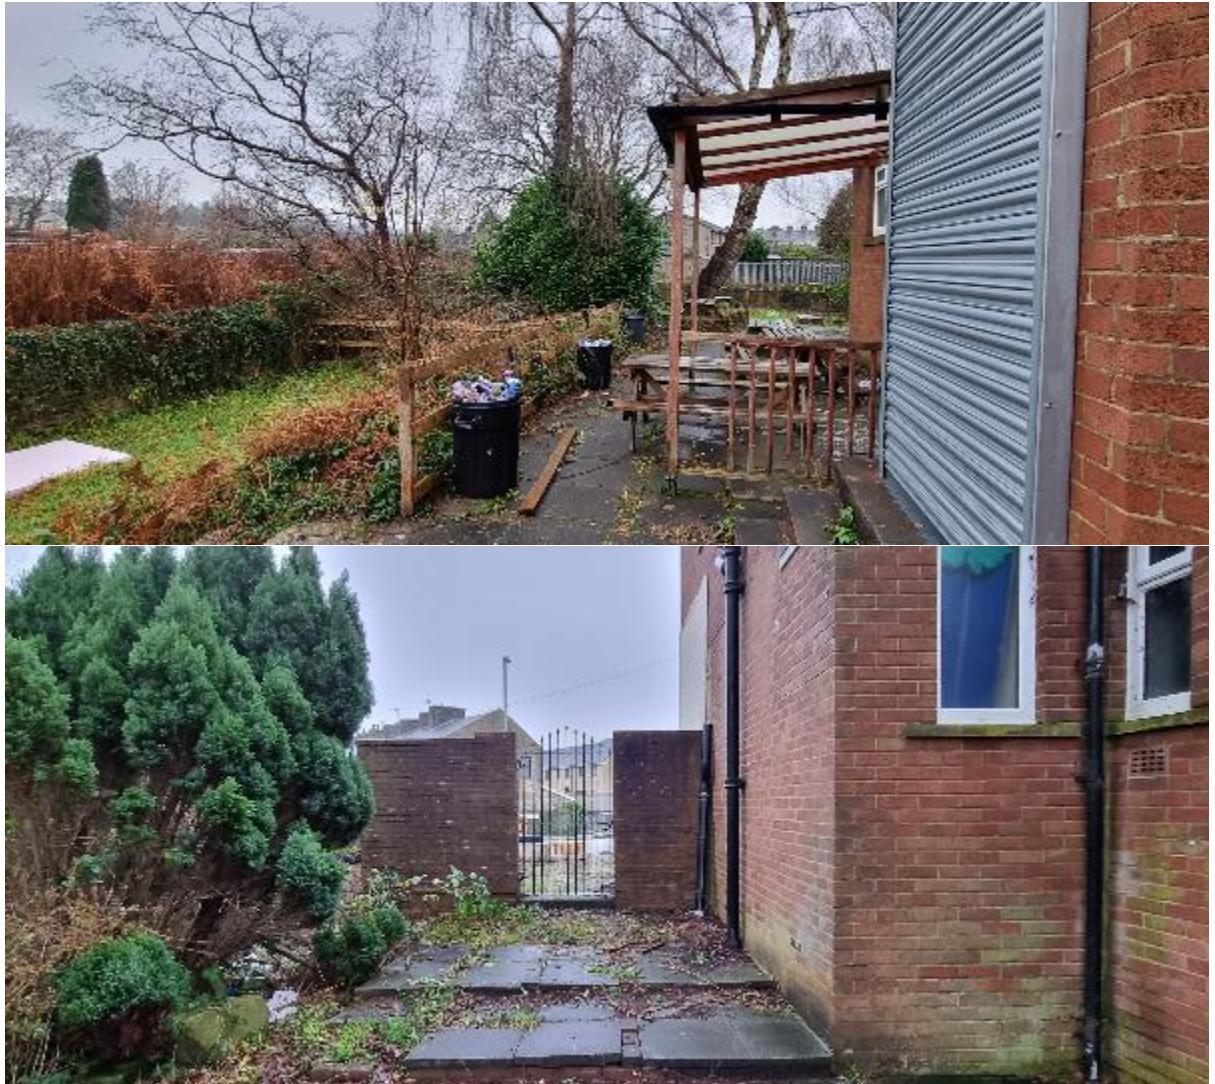
The patio area and northern side of the property
