Arboricultural
Impact Assessment
with
Arboricultural Method Statement

Maghull Health Centre
Westway
Maghull
Liverpool
L31 0DJ

Project No. AIA.13724.02

22nd November 2023

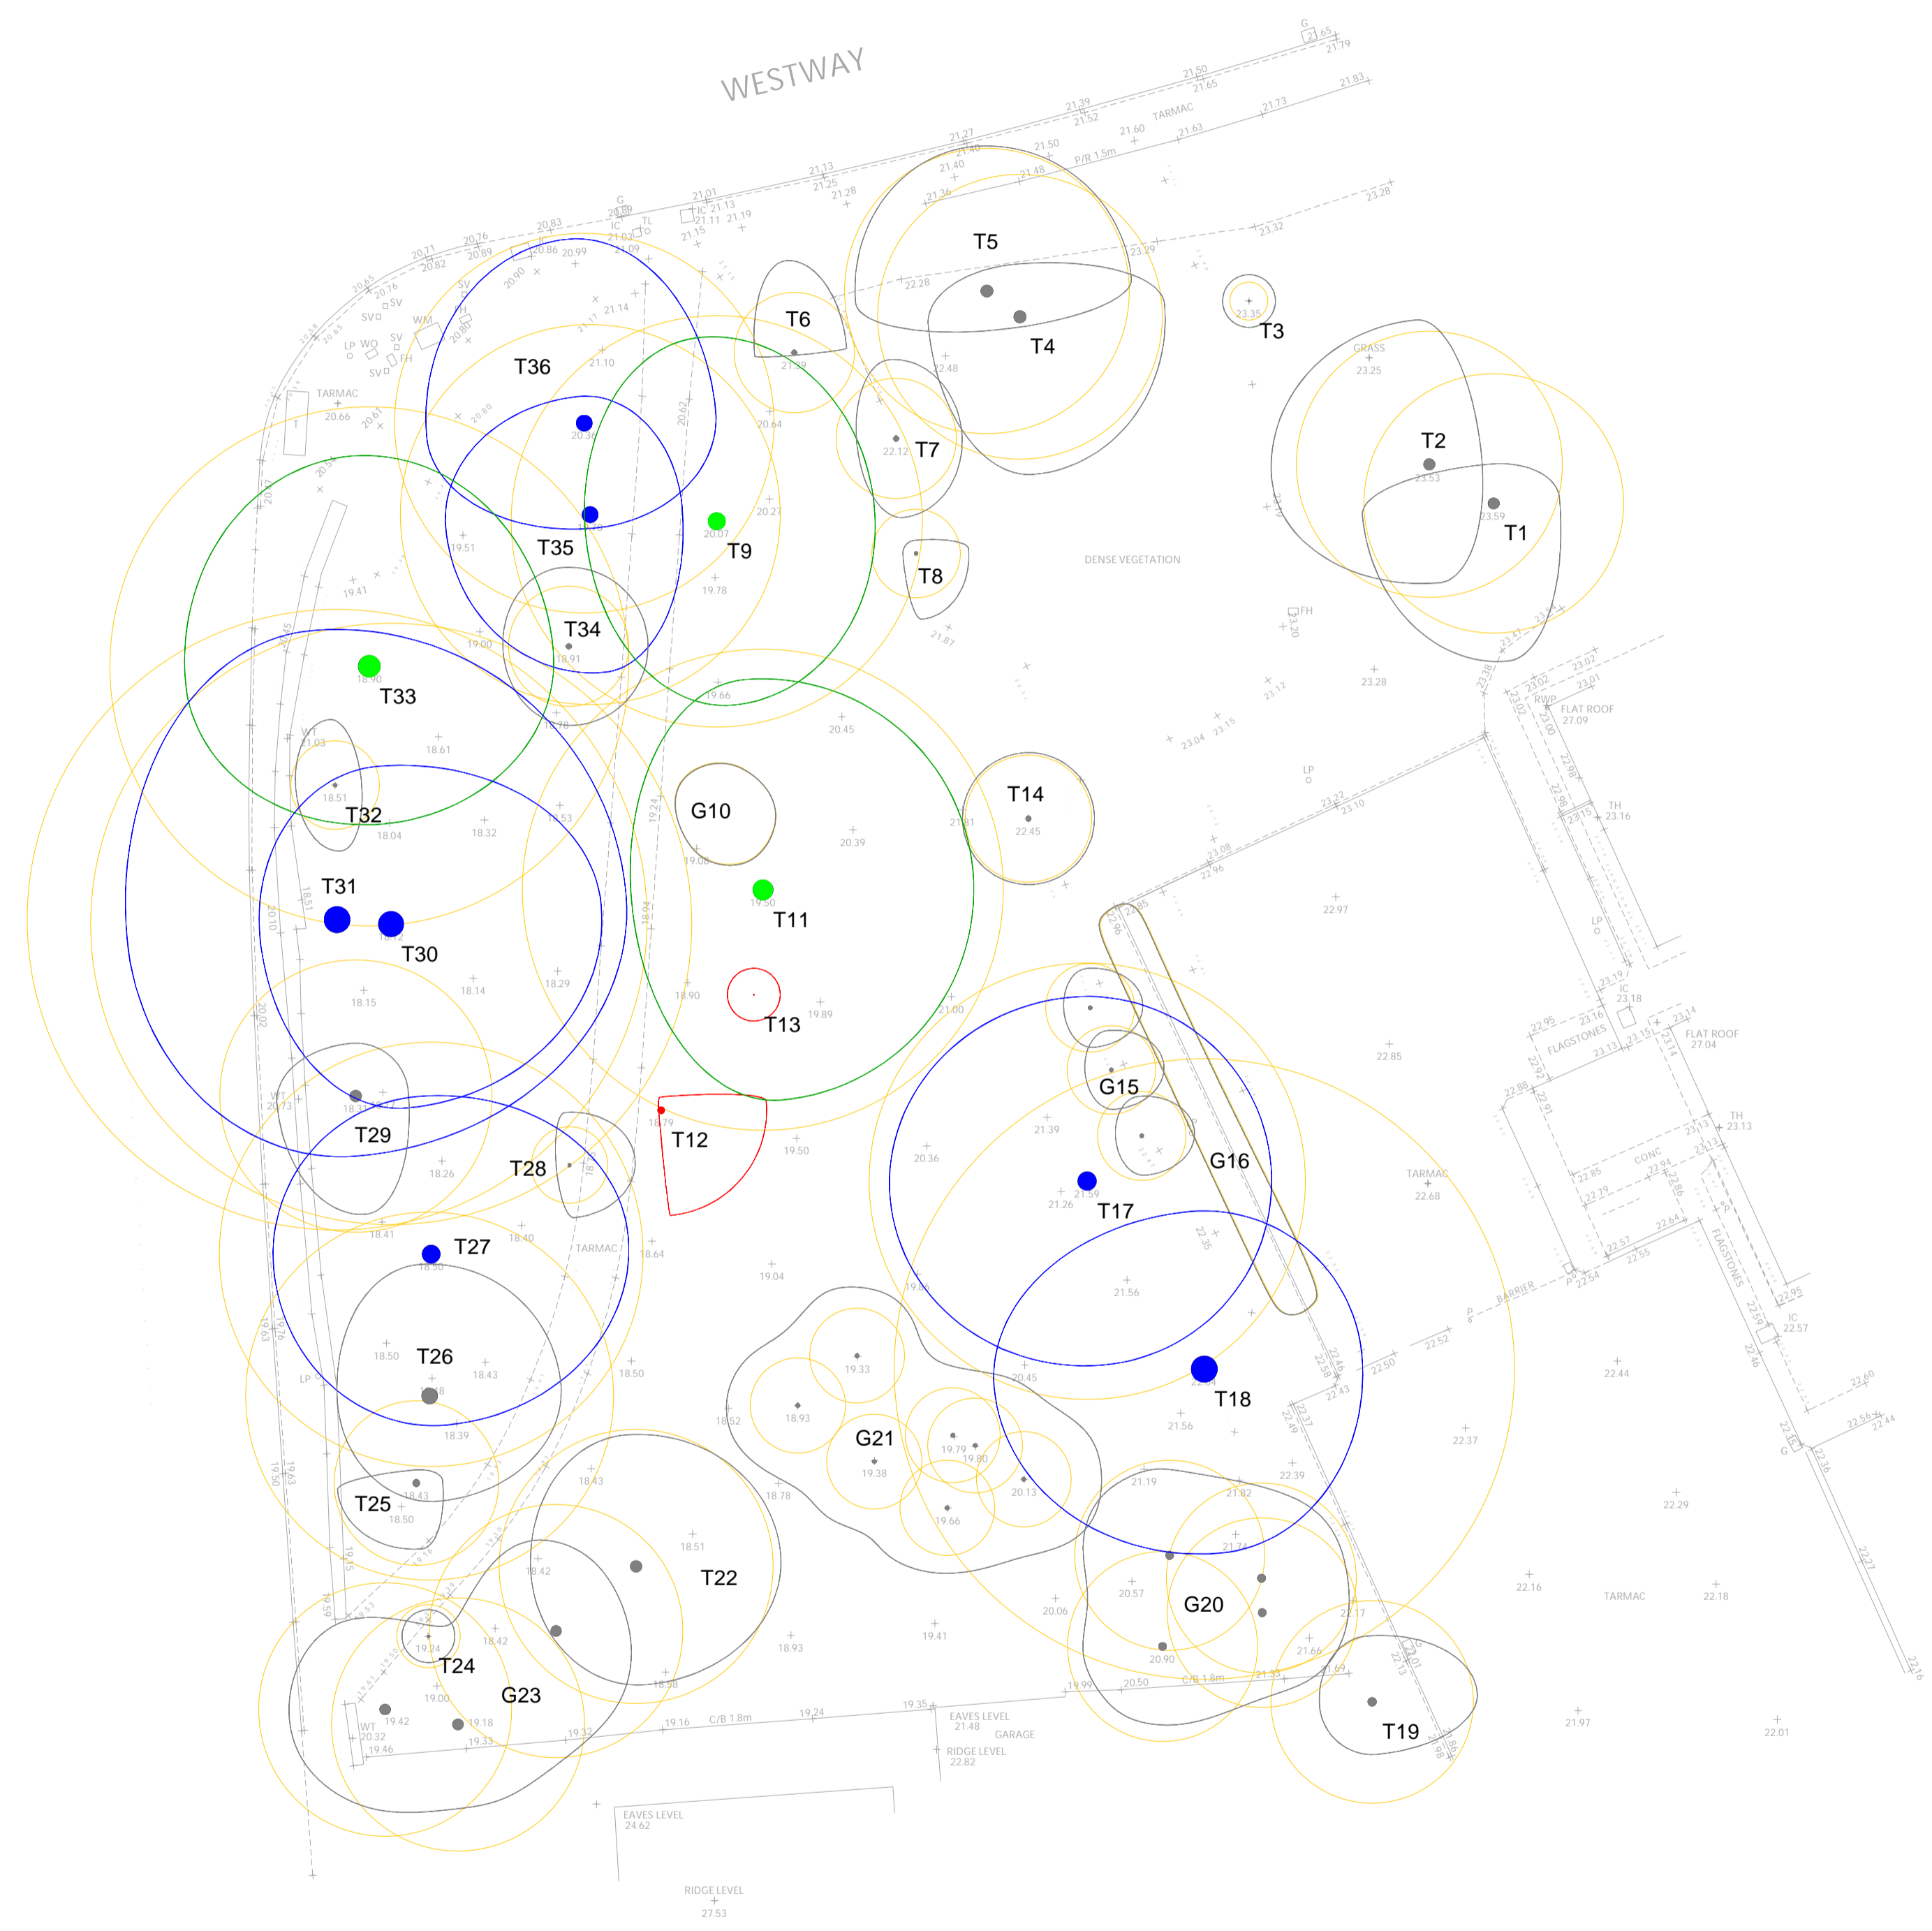
Drawing 1. Tree Constraints Plan

2.1.2. The trees were generally found to be in good to fair condition, however, one individual tree (T12) was classified as retention category 'U' (unsuitable for retention).

2.3.1. The tree Root Protection Area (RPA) is a layout design tool indicating the area around a tree that, along with the tree stem and branches, must be considered during development. The protection of the roots and soil structure within the RPA should be treated as a priority. The RPA of each tree or group is marked on the Tree Constraints Plan at the rear of this report.

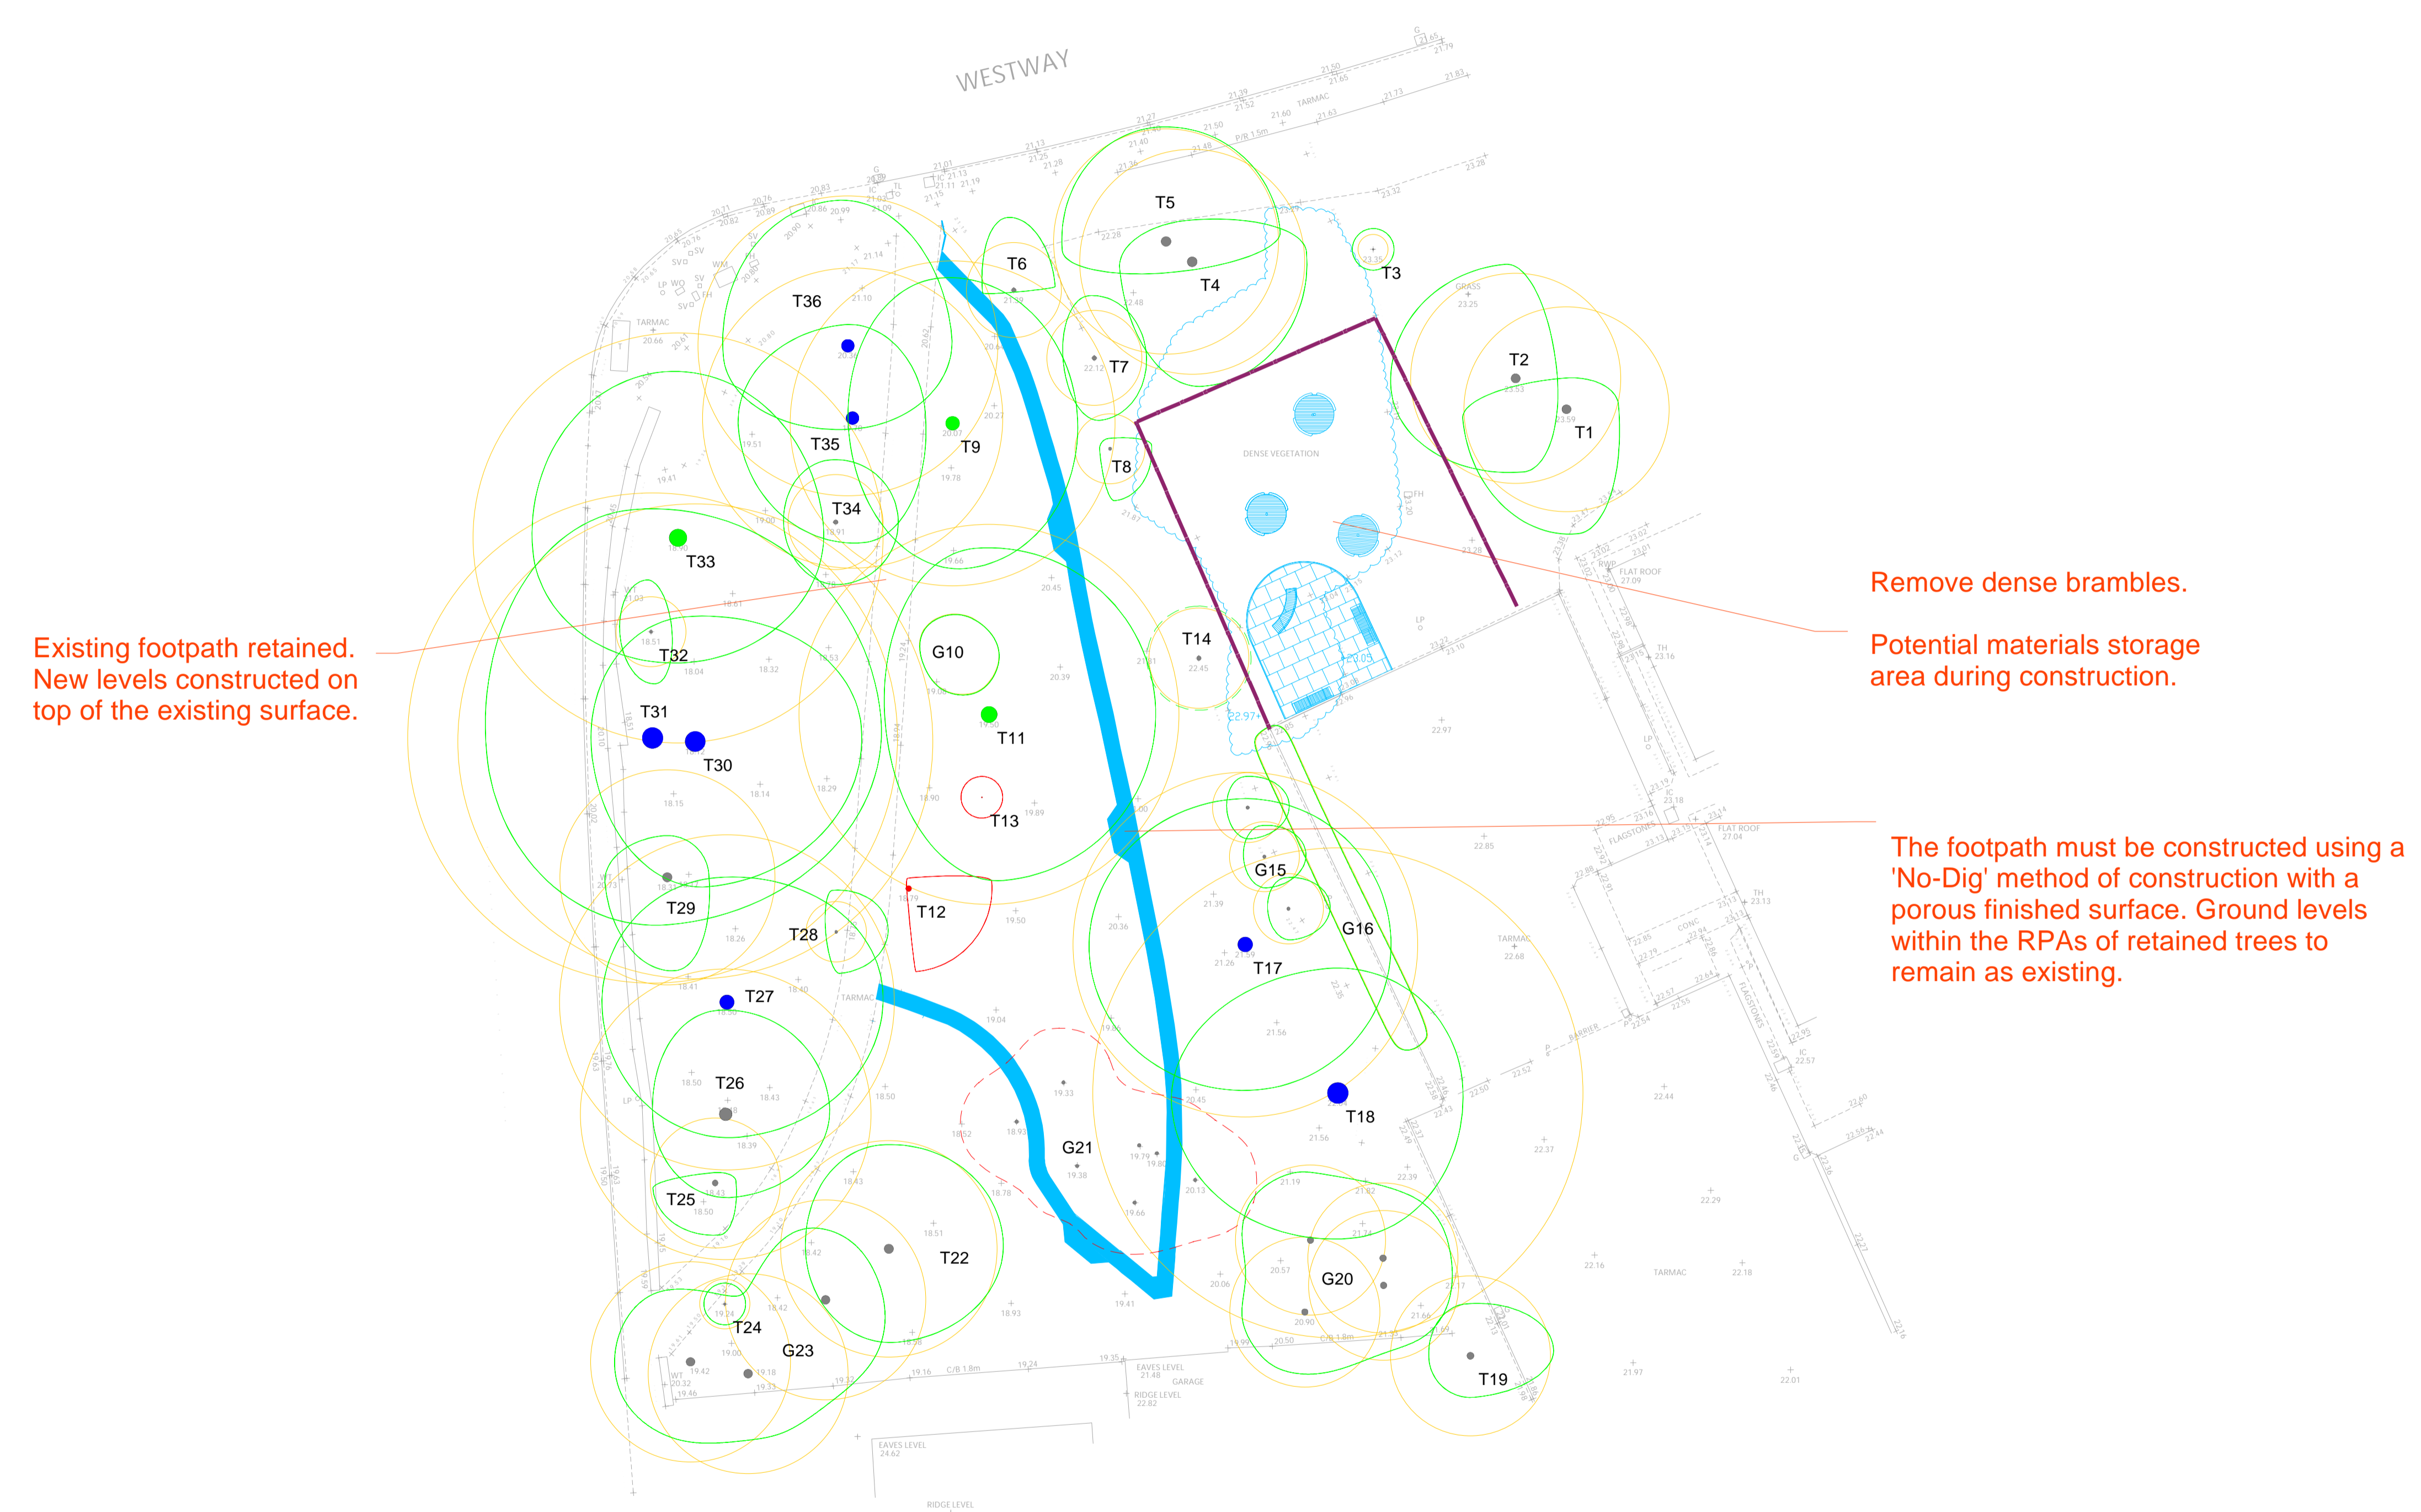
Drawing 2. Tree Protection Plan

- 3.2.1. The proposed development directly impacts one group of self-seeded Sycamore trees. These trees shall require removal due to their close proximity to construction activity. All the trees proposed for removal are considered to be low-quality ('C' category) specimens. Please see the table below for the proposed tree removal details.

3.5.1. Minor sections of RPA from trees T6, T9, T11, T17 and T18 lie within the area proposed for the woodland path. Given the small percentage of potential RPA disturbance, the proposed hard surface is not expected to cause any long-term harm to the adjacent trees. However, given the potential area of RPA disturbance, it is recommended that the proposed hard surface is constructed using techniques sympathetic to tree roots (Cellular Confinement System).

- 3.2.3. The formative pruning of tree T14 is recommended to open the view between the two sites. The proposed pruning works relate to the crown lifting/pruning of small tertiary branches. The overall shape of the tree from the proposed pruning works would not be affected. In addition, the proposed pruning works will have no adverse impacts on tree health and longevity.

4.2.3. Please see Appendix 4 for suggested barrier construction detail. It is recommended that in this instance the protective barrier shown in Figure 2 would be appropriate. The suggested location for protective fencing is shown on the Tree Protection Plan (Drawing 2).

4.3.1. It is recommended that the proposed footpath within the RPAs of trees T6, T9, T11, T17 and T18 is constructed in a manner that would not cause the adjacent trees any long-term harm. In this instance, it is recommended that a 'No-Dig' technique incorporating a Cellular Confinement System is used to prevent damage to the underlying RPAs. Please see Appendix 6 for the proposed method to install the footpath on top of existing ground levels.
