# **Arboricultural Survey and Impact Assessment**

**Athol Villa, Westbourne Road, College Town, Camberley, GU47 0QX**

**On behalf of Rio Homes**

**January 2024**

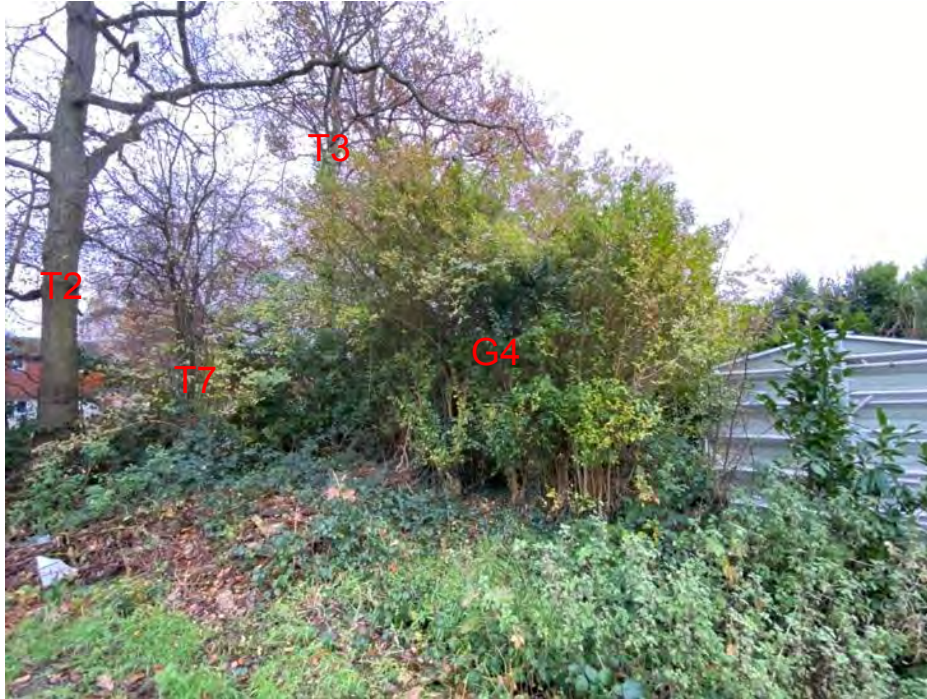
Photoview 1: View looking east at T2, T3, G4 and T7.

- 8.9 It was noted during the tree survey that T2 and T3 contain multiple dead branches and deadwood within their canopy. Although off site trees, it is recommended that discussions are held with tree owners for an aerial inspection of the trees as well as canopy clean of deadwood. This is recommended regardless of proposals.

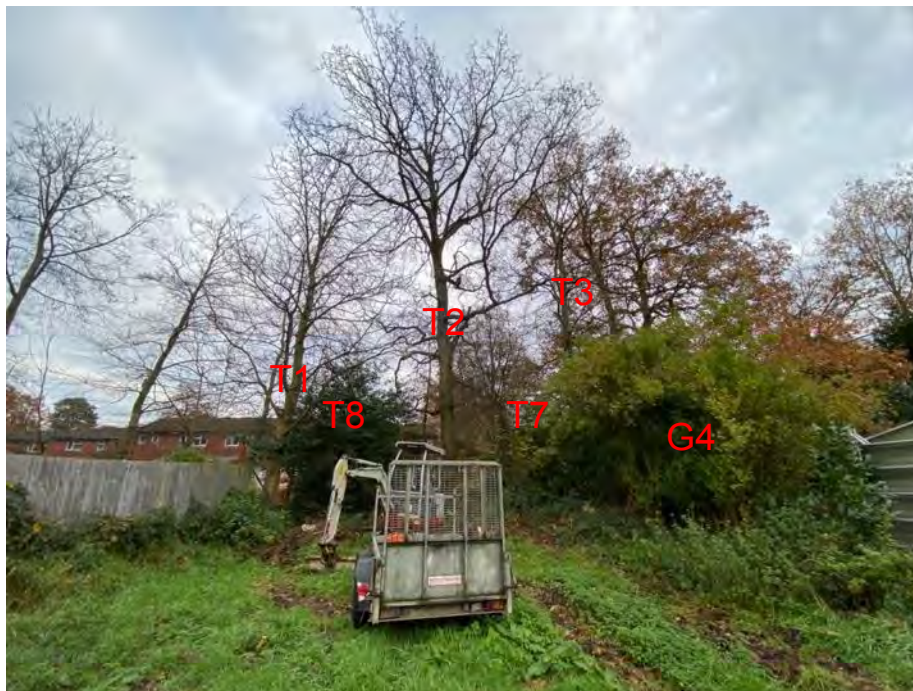
Photoview 2: View east towards T1-T8.

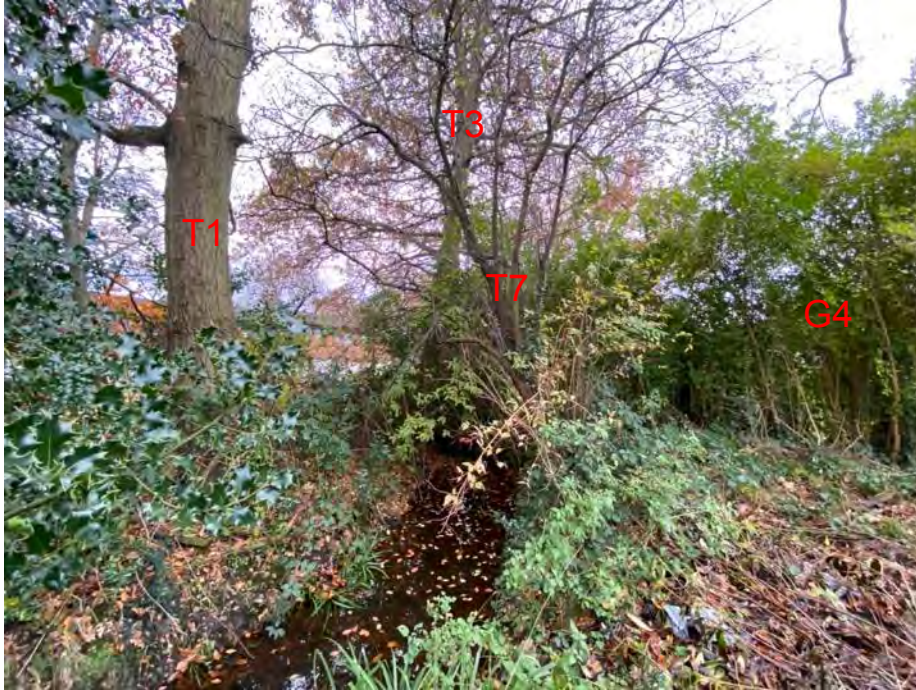
Photoview 3: View looking east at T7.

9.10 In terms of driveway widening works, this would occur largely outside of any RPA. However, as it would be next to the RPA of T7, it is recommended that the widened driveway is constructed using a permeable build up and surface finish.

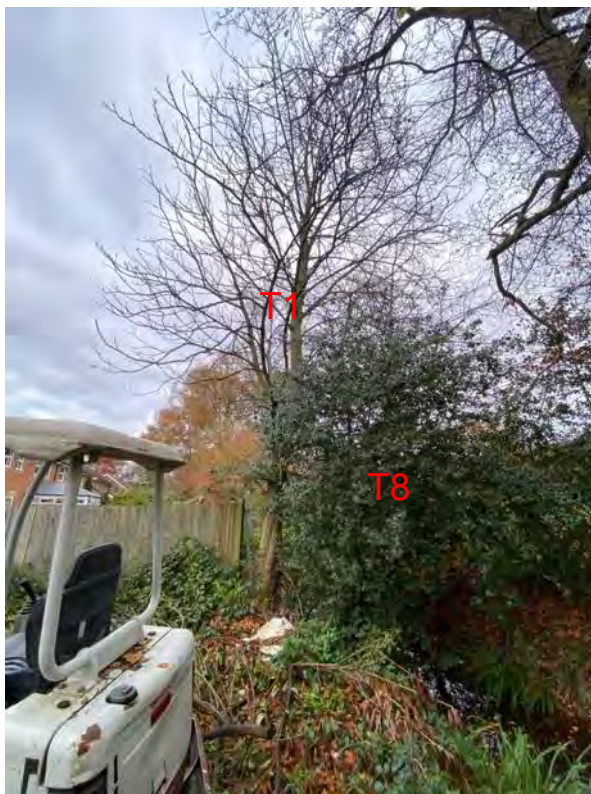
Photoview 4: View north at T1 and T8.

9.6 Fencing will need to be removed to enable access to install a new fence by T1, T7 and T8. It is recommended this element is undertaken as part of landscaping works once main construction is finished.

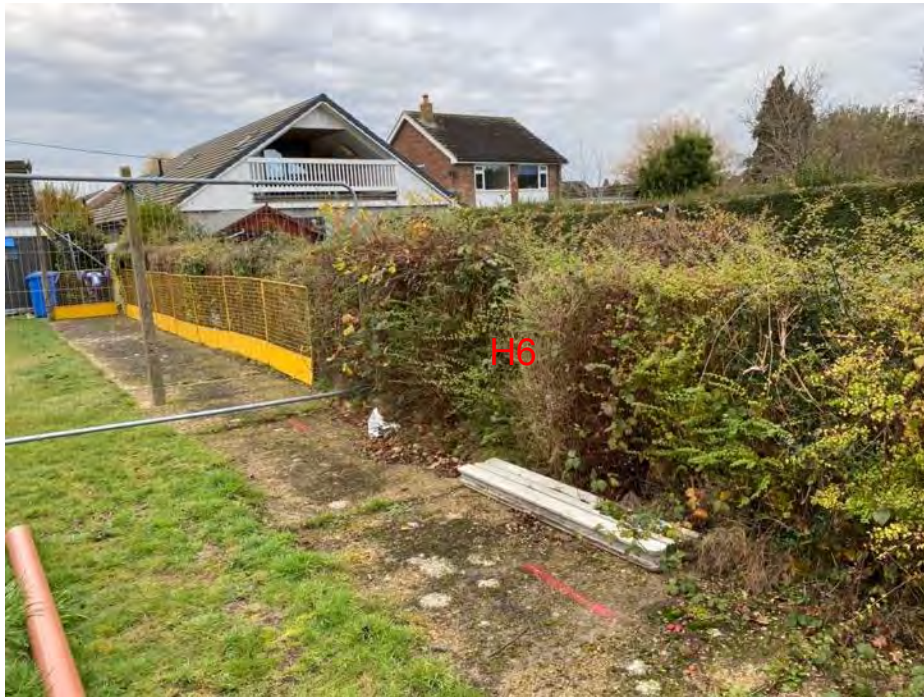
Photoview 5: View looking south along H6.

- 8.11 No existing structures or hard surfacing is required within any RPA of retained trees.
- 8.12 An existing concrete garden path adjacent H6 will be removed. This should be broken up and lifted out, with care taken not to damage H6 in its entirety.

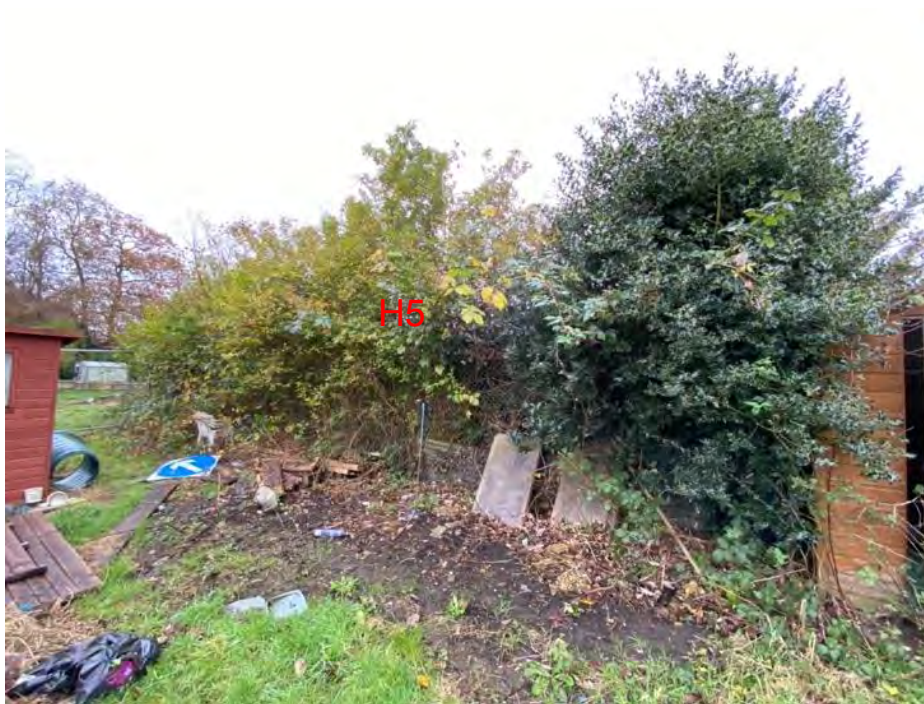
Photoview 6: View looking south at H5.
