BS5837:2012 Tree Survey Report

Proposed Construction of 7 Self Contained Apartments at

23 Crescent East, Hadley Wood EN4 0EY

30th August 2023

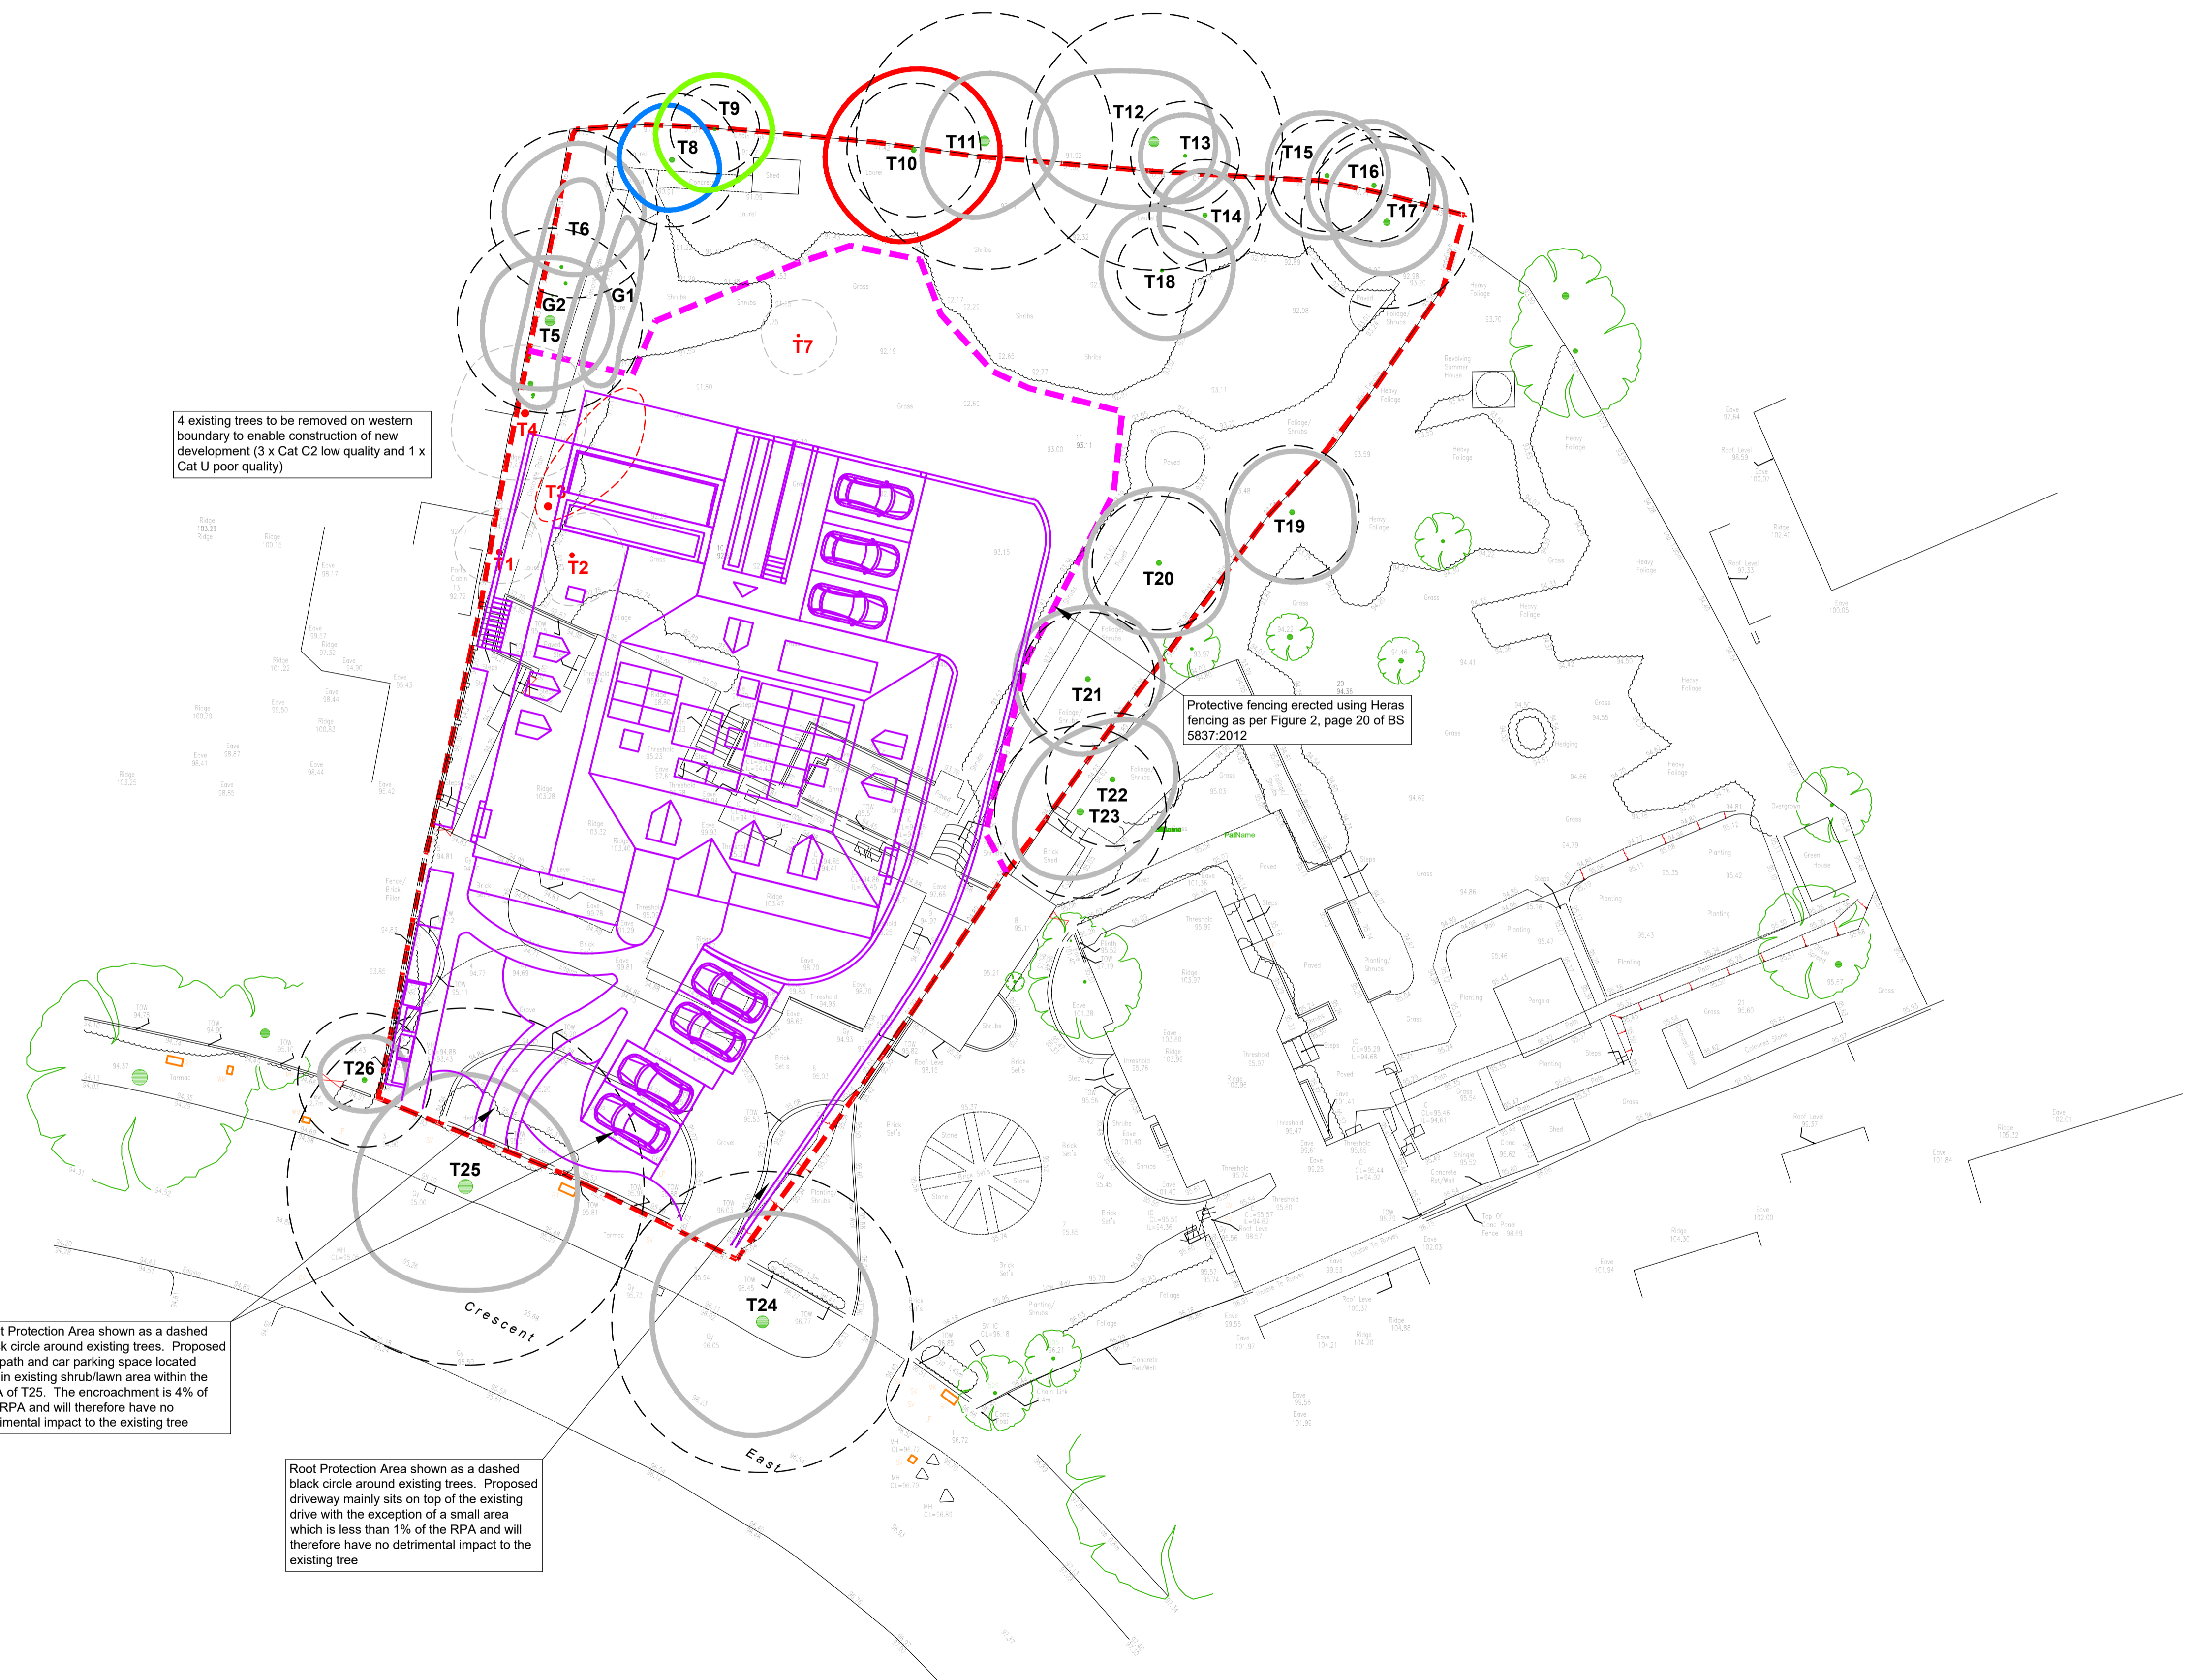
4 existing trees to be removed on western boundary to enable construction of new development (3 x Cat C2 low quality and 1 x Cat U poor quality)

Protective fencing erected using Heras fencing as per Figure 2, page 20 of BS 5837:2012
