### ARBORICULTURAL IMPACT ASSESSMENT

<b>Site:</b>	<b>5 Dagmar Road, London, SE25 6HZ</b>
<b>Client:</b>	<b>Mr Thomas, Inicio Homes, 16 Berkeley Street, London, W1J 8DZ</b>
<b>Date</b>	<b>19th July 2021</b>
<b>Our Ref:</b>	<b>EAS-079v3</b>

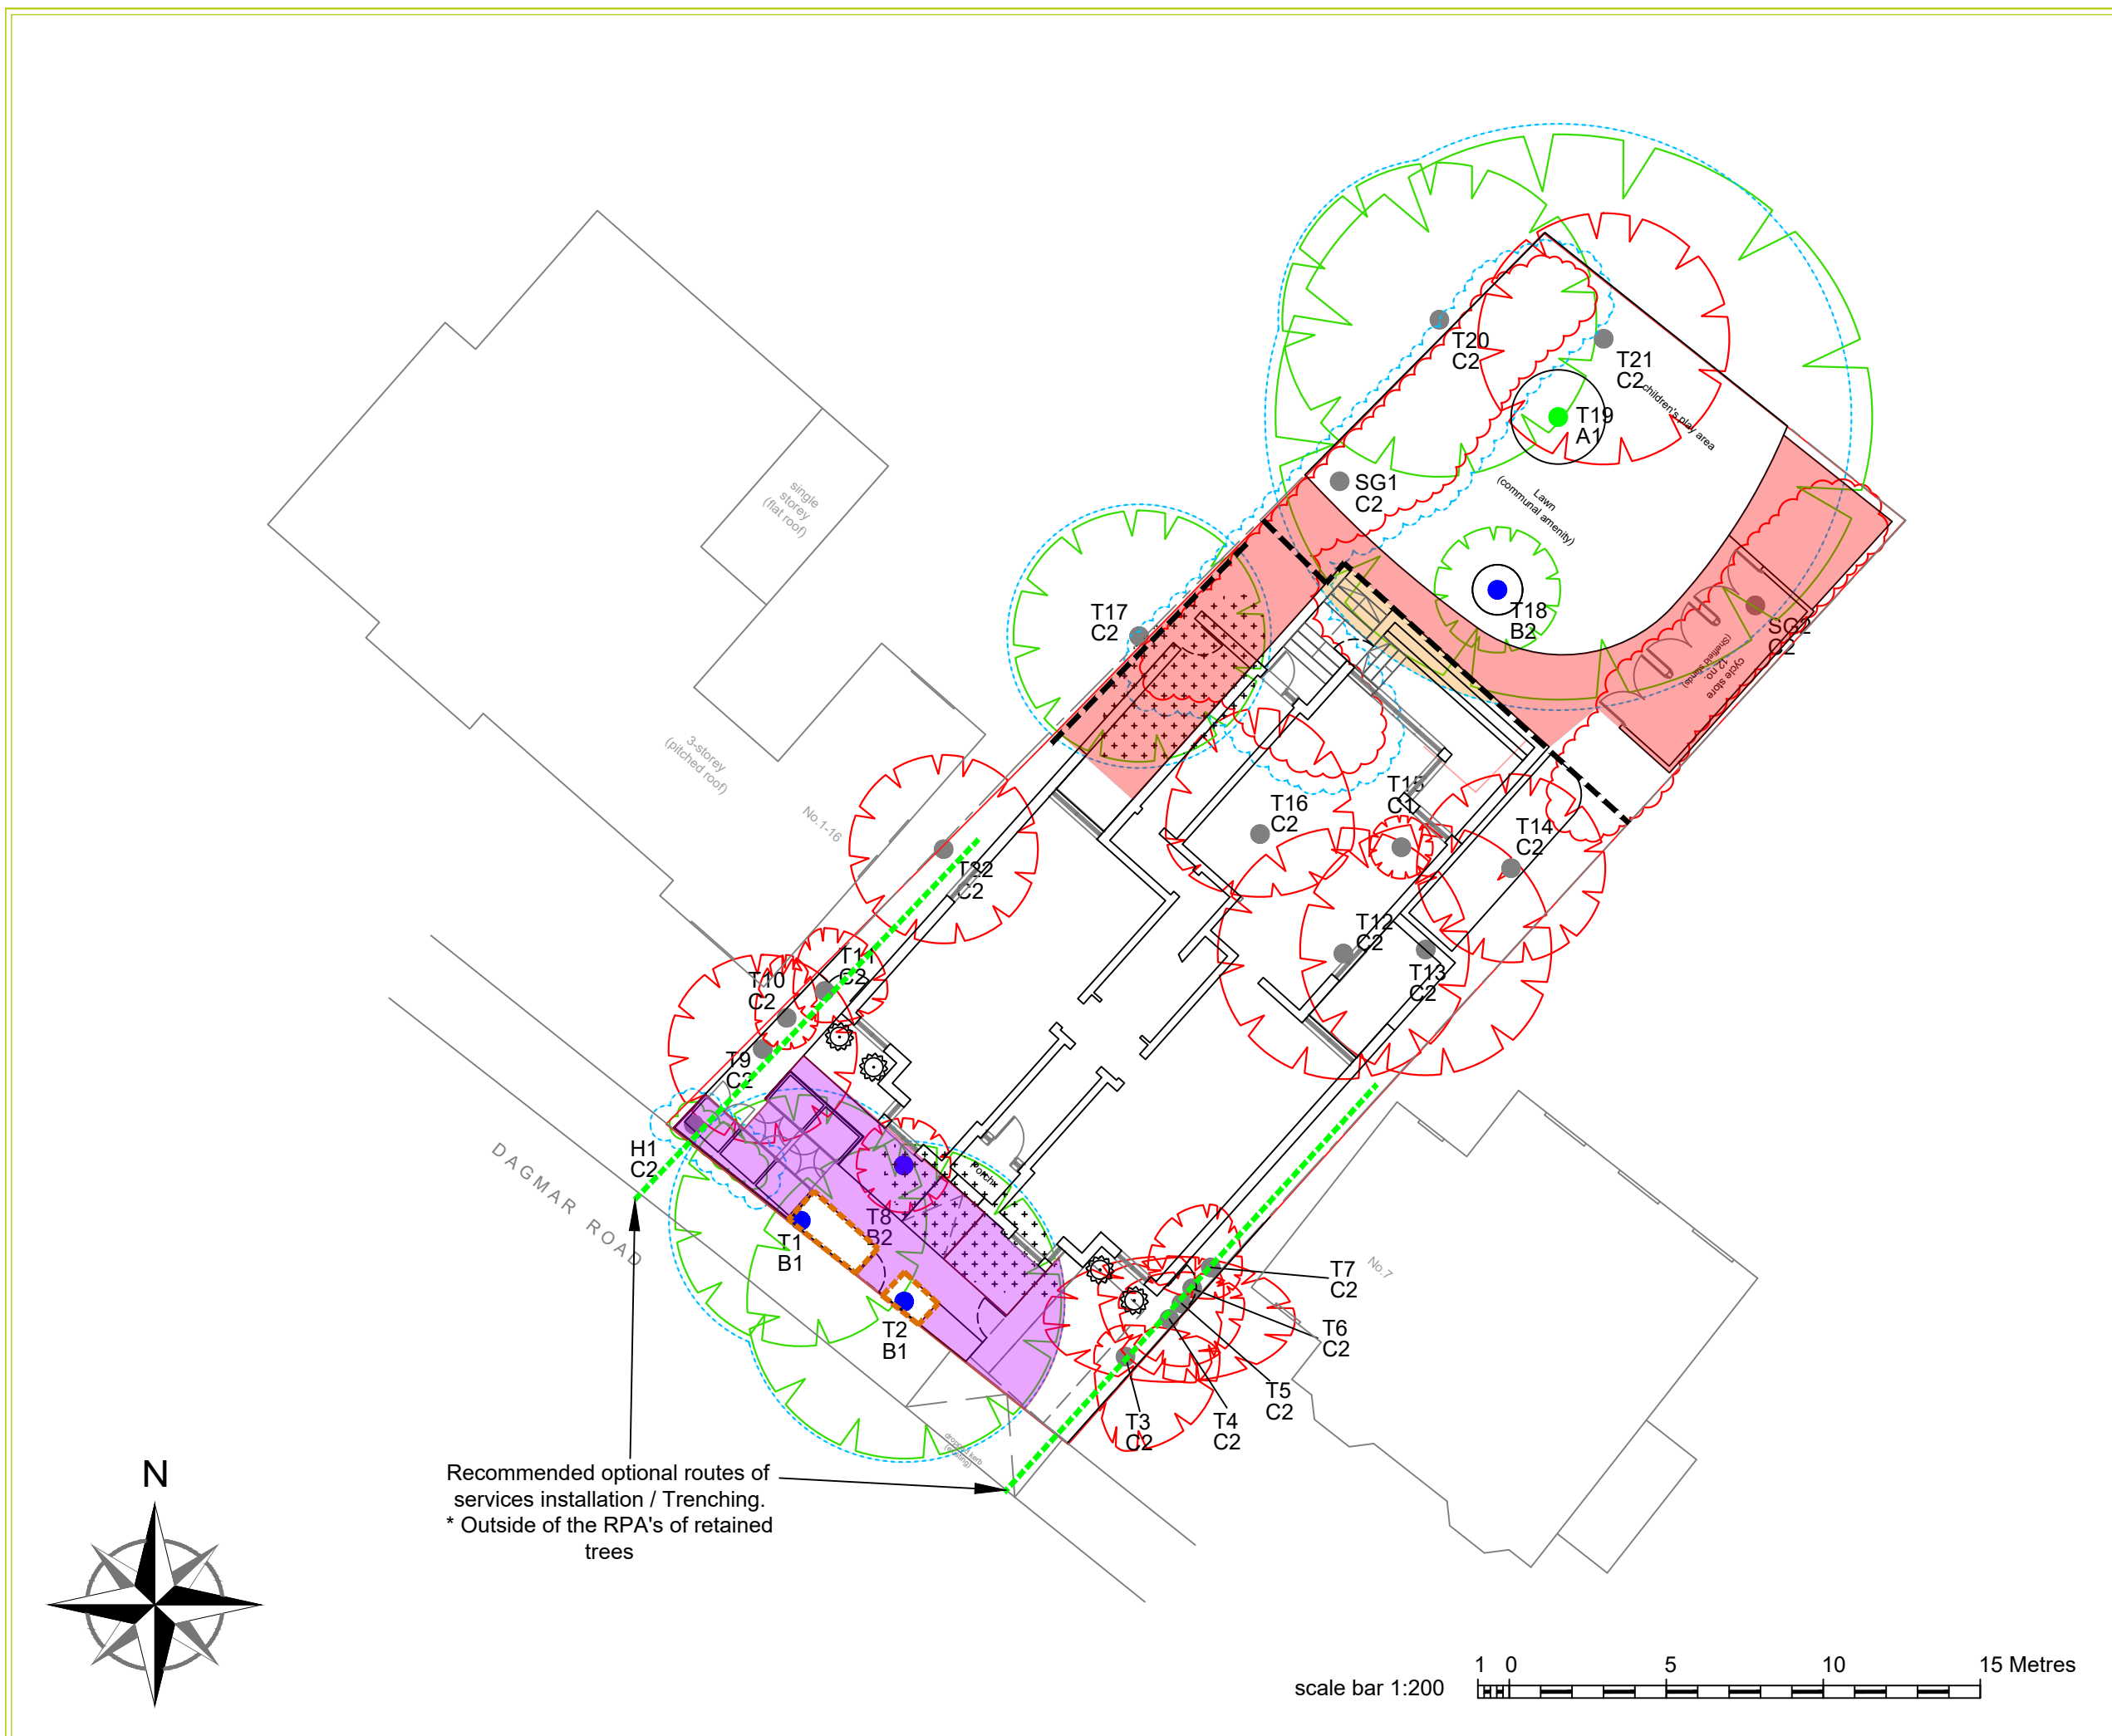
**APPENDIX 4**  
**TREE PROTECTION PLAN**

1.6.3 Confirmation from the client that they can accommodate the location of new services into the site as indicated by the Council tree officer and shown on the revised Tree Protection Plan at Appendix 4.

7.5.2 Following recommendations from the council tree officer services routes into the site have been agreed to be located outside of the RPAs of T1 & T2, as indicated on the revised Tree Protection Plan.

We have updated our recommendations that all drainage and underground service routes are located beyond the RPAs of all the retained trees, T1 & T2, as shown on the revised Tree Protection Plan at Appendix 4. If the service runs are to be located within an RPA, we recommend that this matter is dealt with by the approved SSAMS secured by planning condition. If services are located within an RPA, special implementation techniques such as moling, airspade, or hand digging may be required by the LPA. In the majority of cases, however, careful excavation with a low tonnage mechanical excavator, supervised by the consultant arboriculturist from EnviroArb-Solutions Ltd, can adequately undertake services excavations. When tree roots are encountered, hand digging, and root protection can then be undertaken as and when they are observed.

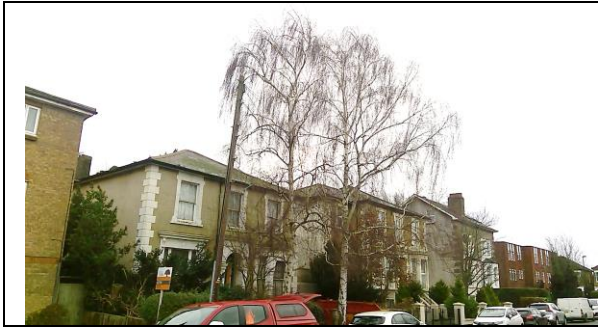
T1 - Birch (Silver)

Tree No	Species	Ht (m)	CS N	CS E	CS S	CS W	DBH (mm)	No of Stems	RPA (m2)	RPR (m)	BS Cat	Age Class	Life Expect	Observation	Recommendations
T1	Birch (Silver)	14.5	4	4	4	4	350	1	55	4	B1	Mature	20-39	Average form, shape and condition. No significant recent crown management. Dense crown, moderate dead wood, some hung up. Lower trunk ivy - unable to fully inspect. BT wires rubbing through crown.	Sever Ivy at 2m from ground level and remove section. Re-inspect. Crown lift to 5m over public footpath / highway. Cut back to suitable side growth point to provide 1-2m clearance from BT wires. Remove dead wood.
T2	Birch (Silver)	15	5	5	5	5	410	1	76	5	B1	Mature	20-39	Average form, shape and condition. No significant recent crown management. Dense crown, moderate dead wood, some hung up. BT wires rubbing through crown.	Crown lift to 5m over public footpath / highway. Cut back to suitable side growth point to provide 1-2m clearance from BT wires. Remove dead wood.

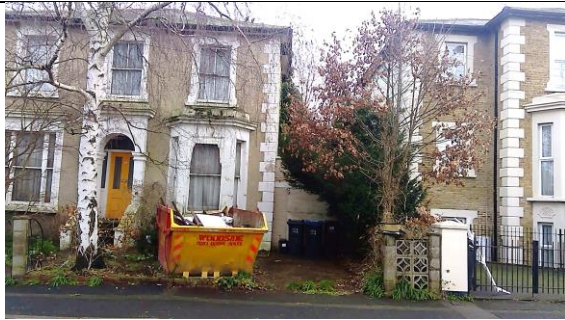
T3 - Sycamore

T3	Sycamore	7	1	3	3	1	140	2	9	2	C2	Semi-Mature	10-19	Poor form (asymmetric canopy), shape and condition. Open crown, low dead wood. Co dominant self sown tree with basal included union. Cut back over drive.	Fell to ground level and treat.
T4	Oak (Sessile)	8	2	4	2	4	100	1	5	1	C2	Semi-Mature	10-19	Poor form (asymmetric canopy), shape and condition. Open crown, low dead wood. Cut back over drive.	Fell to ground level and treat.

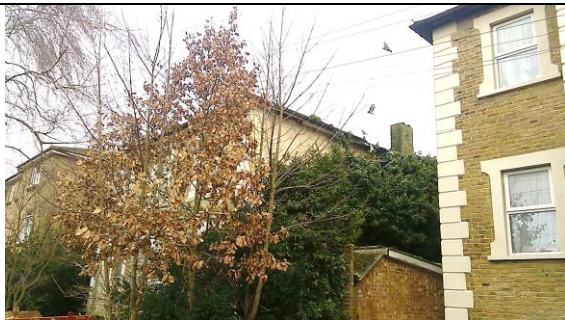
T5 - Sycamore

Tree No	Species	Ht (m)	CS N	CS E	CS S	CS W	DBH (mm)	No of Stems	RPA (m2)	RPR (m)	BS Cat	Age Class	Life Expect	Observation	Recommendations
T5	Sycamore	7	1	2	2	2	140	2	9	2	C2	Semi-Mature	10-19	Poor form (asymmetric canopy), shape and condition. Open crown, low dead wood. Co dominant self-sown tree with basal included union. Cut back over drive. Suppressed.	Fell to ground level and treat.
T6	Yew (Common)	4	1	1	3	3	100	1	5	1	C2	Semi-Mature	10-19	Poor form (asymmetric canopy), shape and condition. Dense, suppressed crown, low dead wood. Cut back over drive.	Fell to ground level and treat.
T7	Laurel (Bay)	5	2	1	1	2	100	m/s	5	1	C2	Semi-Mature	10-19	Poor form (asymmetric canopy), shape and condition. Dense, suppressed crown, low dead wood. Cut back over drive. Overhangs garage	Fell to ground level and treat.
T8	Maple (Japanese)	6	1.5	2	2	2	250	m/s	28	3	B2	Early Mature	20-39	Average form, shape and condition. Dense, crown, low dead wood. Minor deadwood.	No works.

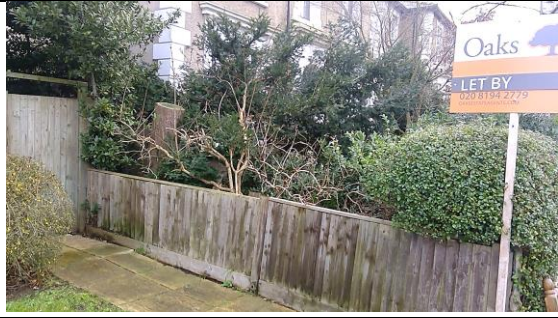
T9 - Yew (Common)

T9	Yew (Common)	3	3	3	3	3	100	1	5	1	C2	Semi-Mature	10-19	Poor form (asymmetric canopy), shape and condition. Dense, suppressed crown, low dead wood. Cut back over fenceline.	Fell to ground level and treat.

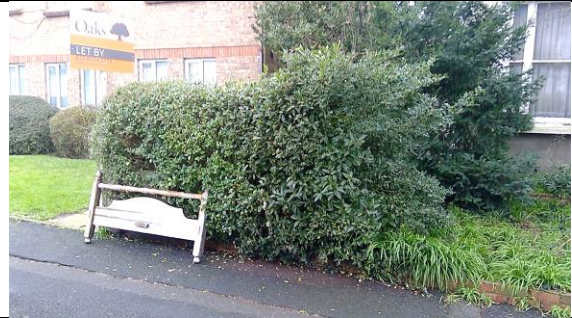
H1 - Mixed species hedge

Tree No	Species	Ht (m)	CS N	CS E	CS S	CS W	DBH (mm)	No of Stems	RPA (m2)	RPR (m)	BS Cat	Age Class	Life Expect	Observation	Recommendations
H1	Mixed species hedge	2	0.5	1	1	1	80	m/s	3	1	C2	Semi-Mature	10-19	Average form, shape and condition. Dense crown, Minor dead wood.	Annual trimming maintenance.
T10	Laurel (Bay)	6	2	1	1	1	100	m/s	5	1	C2	Semi-Mature	10-19	Poor form (asymmetric canopy), shape and condition. Dense, suppressed crown, low dead wood. Cut back over drive. Overhangs boundary fence line.	Fell to ground level and treat.
T11	Laurel (Bay)	7	2	2	1	1	100	m/s	5	1	C2	Semi-Mature	10-19	Poor form (asymmetric canopy), shape and condition. Dense, suppressed crown, low dead wood. Cut back over drive. Overhangs boundary fence line.	Fell to ground level and treat.
T12	Elder	6	4	4	4	4	300	m/s	41	4	C2	Mature	10-19	Poor form, shape and condition. Dense, suppressed crown, low dead wood.	Fell to ground level and treat.

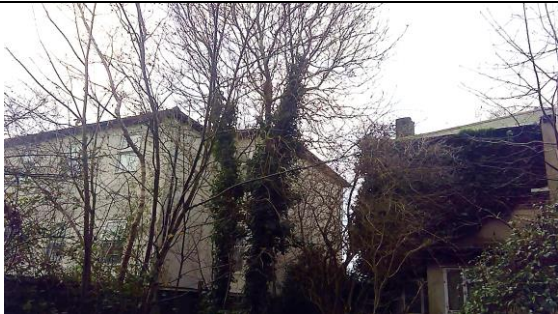
T13 - Ash (Common)

Tree No	Species	Ht (m)	CS N	CS E	CS S	CS W	DBH (mm)	No of Stems	RPA (m2)	RPR (m)	BS Cat	Age Class	Life Expect	Observation	Recommendations
T13	Ash (Common)	14	4	4	4	4	600	m/s	163	7	C2	Early Mature	10-19	4 x 150mm stems. Multiple-stemmed with basal included unions. Ivy clad crown and stem, unable to fully inspect. Unable to inspect due to restricted access & vegetation. Open crown, moderate dead wood.	Fell to ground level and treat.
T14	Silver Birch & Sycamore	12	3	3	3	3	500	m/s	113	6	C2	Early Mature	10-19	5 x 100mm stems. Self-sown Multiple-stemmed trees with basal included unions. Ivy clad crown and stem, unable to fully inspect. Unable to inspect due to restricted access & vegetation. Open crown, moderate dead wood. X 1 stem dead.	Fell to ground level and treat.
T15	Snake bark Maple	4	1	1	1	1	100	1	5	1	C1	Semi-Mature	10-19	Poor form, shape and condition. Sparse crown moderate deadwood.	Fell to ground level and treat.

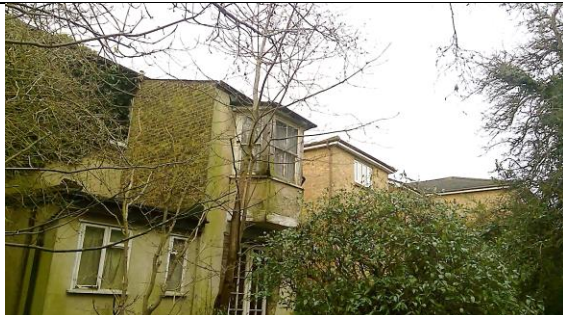
T16 - Cherry

Tree No	Species	Ht (m)	CS N	CS E	CS S	CS W	DBH (mm)	No of Stems	RPA (m2)	RPR (m)	BS Cat	Age Class	Life Expect	Observation	Recommendations
T16	Cherry	12	4	3	2	3	260	2	31	3	C2	Early Mature	10-19	Poor form (asymmetric canopy), shape and condition. No significant recent crown management. Dense crown rubbing building, minor dead wood. Co dominant tree with severe included unions.	Fell to ground level and treat.
T17	Pear	11	4	4	4	4	350	1	55	4	C2	Mature	10-19	Average form, shape and condition. Unable to inspect due to restricted access & vegetation. No significant recent crown management. Dense crown, minor dead. Ivy clad crown and stem and 3rd party off site tree - unable to fully inspect with overhanging branches.	No works.
T18	Magnolia	2.5	2	2	2	2	100	2	5	1	B2	Early Mature	20-39	Average form, shape and condition. Dense crown, minor dead wood.	No works.
T19	Cedar (Blue Atlas)	18	9	10	9	9	690	1	215	8	A1	Mature	40+	Good form (asymmetric canopy), shape and condition. No significant recent crown management. Dense low crown, moderate dead wood.	Remove dead wood.

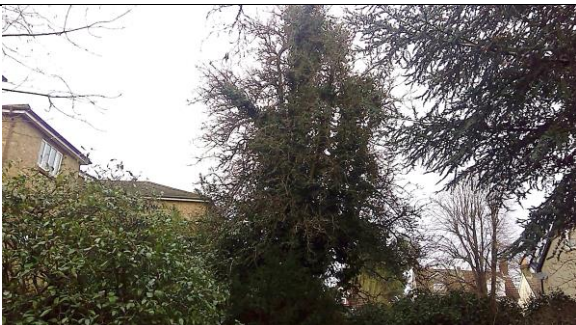
T17 - Pear

T17	Pear	11	350	C2	Mature	Average form, shape and condition. Unable to inspect due to restricted access & vegetation. No significant recent crown management. Dense crown, minor dead. Ivy clad crown and stem and 3rd party off site tree - unable to fully inspect with overhanging branches.	Cut back branches overhanging the site boundary fenceline.
T19	Cedar (Blue Atlas)	18	690	A1	Mature	Good form (asymmetric canopy), shape and condition. No significant recent crown management. Dense low crown, moderate dead wood.	Remove dead wood.

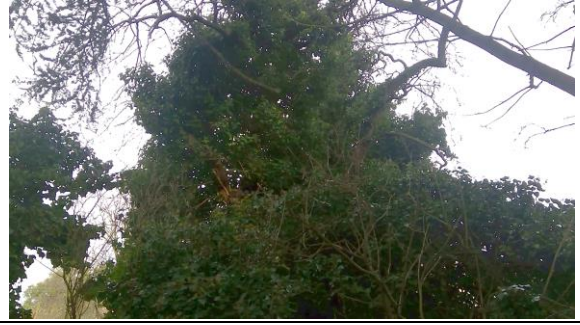
T20 - Pear

Tree No	Species	Ht (m)	CS N	CS E	CS S	CS W	DBH (mm)	No of Stems	RPA (m2)	RPR (m)	BS Cat	Age Class	Life Expect	Observation	Recommendations
T20	Pear	11	5	5	5	5	350	1	55	4	C2	Mature	10-19	Poor suppressed form, shape and condition. Unable to inspect due to restricted access & vegetation. No significant recent crown management. Dense crown, major dead. Ivy clad crown and stem and 3rd party off site tree - unable to fully inspect with overhanging branches.	No works.
T21	Pear	11	4	4	4	4	400	1	72	5	C2	Mature	10-19	Poor form, shape and condition. Unable to inspect due to restricted access & vegetation. No significant recent crown management. Dense crown, major dead. Ivy clad crown and stem on tree - unable to fully inspect with overhanging branches.	Fell to ground level and treat.
SG1	Mixed species shrubs; Yew, Holly, Bottlebrush, Viburnum	3	2	2	2	2	109	m/s	5	1	C2	Mature	10-19	Poor form, shape and condition mixed tired shrub planting. No significant recent crown management. Dense crowns, moderate dead wood. Ivy clad.	Fell to ground level and treat.

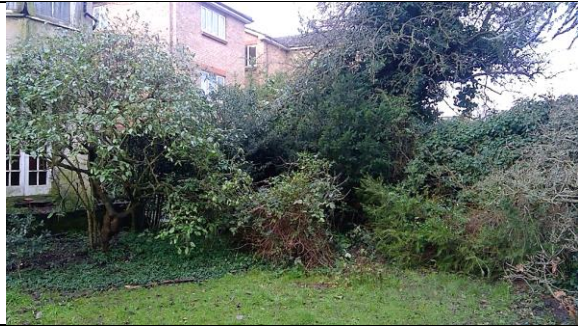
SG1 - Mixed species shrubs

Tree No	Species	Ht (m)	DBH (mm)	BS Cat	Age Class	Observation	Recommendations
SG1	Mixed species shrubs; Yew, Holly, Bottlebrush, Viburnum	3	109	C2	Mature	Poor form, shape and condition mixed tired shrub planting. No significant recent crown management. Dense crowns, moderate dead wood. Ivy clad.	Fell to ground level and treat.
SG2	Mixed species shrubs; Rose, Spirea, Philadelphia, Elder	3	109	C2	Mature	Poor form, shape and condition mixed tired shrub planting. No significant recent crown management. Dense crowns, moderate dead wood.	Fell to ground level and treat.
T22	Sycamore	11	100	C2	Semi-Mature	Poor, etiolated form, shape and condition. No significant recent crown management. Self-set pioneer tree.	Fell to ground level and treat.

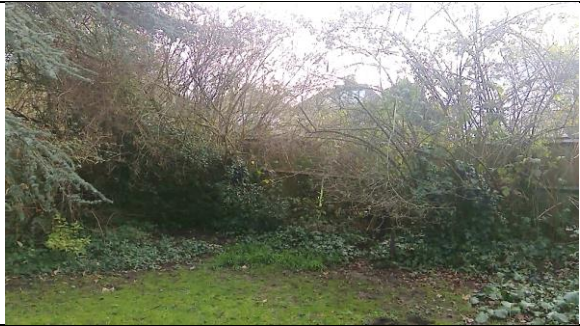
SG2 - Mixed species shrubs; Rose, Spirea, Philadelphia, Elder

Tree No	Species	Ht (m)	CS N	CS E	CS S	CS W	DBH (mm)	No of Stems	RPA (m2)	RPR (m)	BS Cat	Age Class	Life Expect	Observation	Recommendations
SG2	Mixed species shrubs; Rose, Spirea, Philadelphia, Elder	3	2	2	2	2	109	m/s	5	1	C2	Mature	10-19	Poor form, shape and condition mixed tired shrub planting. No significant recent crown management. Dense crowns, moderate dead wood.	Fell to ground level and treat.
T22	Sycamore	11	3	3	3	3	100	1	5	1	C2	Semi-Mature	10-19	Poor, etiolated form, shape and condition. No significant recent crown management. Self-set pioneer tree.	Fell to ground level and treat.
