B. J. UNWIN FORESTRY CONSULTANCY Ltd.

Site: **Part of Winterfold Farm, Chaddesley Corbett, DY10 4PL.**

Subject: ***BS5837 Tree Constraints, Impact Assessment
& Tree Protection Method Statement for widened gateway.***

Surveyor: Jim Unwin.
Report: Jim Unwin. (professional-CV in Appendix VI).
Dates: Inspection 14th Nov 2023. Report: Stage 1: 27th Nov 2023.
Stage 2: 27th Nov 2023 **rev 22nd Jan 2024 with optimised access location.**

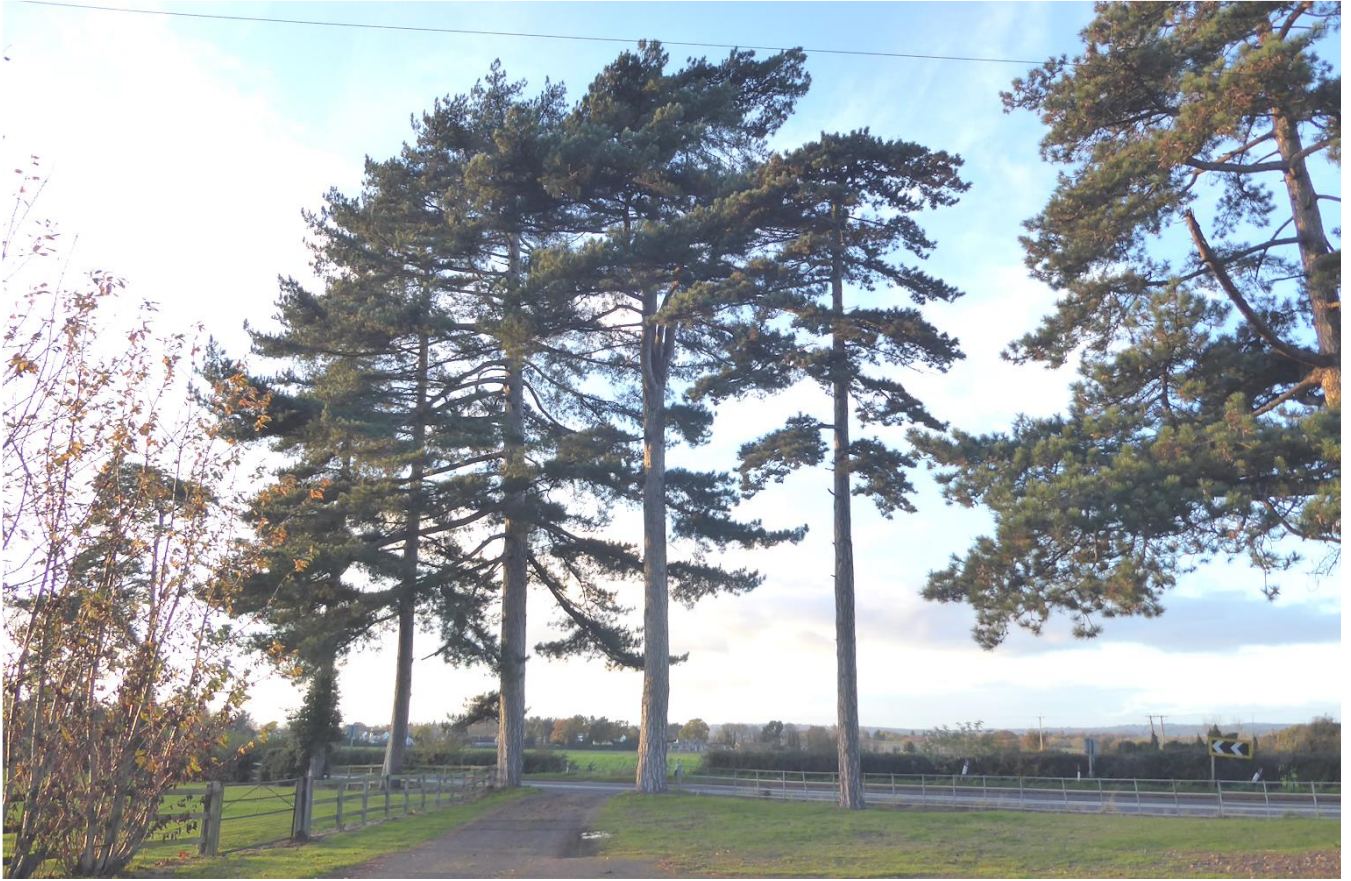
4.4.1 View north west to big pines flanking existing entrance.

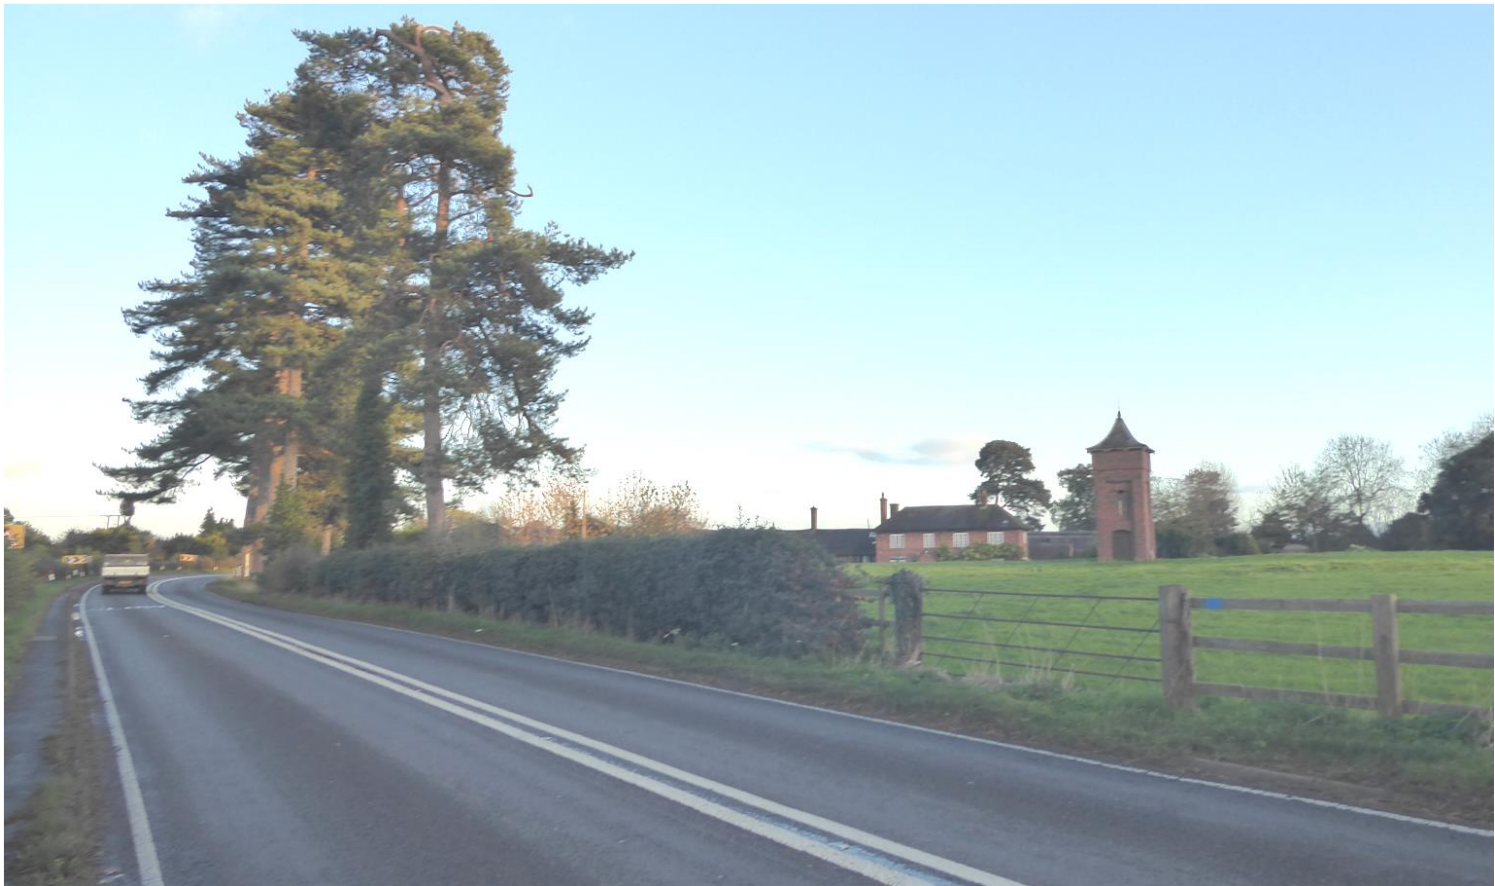
4.4.2 View east past proposed entrance to holly hedge H13 and pines T14 etc.

- Visibility splay requires the western end of holly T13 to be pruned back to stems.

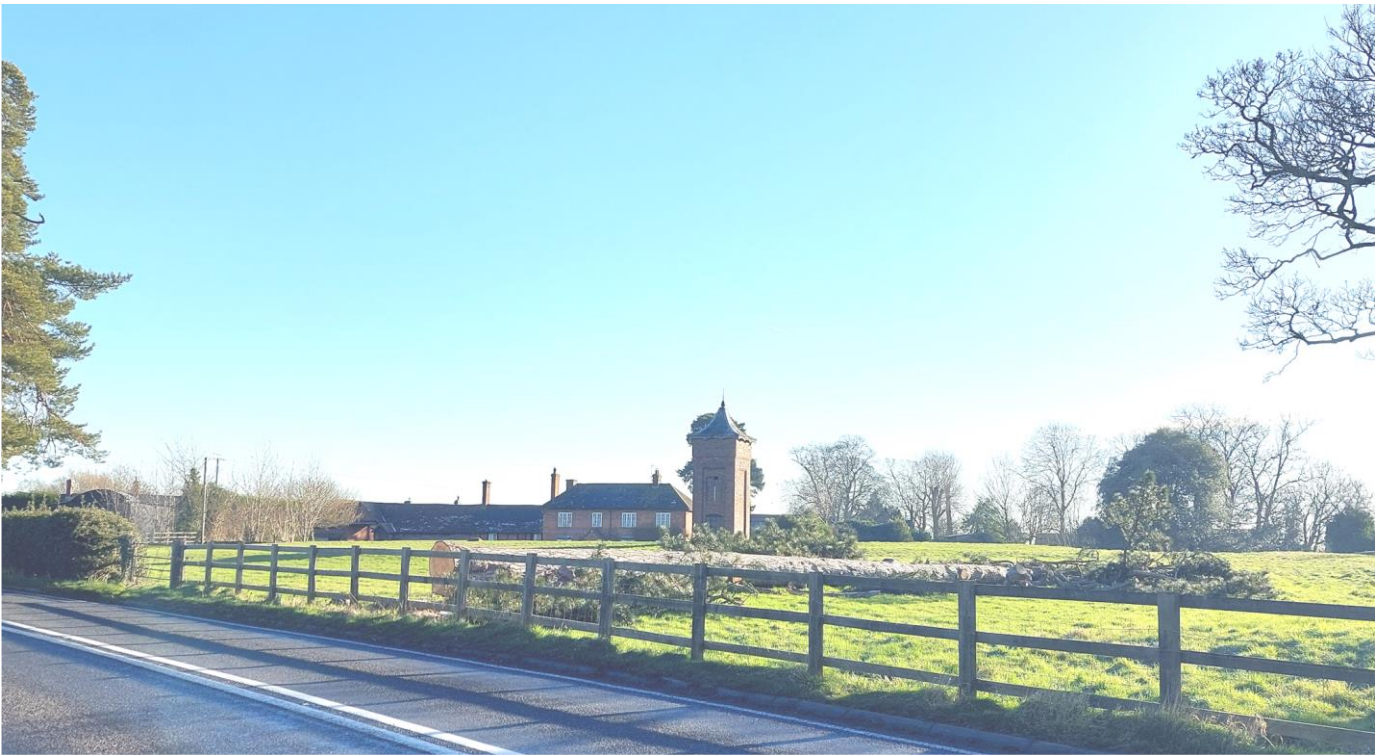
4.4.3 End of H13 on left.

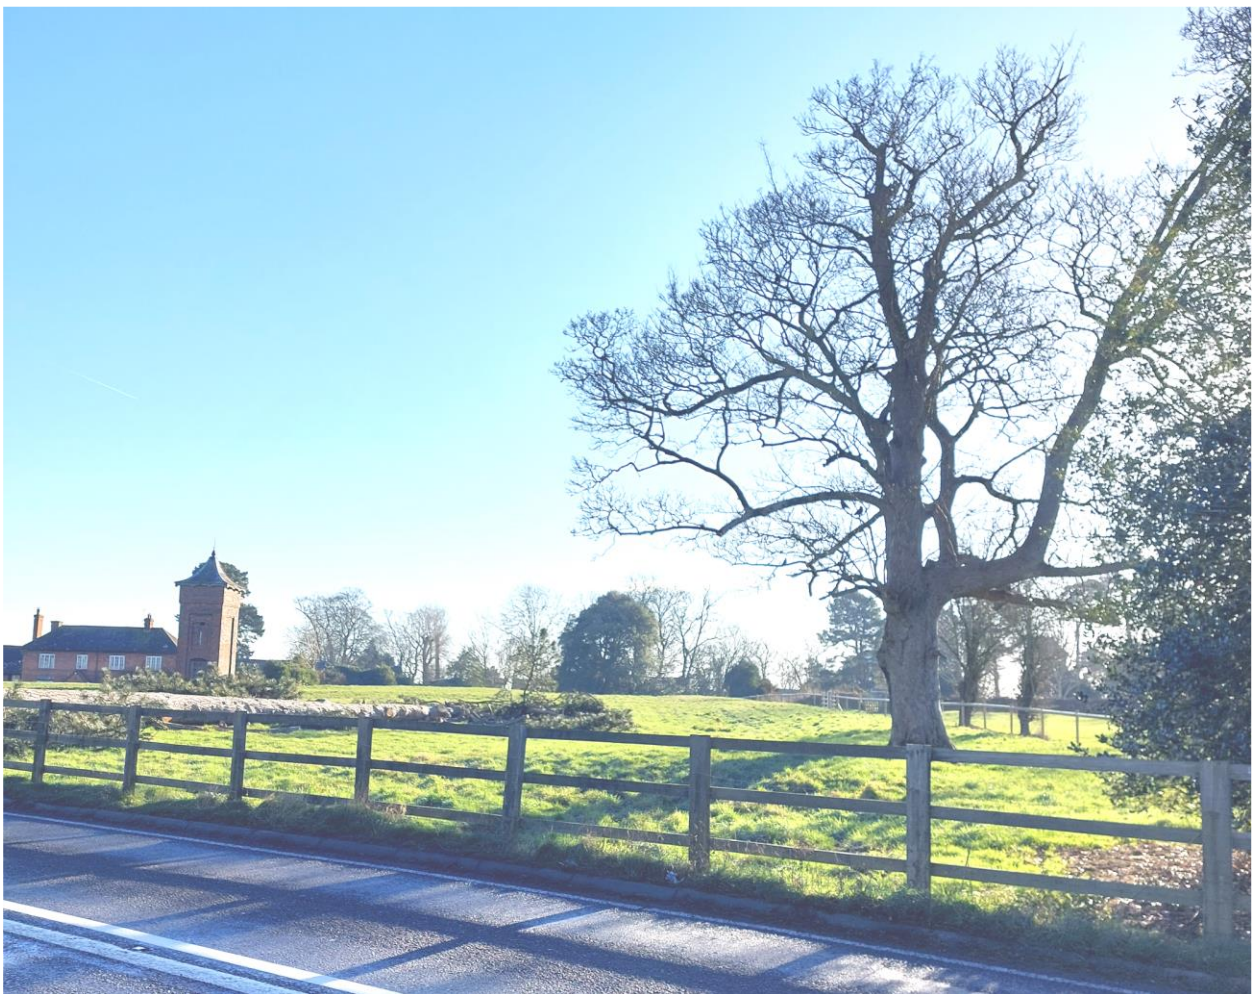
4.4.4 Sycamore T11 right and holly T10 just out of picture right.

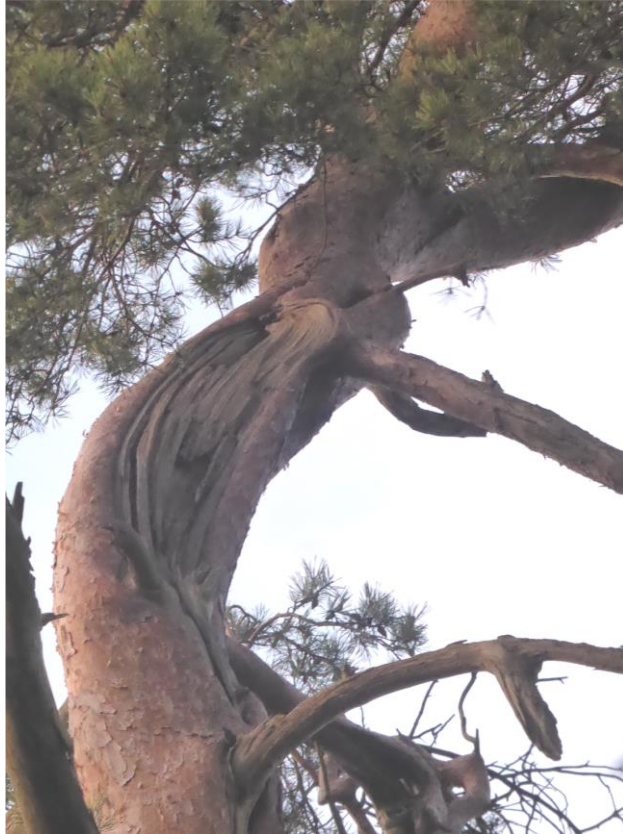
- 4.1 Trees on or adjacent to site:
 - The biggest trees are ten Corsican pines and two Scots pines flanking the existing entrance.
 - They are large and mostly good trees.
 - Scots pine T14 has a twisted top with a risk of falling into the road.

4.4.5 Cavity at top of pine T14.

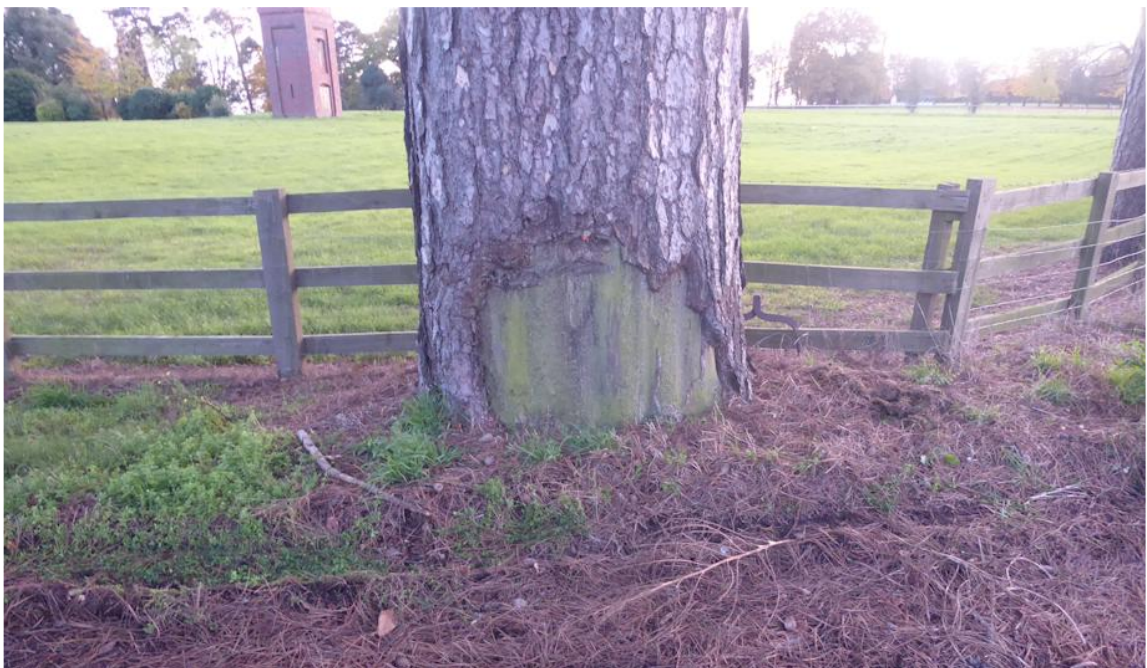
- The base of Corsican pine T18 on the entrance has been damaged by vehicles over many decades, but none in the past twenty or so years.
- A short section of good holly hedge H13 links the existing drive entrance and gateway.
- A good multi-stem holly T10 and old sycamore T11 stand in the western corner of the paddock.
- Pine T12 has been recently felled.
- Sycamore T11 has historic basal damage and *Ganoderma* basal decay (see photo).

4.4.6 View west to old wound at base of pine T18.

T18	Corsican pine	1150	27	6	27	6	6	6	6	M/Lm	F	F	>40	1/3 basal dead cambium: historic vehicle damage. Flanking drive.	A2 as a group.	13.8	
T19	Corsican pine	1050	27	9	27	6	6	6	6	M/Lm	F	F	>40	Flanking drive.	A2 as a group.	12.6	
T20	Corsican pine	750	20	9	20	4	4	4	4	M/Lm	F	F	>40		A2 as a group.	9.0	
T21	Corsican pine	900	22	7	22	6	6	6	6	M/Lm	F	F	>40		A2 as a group.	10.8	
T22	Corsican pine	750	25	7	25	6	6	6	6	M/Lm	F	F	>40	Narrow forks.	A2 as a group.	9.0	
T23	Corsican pine	700	20	8	20	4	6	3	5	M/Lm	F	F	>40	Tag 4633. Lean east.	A2 as a group.	8.4	
T24	Corsican pine	800	25	8	25	3	5	5	4	M/Lm	F	F	>40	Tag 3554.	A2 as a group.	9.6

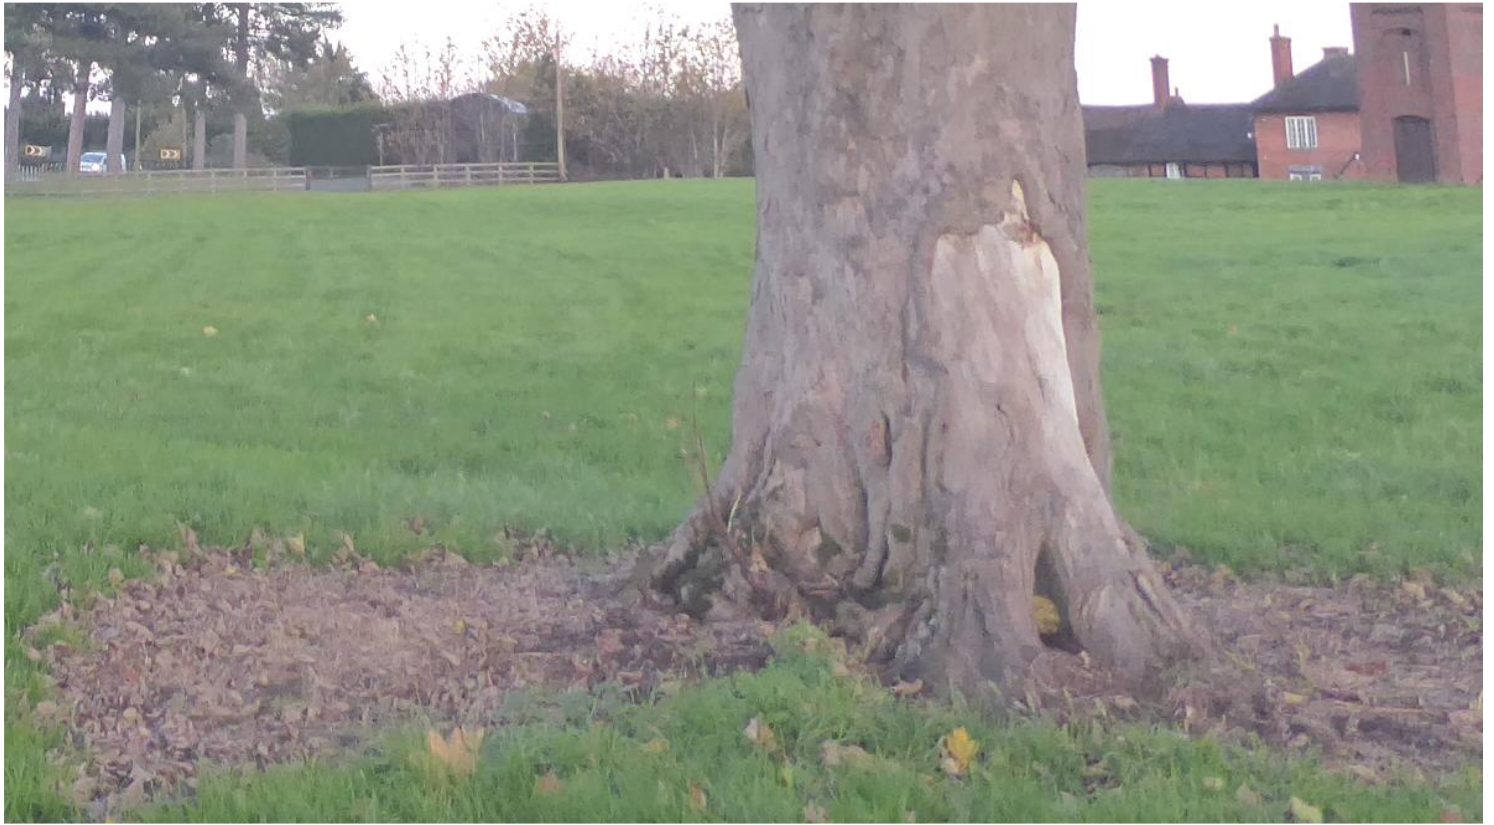
4.4.7 Base of sycamore T11 showing areas of eaten-off cambium, and *Ganoderma* bracket.

T10	Holly	10 stems x 150	9	0	9.5	3.5	3.5	3.5	3.5	M	F	F	>40	Bushy, good. Elder growing into crown.	B1 / B2	5.7	Cut out elder.
T11	Sycamore	970	16	4	16	7	8	9	9	Lm	F	P	>20	Severe animal damage around base. 2/3 basal cambium dead and <i>Ganoderma</i> fungal decay spore body.	B2	11.6	
T12														Corsican pine stump.			
H13	Holly	200 basal	2	0	2	0.8	0.8	0.8	0.8 ext.	M	F	F	>40	Trimmed. Occasional hawthorn and elder.	B2	2.0	
T14	Scots pine	550	22	5	22	4	6	4	5	Lm	F	P	>40	Tag 1443. At 4/5 height the stem twists with a long open scar. Upper part over road.	B2	6.6	Top down to twist.
T15	Scots pine	450	20	9	20	3	3	3	3	Lm	P/F	F	>40	Slender.	C2	5.4	
T16	Corsican pine	650	26	5	26	5	5	5	5	M/Lm	F	F	>40	Tag 1445.	A2 as a group.	7.8	
T17	Corsican pine	900	27	7	27	5	5	5	5	M/Lm	F	F	>40		A2 as a group.	10.8

- The sycamore just overhangs the drive. This combined with its historic basal damage, suggests that a minor crown reduction is needed to maintain harmony and tree safety by the drive.
