Biodiversity Assessment

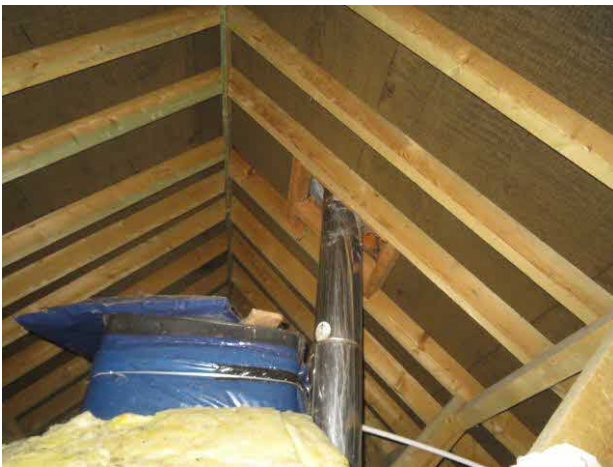
Existing roof looking north towards the flue which will be removed

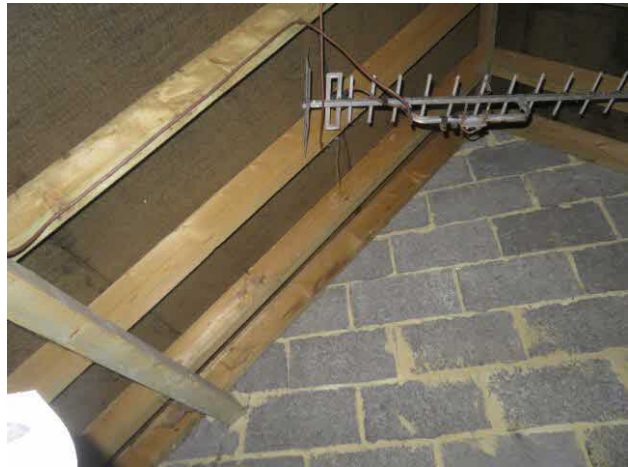
Existing roof looking south
