**CHRIST CHURCH,
MALVERN ROAD,
CHELTENHAM,
GLOUCESTERSHIRE
GL50 2JH**

STATEMENT OF HERITAGE SIGNIFICANCE

November 2023

Edward Holland

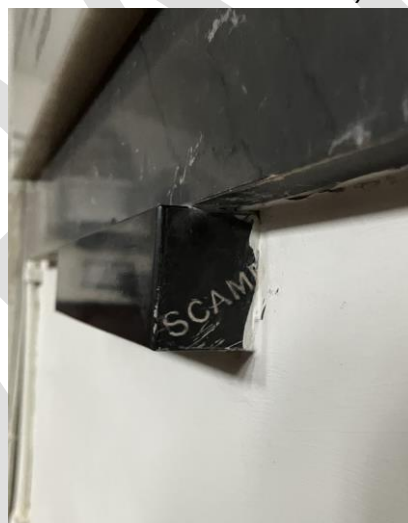
Figure 48 Example of where later dry-lining of aisle wall has partially obscured the signature on the monument

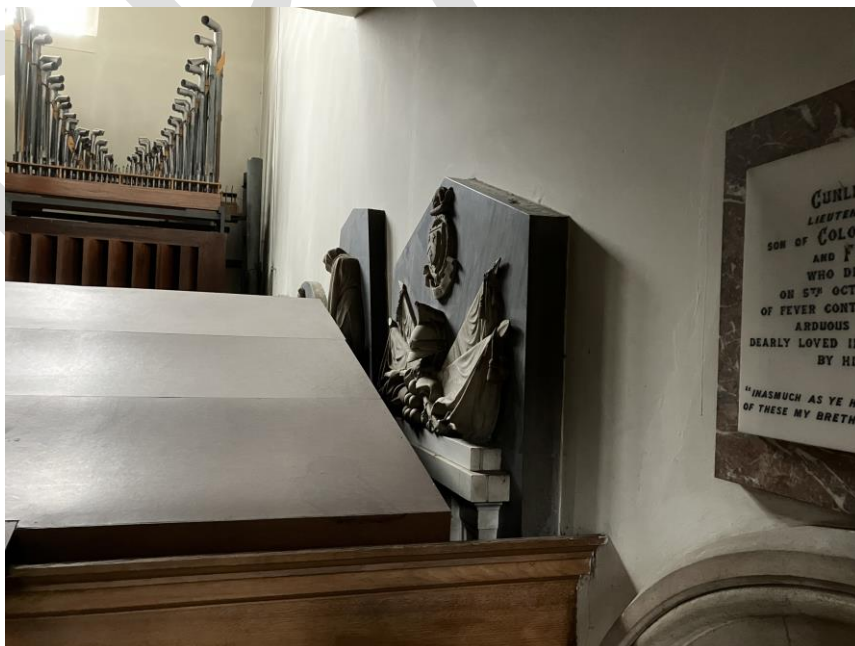
4.12.4 Distinctive, neo-classical, monuments to the North Transept east wall have been insensitively obscured by the creation of the Lady Chapel altar and can no longer be read. Some monuments to the South Transept are also obscured by chairs stacked against them.

Figure 50 Monuments obscured by the Lady Chapel altar that butts up against them

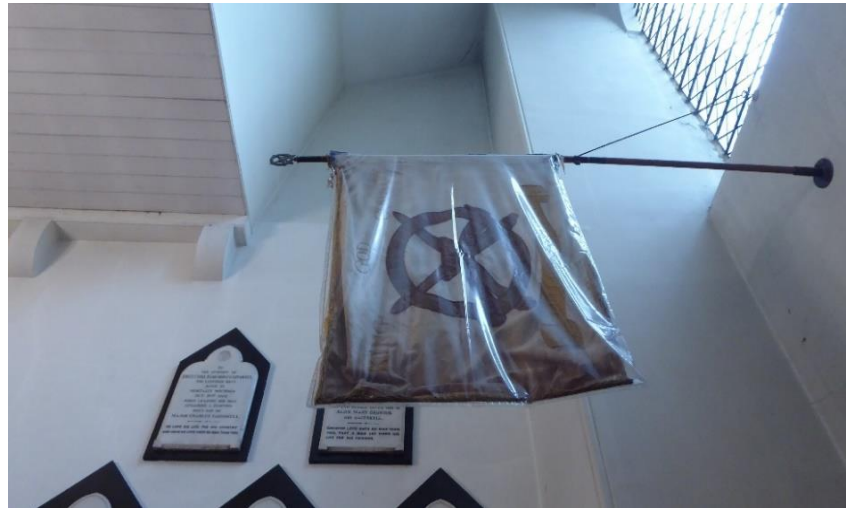
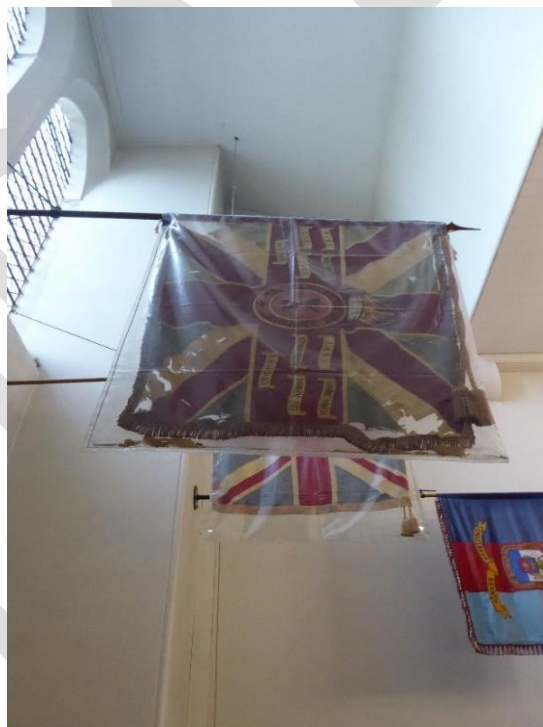
Figures 54 and 55 Regimental colours hanging at west end of church

4.15.2 The condition of these could not be closely inspected at the time of survey but it is recommended that they are periodically inspected by a specialist conservator. The coverings will protect the textiles from dust but long-term they may create high levels of humidity that could be damaging.

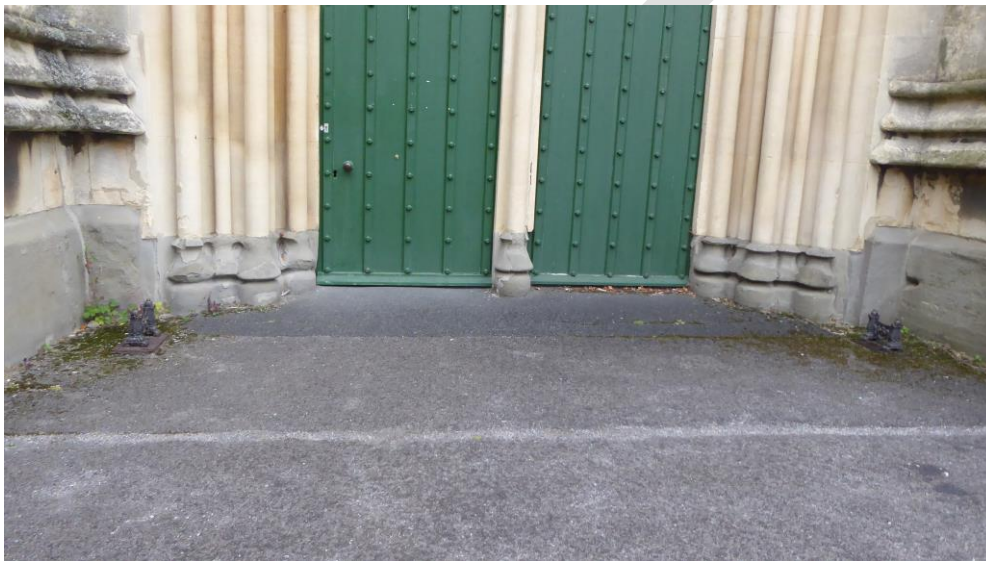
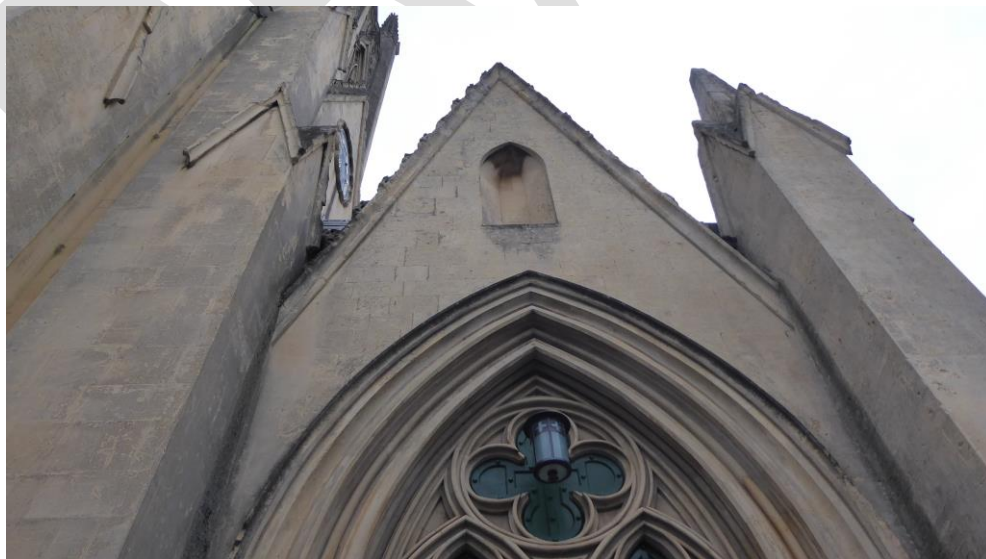
7.1 The latest Quinquennial report⁶ refers to the fact that the soft local stone has suffered erosion, although the church appears in generally good condition. In terms of stonework conservation issues, it is understood that pinnacles have in the past fallen and the weathering of those that remain is clear, especially with regard to the crocketed detail. The loss of original detail on these has resulted in some diminution of the heritage significance of the building. The plinth and bases of the clustered shafts to the jambs of the main entrances also evidence stone decay.

Figures 61 and 62 Evidence of stonework erosion

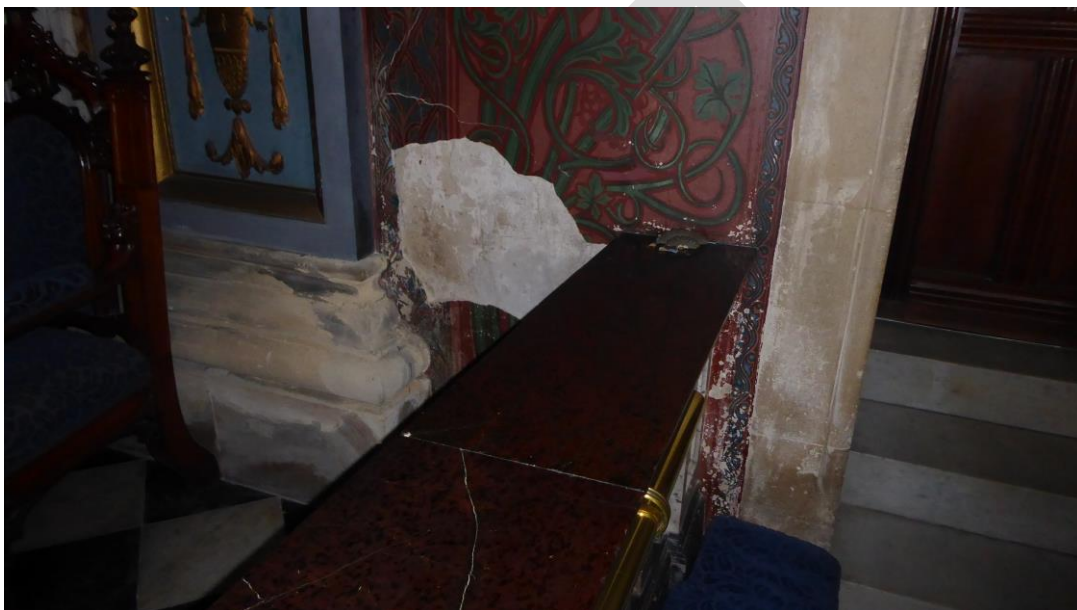
7.2 Internally there are areas of flaking plaster, potentially as a result of the application of non-breathable paint. This may be a long-standing problem and the reason for the dry-lining of the lower part of the nave walls. More seriously the surface of the plaster in the apse is crumbling probably due to moisture penetration or condensation and in the process this is losing some of the important fresco painting. The intensity of the original colour has been lost due to an accumulation of dirt and candle grease and this has especially affected the reredos. Cleaning by a specialist paint conservator is needed to restore the quality of this interior decoration. Conservation is also needed of the pulpit where cracking of the marble cornice has led to a large piece breaking off.

Figure 63 Evidence of moisture ingress damaging the painted plaster

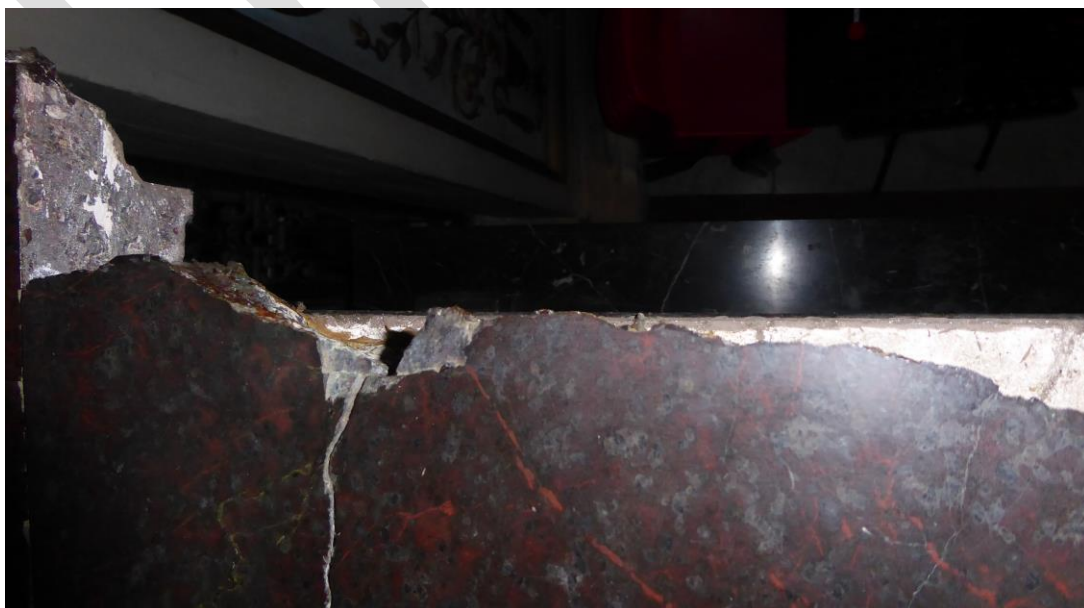
Figure 64 Damage to the marble on the pulpit

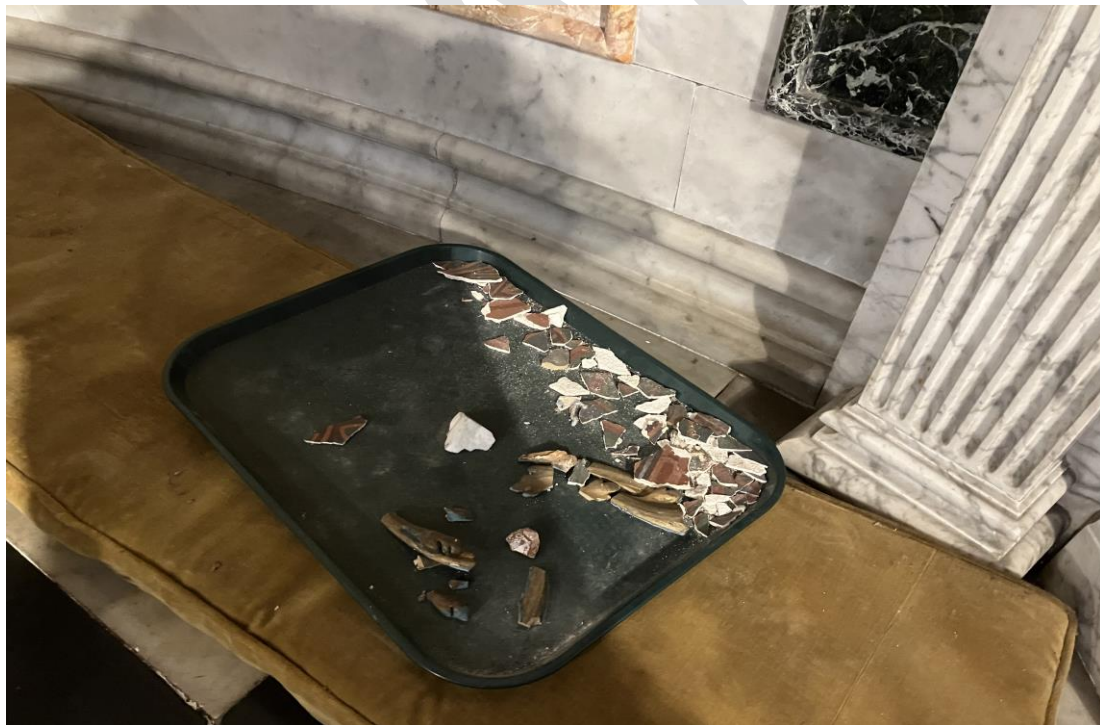
Figure 66 Evidence of progressive loss of painted decoration
