HERITAGE STATEMENT

**FOR REPLACEMENT WINDOWS & DOOR, REPAIRS TO EXTERNAL RENDER AND INTERNAL ALTERATIONS
TO FORM NEW GROUND FLOOR CLOAKROOM & LARGER 1ST FLOOR BATHROOM AT**

**Moot Hall,
Well Lane, Clare,
Sudbury,
CO10 8NH**

Date: February 2024

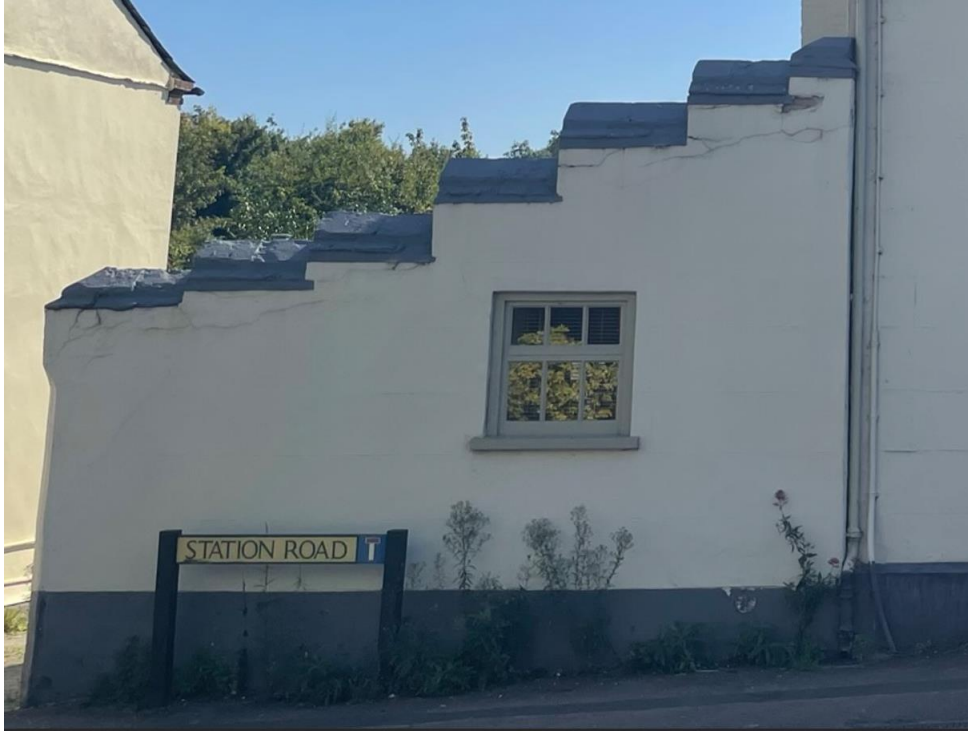
Figure 1a

Careful removal of cracked and blown sand cement render to front and side walls of existing crow stepped historic addition (Figs 1a & 1b) which has been allowing rain penetration at high level.

External Plaster Repairs: The proposal is to carefully remove the existing sand cement render from the brick substrate at high level below wall capping (Fig. 1a & b)

Remove the sand cement render to the top half of wall to a point where the existing render is fully adhered to the brick substrate and on an existing horizontal ashlar line, using hand tools to prevent damage to the surface of the brick.

Allow the brickwork to dry out.

The surface of the existing brick is to be cleaned and the joints raked back (10mm) to provide a key for the undercoat. Water will be applied to provide sufficient suction and a dubbing out coat applied if there are areas with damaged joints/defaced surface. Strength of plaster to be compatible with brick substrate.

Apply lime plaster to the exposed brickwork to an Anglia Lime specification suitable for external plaster over a brick substrate.

The edges of the exposed line of existing render should be slightly undercut to help provide a key for the repair.

New plaster finishing coat is to form a flush surface with the existing render line.

Plaster repair is to match existing ashlar pattern.

Redecoration with breathable external quality paint to match the existing colour.

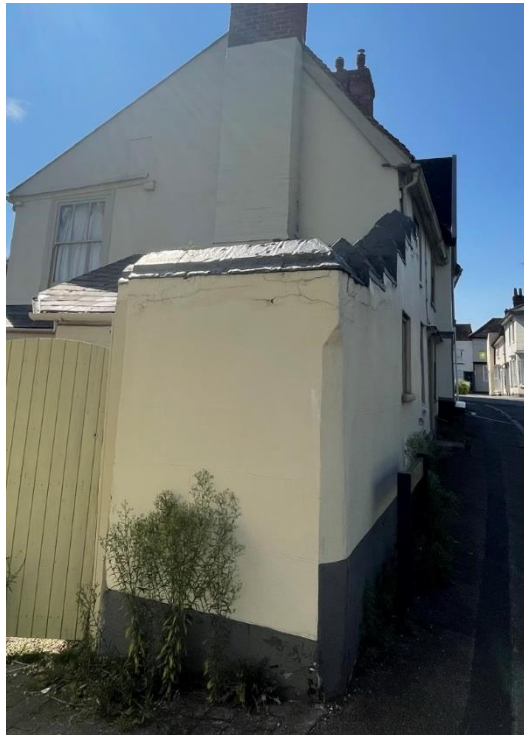
Figure 1b

The surface of the wall at lower level is to be investigated to confirm that there are no other areas of cracked/blown render and that the remaining areas are in sound condition.

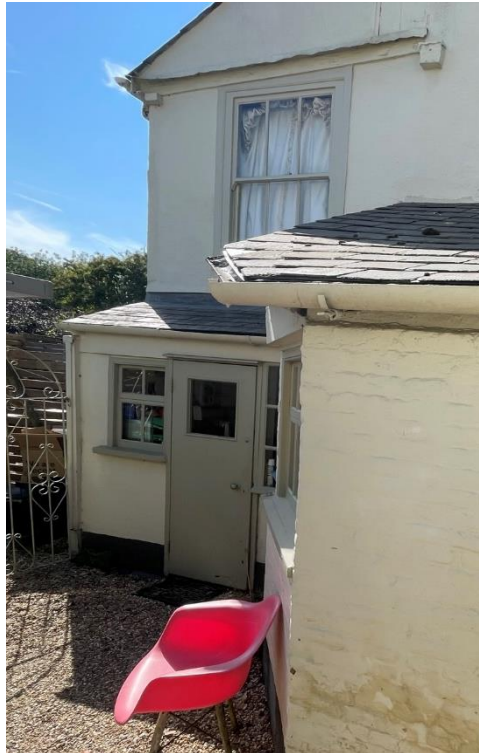
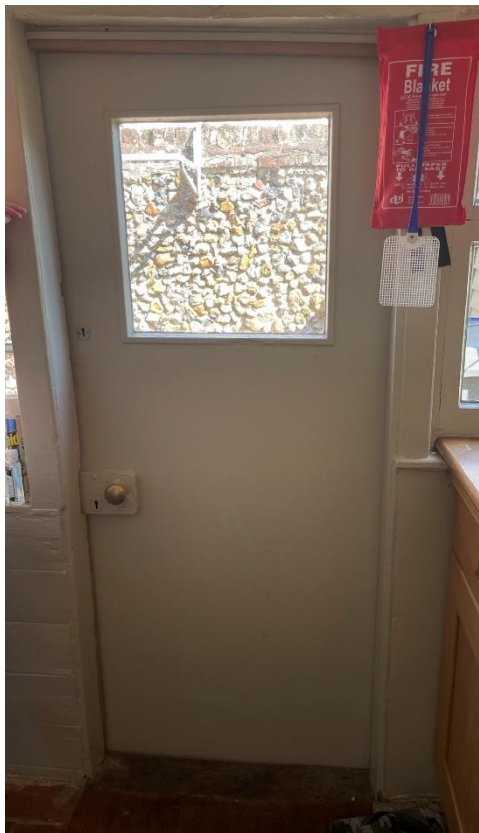
The existing external door to the kitchen is flush panel part glazed 20th century (low significance) (Figs 2 & 3)

Figures 2 & 3: External and internal view of modern external door to kitchen to be replaced with traditional style external door

3)	The existing flush panel part glazed external kitchen door is 20 th century and is to be removed.	Low significance	Positive conservation impact	Replacement with a high quality joinery traditional style timber door will enhance the appearance of the listed building. Breathable paint finish to match existing colour.

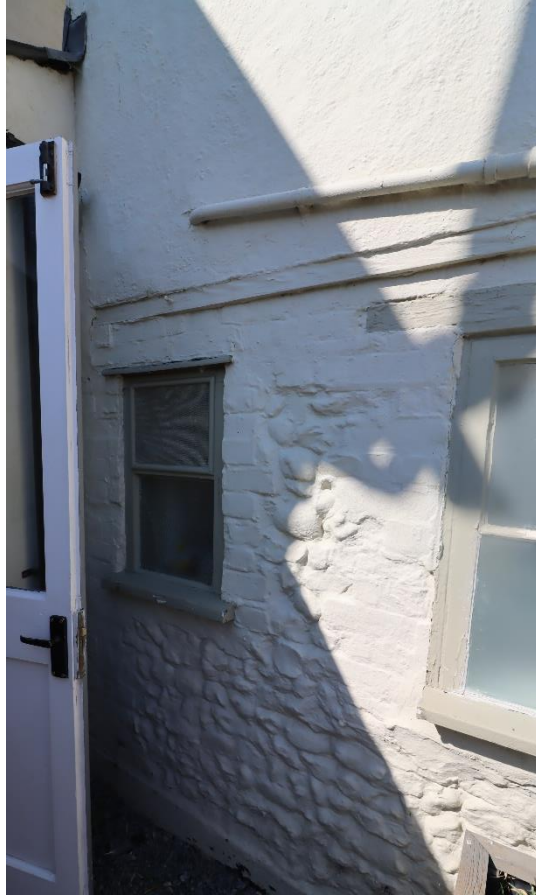
The existing small kitchen window is a 20th century timber fixed pane and fanlight window (low significance) (Fig 4)

Figure 4: Existing kitchen window to be removed and replaced with traditional timber flush casement window

4)	The existing (small) kitchen window and 1 st floor bathroom window are 20 th century and are to be removed.	Low significance	Positive conservation impact	Replacement with a high quality joinery traditional style flush casement timber windows will enhance the appearance of the listed building. Breathable paint finish to match existing colour.

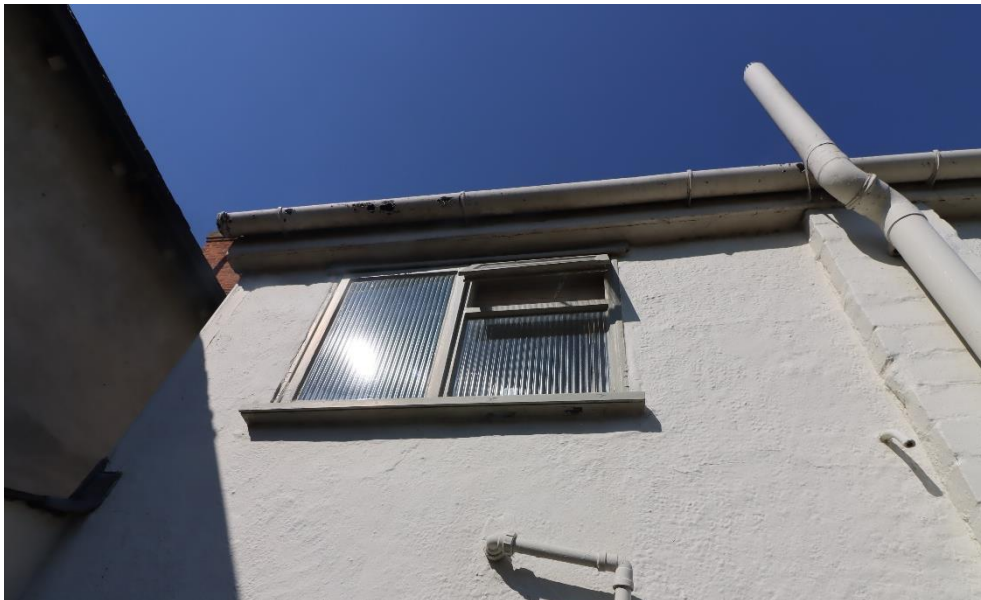
The existing 1st floor bathroom window is a 20th century timber single casement and fanlight window (low significance) (Fig 5)

Figure 5: Existing bathroom window to be removed and replaced with traditional timber flush casement window

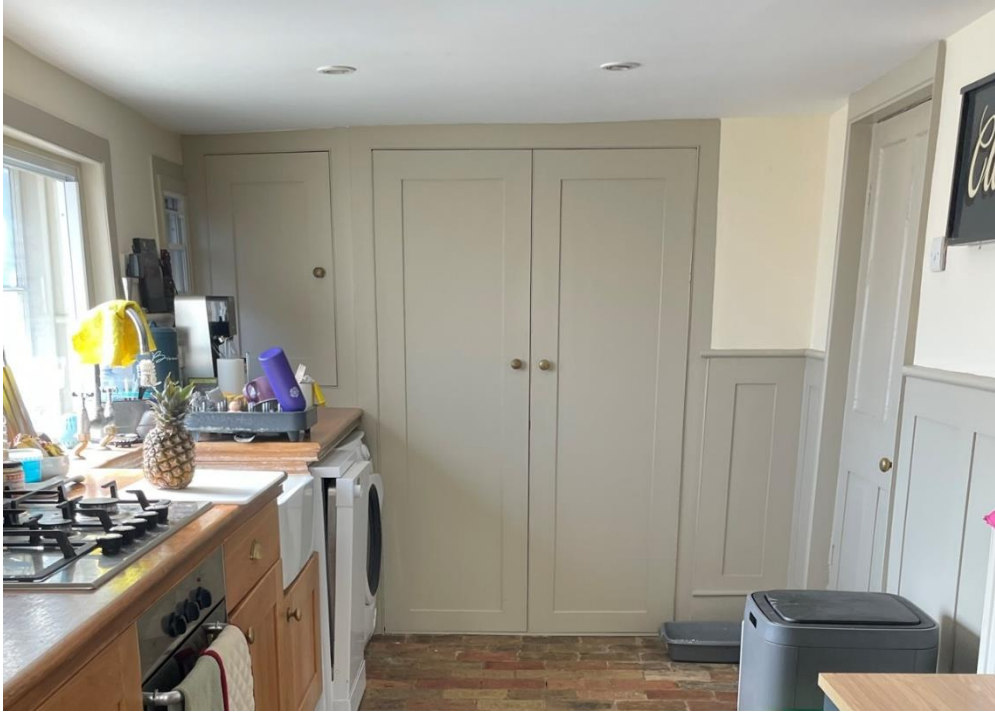
The existing kitchen cupboards are 20th century (low significance) (Fig 6)

Figure 6: Modern kitchen cupboards to be removed and replaced with partition and door to form new downstairs cloakroom

5)	Removal of modern cupboard doors and framing to kitchen	Low significance	No loss of historic fabric	The provision of a downstairs cloakroom improves the viability of the listed property as a family home. The installation is reversible.

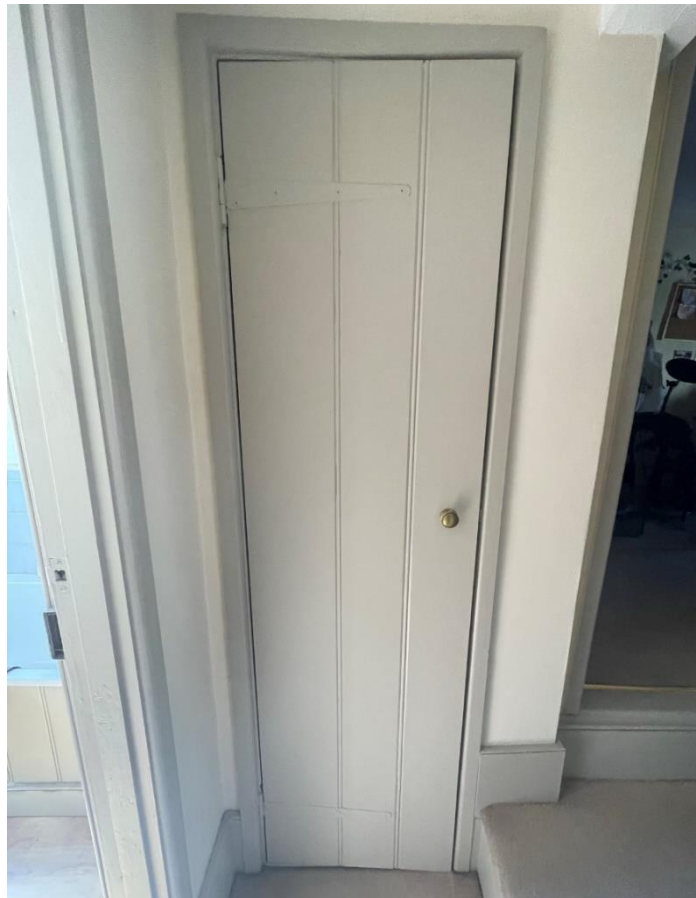
The existing 1st floor landing cupboard and partition forming the bathroom is 20th century (low significance) (Fig 7)

Figure 7: Existing landing cupboard door to be removed and opening infilled

6)	Removal of modern cupboard door and section of bathroom partition	Low significance	No loss of historic fabric	The provision of improved bathroom facilities improves the viability of the listed property as a family home. The installation is reversible.
