Supporting Documents – To The Old School House – LBC

Appendix

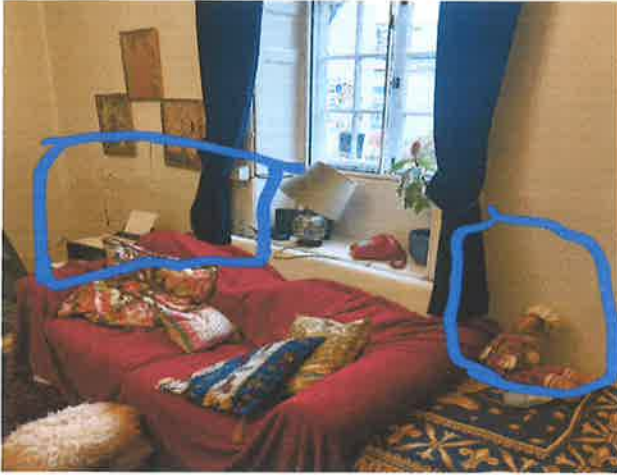
Appendix: 1a - photo of existing sitting room wall in need of replastering (Area circled in blue)

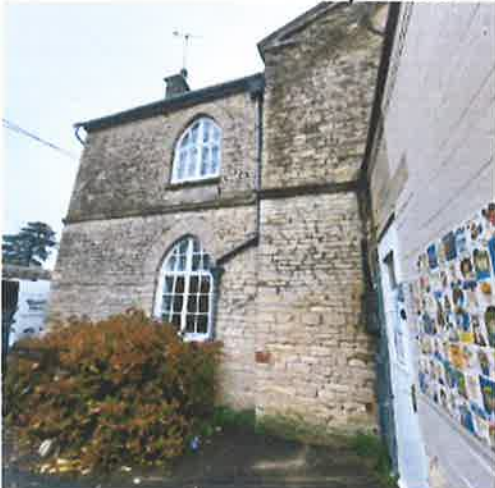
a School side wall to be pointed

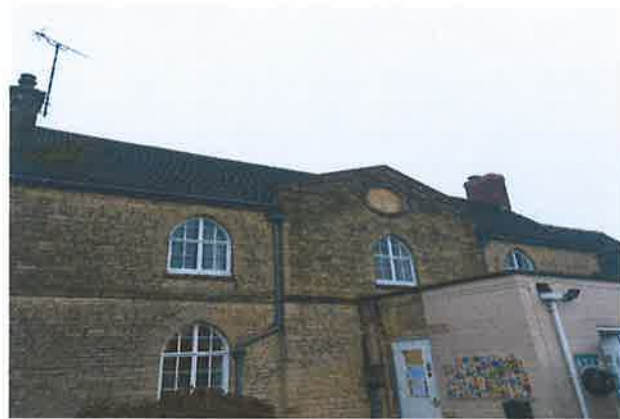
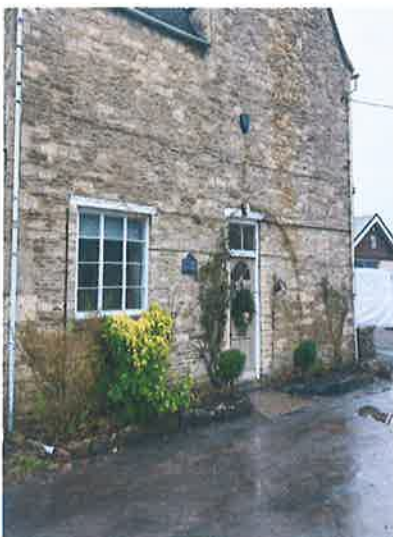
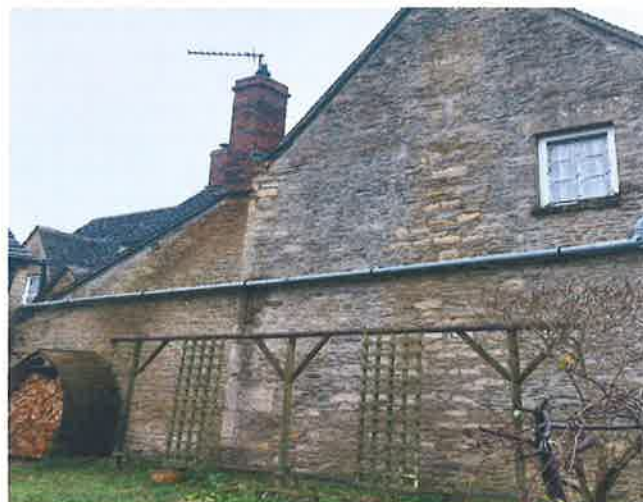
b. School side to be pointed

c. Front to be pointed

d Kate's cottage side walls to be repointed

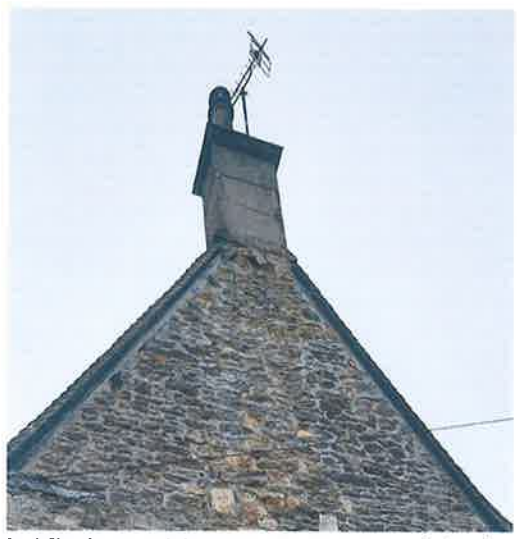
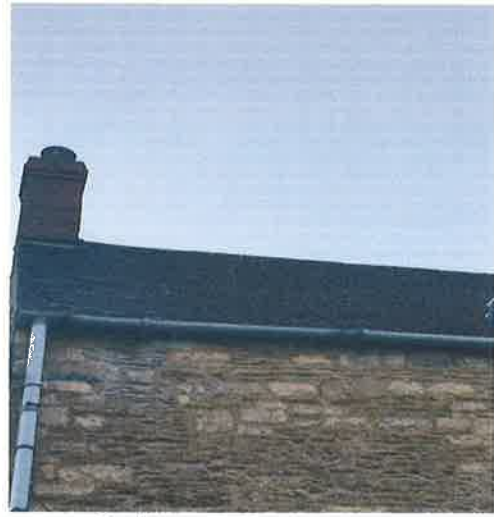
f. Front chimney, above front door

g, chimney above bathroom window – Kate's Cottage side

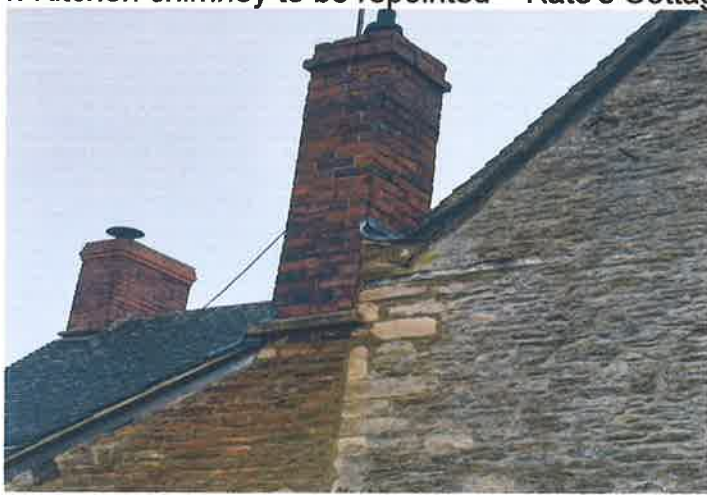
h Kitchen chimney to be repointed – Kate's Cottage side

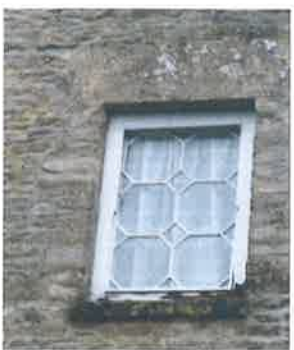
3a - photo of bathroom window frame in need of repair

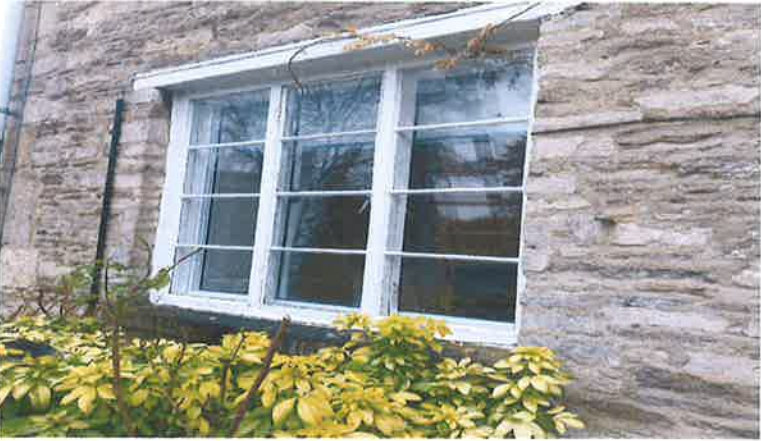
Appendix 3c photo of dining room window outside in need of replacing

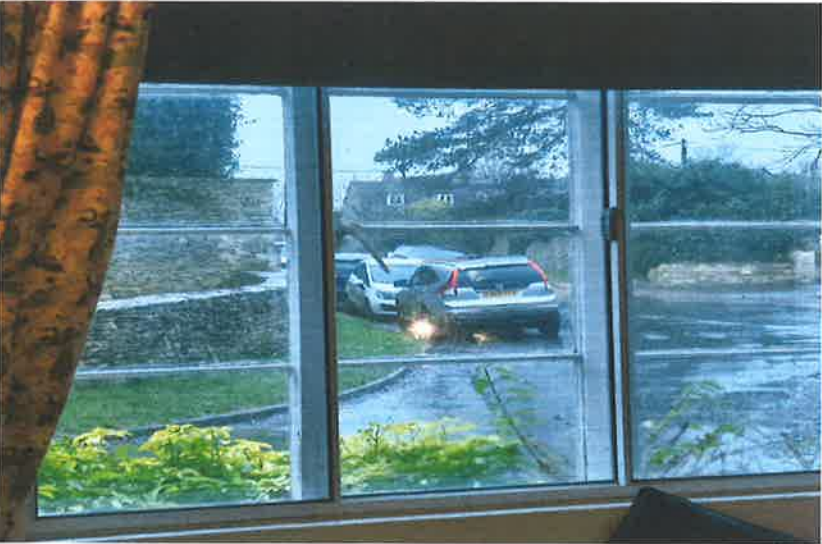
3d - photo of dining room window inside in need of replacement

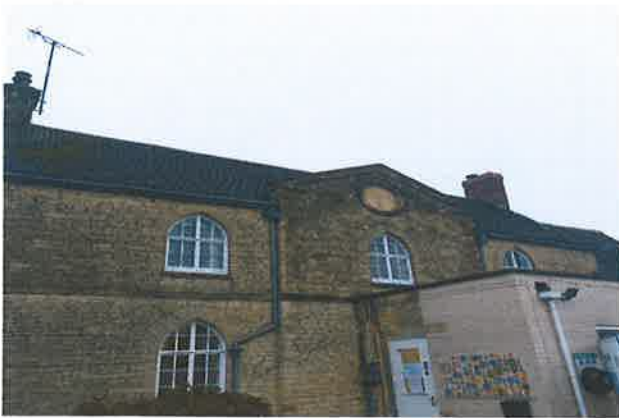
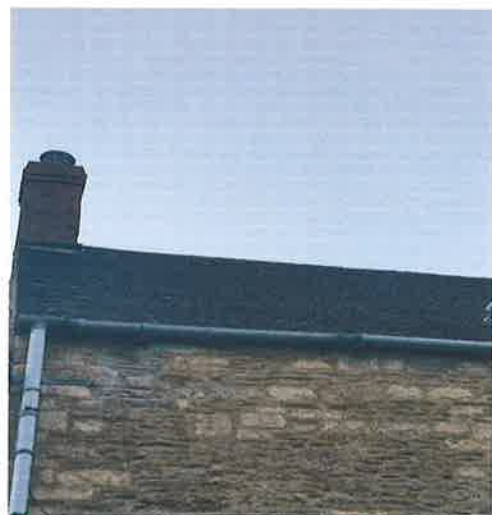
Appendix 2b and 2g - photo of existing verges/cornice in need of repair

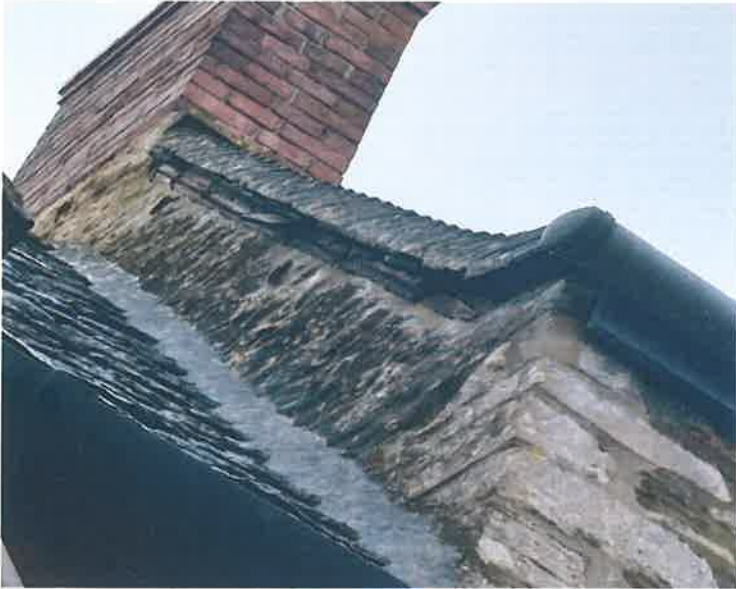
Appendix - 6a photo of rear rafter in need of replacement
