Aerial Tree Bat Inspection

Project	Land on the south-east side of A12, Ardleigh
Date	21/12/2023
Update	18/01/2024 Version A – Tree numbers changed to match with tree survey.
Author	Brooke Waites, ACIEEM, Principal Ecologist
Review	Simon Thomas, MCIEEM, Director of Ecology

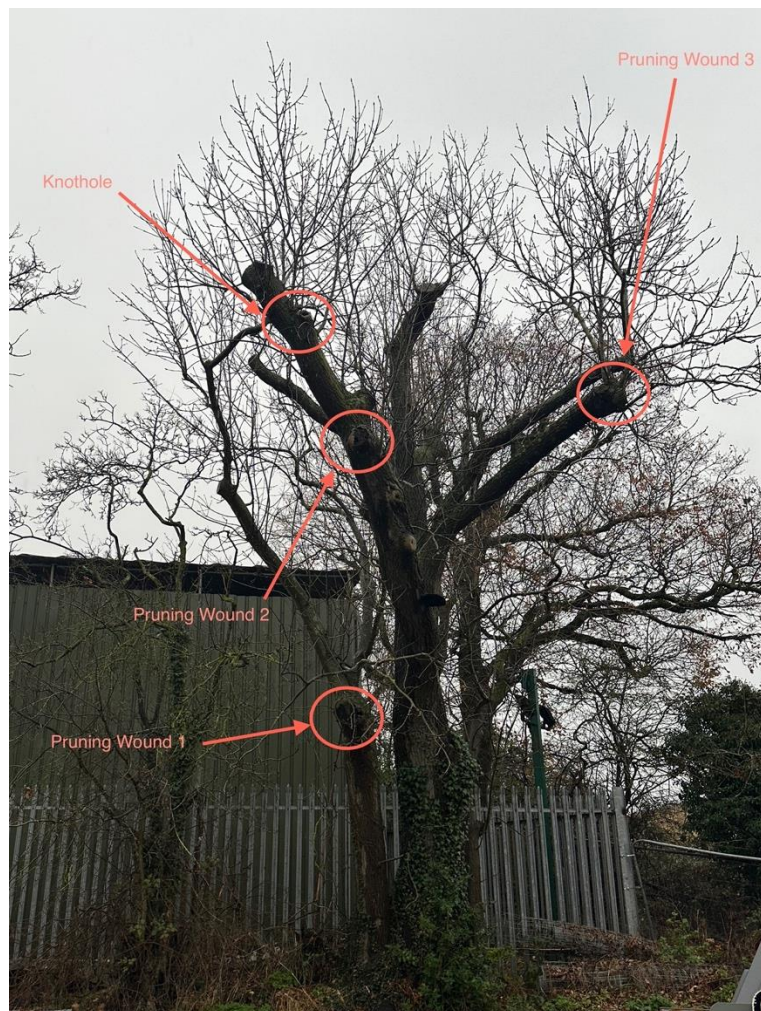
Features	Notes	Overall Bat Roosting Potential	Recommendation
Knothole – 9m high, South facing.	Knothole: Entrance measures approx. 5x4 cm Upward facing wet bowl – Negligible.	PRF-I (low roost suitability)	No Further surveys required. A pre-works check (by licence bat ecologist) to confirm continued absence of roosting bats immediately prior to removal is recommended as PRF-I features still retain some suitability.
Pruning Wound 1 – 3m high, south facing on second stem.	Pruning Wound 1: Pruning wound with split leading in 4cm exposed on the eastern side – PRF-I.		
Pruning Wound 2 – 6m high, south facing	Pruning Wound 2: Pruning wound with split leading in 8cm, wet at base with sludge – PRF-I.		
Pruning Wound 3 – 6m high, east facing end of limb.	Pruning Wound 3: Pruning wound with split at end of limb leading in 8cm, wet at base with sludge – PRF-I.

Picture 1: Southern view of T8

In line with BCT Guidelines, it is recommended that a precautionary pre-works inspection is undertaken by a licensed bat ecologist immediately prior to felling. Where possible, the inspection should be undertaken using an elevated work platform.

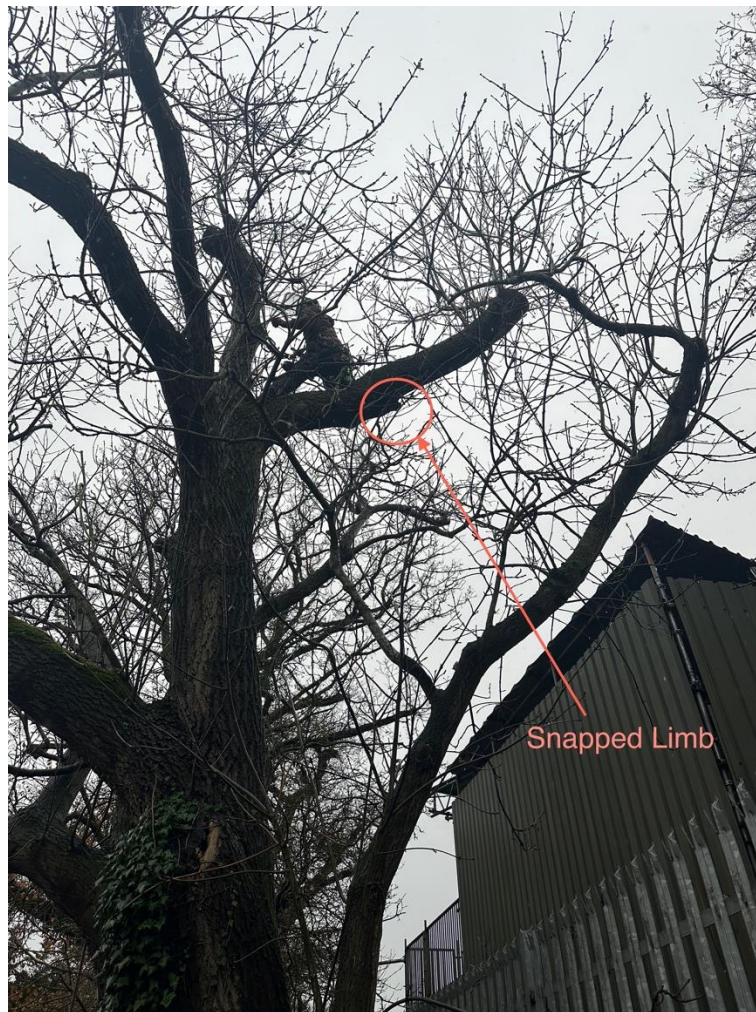
<p>Snapped Limb – 7m high. North facing.</p>	<p>Snapped Limb: Rot hole, underside of limb. Closed – Negligible.</p>		
---	--	--	--

Picture 2: View of Snapped limb on northern side of tree

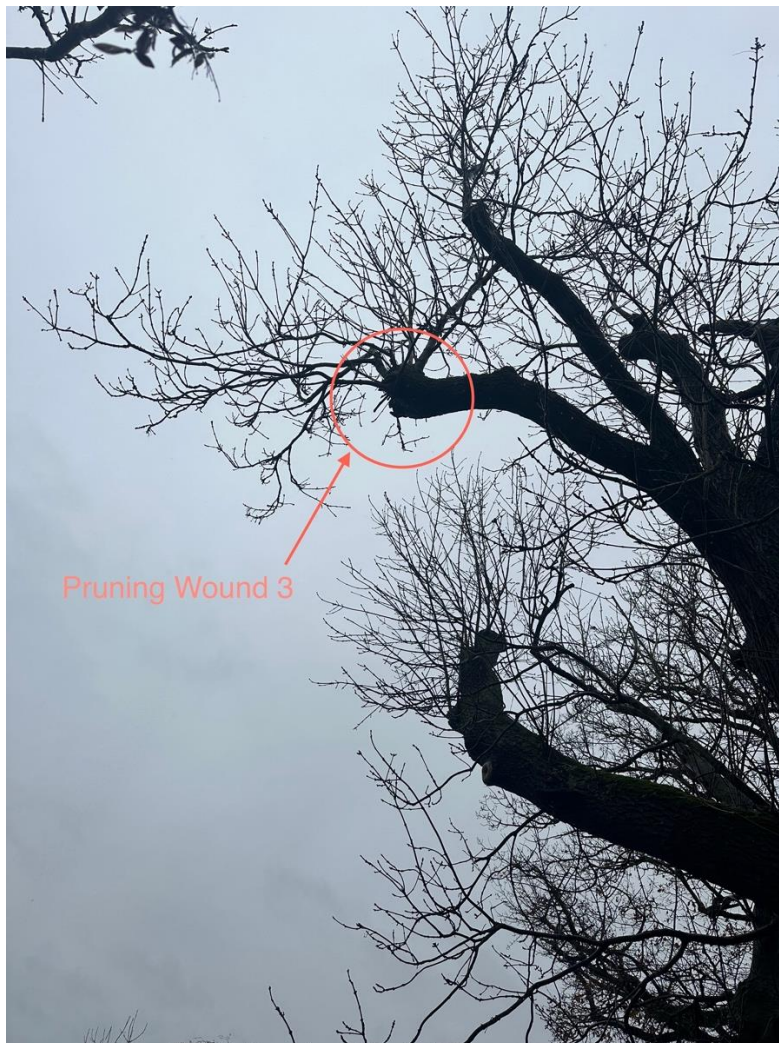
Picture 3: Alternate view of Pruning Wound 3
