Application PP-12747392

Replacement of windows to the rear of Hyde Manor, The Street, Kingston.
Applicants: Daniel and Rachael Maldoom

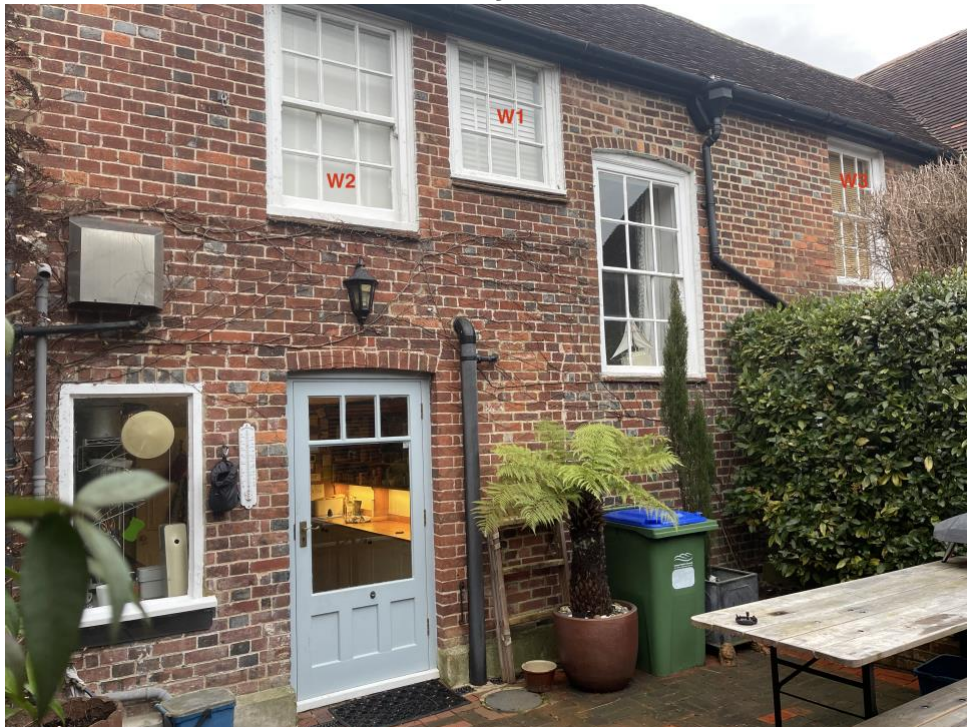
Photo A – elevation to the rear of Hyde Manor

The three affected windows are within a small courtyard at the rear of the building. An orienting photograph (Photo A below) labels the windows W2, W1 and W3 (left to right). This labelling is also used on the plans. The larger central window (above the recycling bin) is in good condition and will not be affected by the proposed works.

W1 and W2 are windows in a first-floor bathroom. W2 is an opening sash window, whereas W1 is fixed. Both are of softwood construction. We suspect that they date from the 1970's (when extensive remodelling of the building appears to have been undertaken by previous owners).

Both W1 and W2 were subject to extensive renovation approximately 5 years ago, with new sections spliced into the sash boxes of W2 and a replacement sill and lower rail for W1. However, these repairs have not proved durable and further repairs are not feasible. The joints of the sashes of W2 have opened, with water ingress causing swelling. This means that it is now not possible to open W2, which limits ventilation of the bathroom.

Both W1 and W2 are subject to rot and mould on the inside due to condensation from the bathroom. Therefore, it would be beneficial to double glaze the replacement to reduce condensation, in addition to the heat conservation benefits.

We are proposing a like-for-like replacement preserving the existing sizing, location of glazing bars and profiles. However, we propose to fit low-profile (16mm) double glazing units within each individual pane. The new joinery would be made in Accoya for stability and longevity.

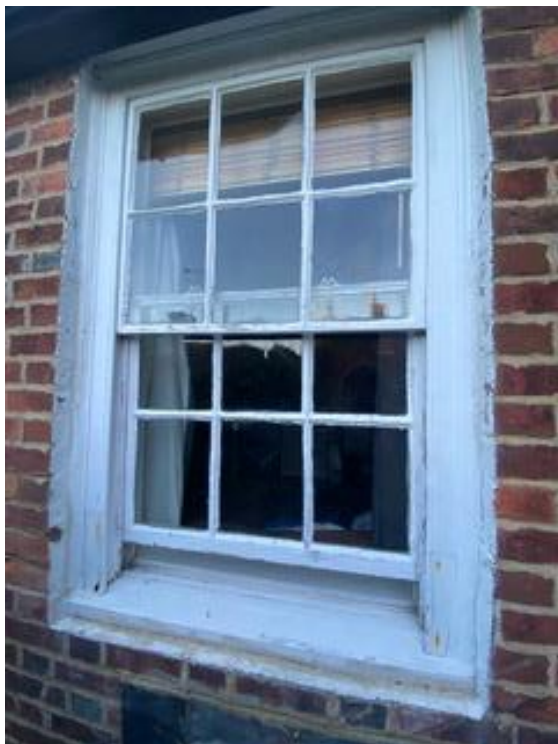
Photo C – closer view of W3

W3 is a bedroom window. It is partially obscured in Photo A, so a close-up is shown in Photo C below. Previous failed repairs to the lower sections of the sash boxes are visible. The glazing bars are also in poor condition. The sill is in poor condition and allowing water ingress into the wall below.
