Introduction & Purpose of the Statement

Heritage, Design & Access Statement

Listed Consent Application PP-12751763

Submitted: 09 February 2024

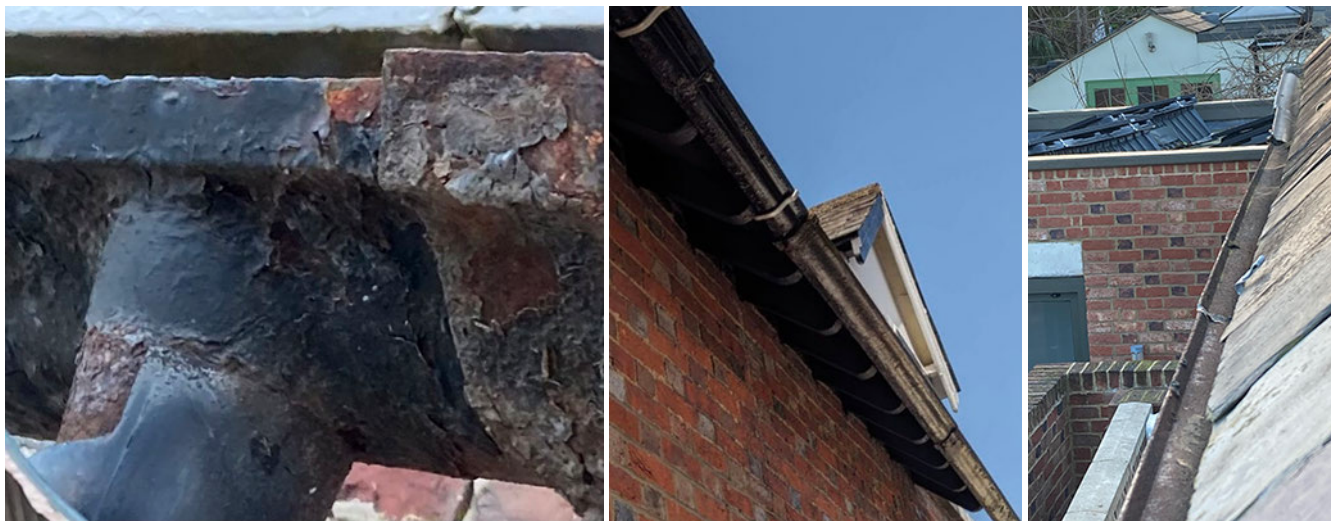
Image 01 – Close up shows corrosion to existing cast iron goods

Image 02 – Existing corroded cast iron gutter

Image 03 – Irregular existing gutter

- The existing cast iron Ogee guttering is failing at the rear of the property. It has a cracked junction over the back door and the rest of the guttering doesn't align properly or have the correct fall to carry the water to the downpipe in the neighbour's rear courtyard – this leads to large quantities of water falling directly onto the decking outside the back door during rainfall which splashes onto the brickwork. In addition, the cast iron has significantly corroded over time due to rust (see Images 01, 02 & 03).

Replacing the defective rainwater system with a new system will prevent rainwater from falling into the rear courtyard and help to protect the property from potential damp and unnecessary spalling of the brickwork.

The Applicant proposes replacing the mixture of plastic and cast iron goods with cast aluminium goods. Cast aluminium requires little maintenance compared with cast iron as it has higher corrosion resistance – cast iron is prone to rust, more brittle at low temperatures and requires painting more frequently. Environmentally, cast aluminium products are lighter than cast iron, producing a lower carbon footprint, as less energy is required for its production and transportation.

- The existing, cast iron goods are in the traditional Ogee style (see Images 01, 02 & 03) with a depth of 110 mm, along with corresponding round downpipes. The Applicant proposes new cast aluminium Ogee guttering, hoppers and downpipes to replicate the existing system both in style and in size in order to retain the original character and intended aesthetic of the building (see example images 04 & 05).

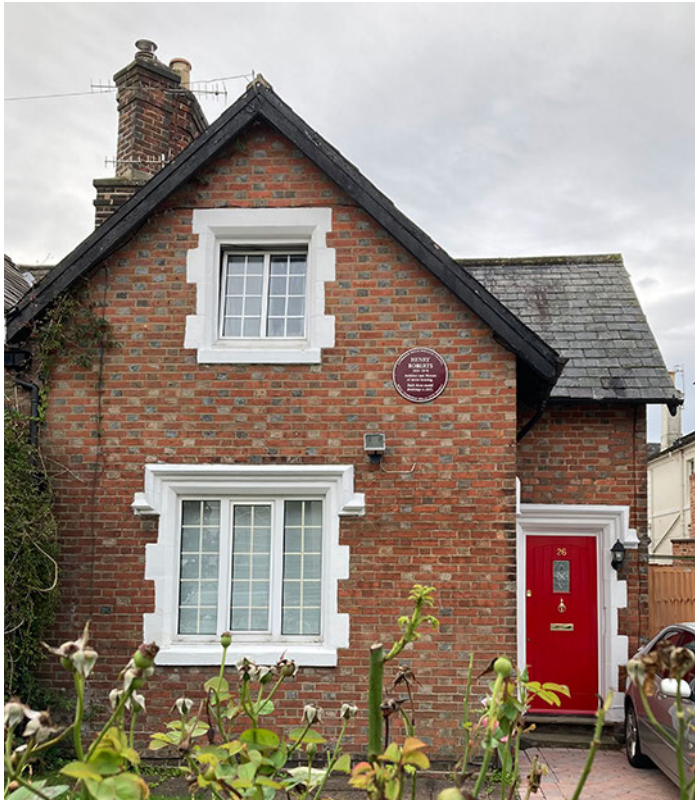
- When the Applicant purchased the house in June 2021, the stonework was decorated with multiple layers of white paint (see Images 06 & 07). Evidently the paint had cracked and flaked over time. There was also evidence of stone repairs in many areas, involving fillers consisting of unknown material.

Image 06 – Front elevation after Applicant’s purchased the property in 2021

By removing the paint and any poorly selected filler, the stone would be allowed to ‘breathe’ and begin to release trapped moisture. In addition, paint removal would allow former repairs to be visually assessed, then treated correctly to help prevent unnecessary decay caused by poorly selected materials.

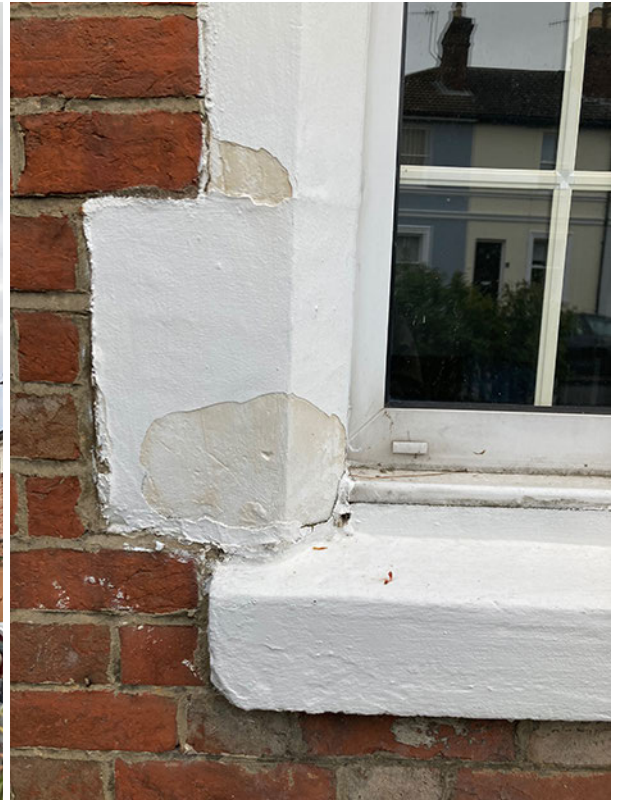
Image 07 – Evidence of cracked, flaking paint

Non-breathable, cracked paint can trap water and cause the substrate to perish underneath, in this case the stonework. In a similar way, inappropriate materials used to fill cracks and holes can cause the stone to erode where the filler mix is stronger than the stone.

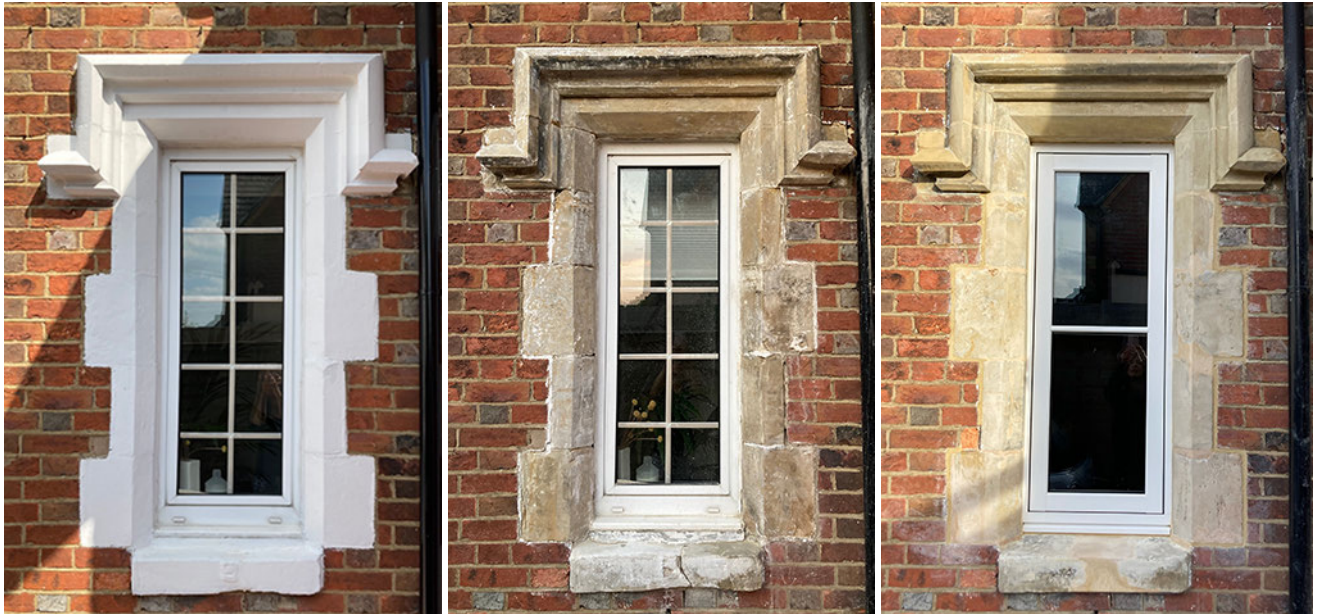
Image 08 – Before

Image 09 – During

Image 10 - After

Originally, the Applicant intended to maintain the decorative stonework by removing the defective paint, assessing and undertaking any necessary repairs using the correct materials and then redecorating the stonework with a breathable paint, in order to protect the stonework from unnecessary decay caused by inappropriate materials. During the process, considering the labour-intensive process of removing the defective paint, it seemed a shame to redecorate the stonework again (albeit with a breathable paint or ideally a limewash) but at the time it was thought it would be necessary to do so in order to hide the stone repairs. However, the paint removal and subsequent release of moisture from the stone, paired with the stone repairs and repointing around the windows all contributed to improving the overall appearance of the decorative stonework and it regained its charm despite the tonal irregularity of the repairs (see example ‘Before, During & After’ - Images 08, 09 & 10).

The stonemason undertaking the work was/is using a lime based stone mix to repair the stonework and a lime based mortar to repoint the stonework.

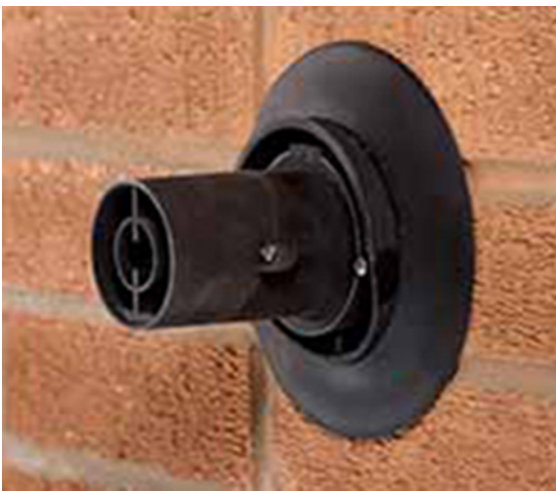
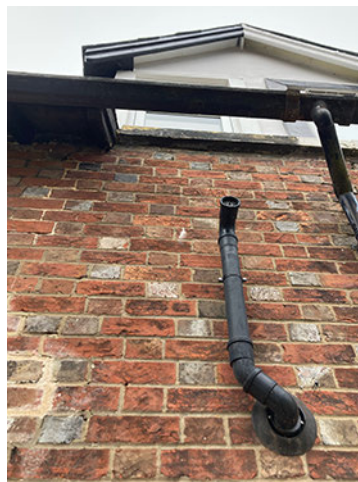
Under Listed Consent Application PP-11229984 the kitchen alterations included relocating the boiler (see Plan 01). On fitting the new boiler in the new location, the plumber decided the proposed boiler flue (see Image 11) would not comply with Building Regulations, so additional parts were fitted in order to resolve this (see Image 12).

Image 11 – Proposed boiler flue

Image 12 – Subsequently installed boiler flue with additional parts

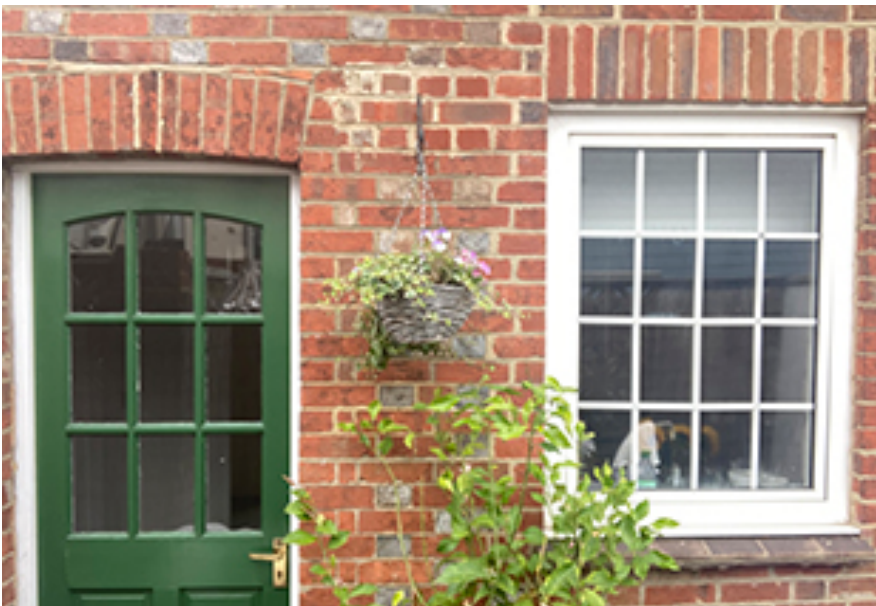
Image 13 – Existing kitchen window with non-original straight soldier brick lintel (now replaced), adjacent to back door with original curved soldier brick lintel

The kitchen window that existed at the time the Applicant purchased the property had a non-original, straight soldier coarse brick lintel but historically, the lintel would have been formed from a curved coarse brick lintel, as seen over the back door (see Image 13).

During the works, the Applicant asked the builder to replace the non-original, straight lintel over the existing kitchen window with a new curved lintel while the builder was on site with all the relevant tools and creating the same curved lintel over the new window. Now the three apertures on the ground floor of the rear elevation have matching, curved coarse brick lintels - for consistency, based on the original design of the property (see Image 14).

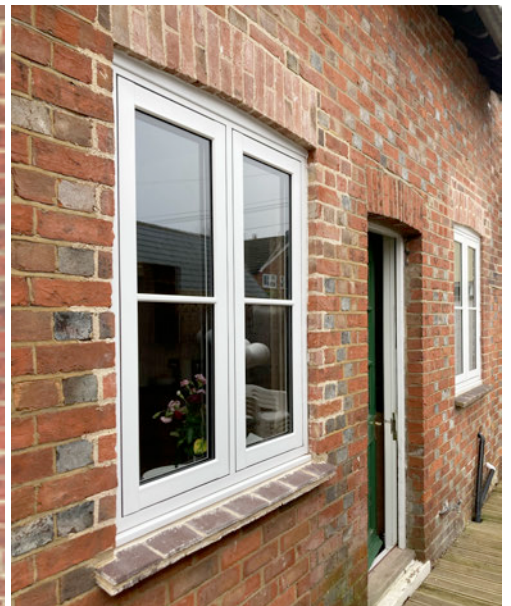
Image 14 – New kitchen window reveal in the foreground – now all three apertures have curved soldier brick lintels
