Land off Pilling Lane, Preesall

Phase 1 Geo-Environmental Investigation Report

For: Breck Homes Ltd

Job Number:	4112
Report Reference:	4112-01
Issue Status / Revision:	1 st Issue
Date:	February 2024
Written By:	Alfie Leach MSci, FGS
Checked By:	Liam McMahon MESci, MSc, CGeol, FGS
Authorised By:	Andrew Edwards MSc, PIEMA, MIEnvSoc, FGS, CEnv
Previous Revisions and Date:	N/A
IGE Consulting Ltd,	Office 16, Bartle House, Oxford Court, Manchester, M2 3WQ
	Tel: 0161 914 9170
	Email:contact@igeconsulting.co.uk

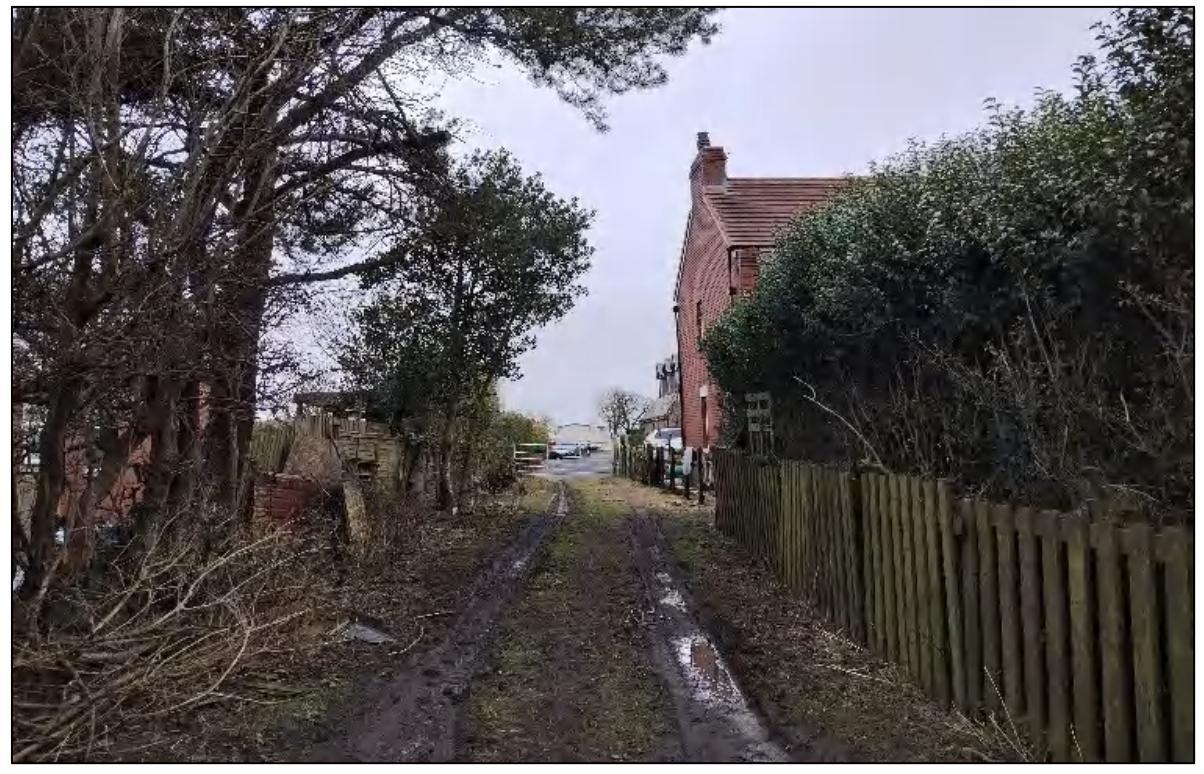
Figure 3: Photographs of the site entrance looking north.

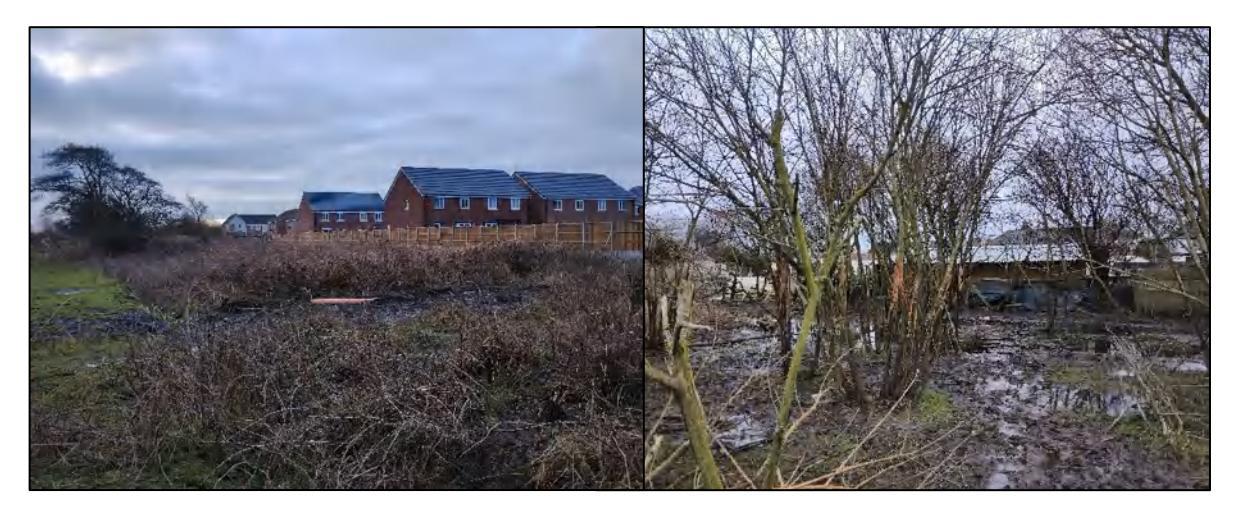
The site currently comprises an open field, used for sheep, goat and chicken grazing. A fenced off section in the southwestern corner of the site exists as part of a residential garden. Dense vegetation is noted along the eastern and southern site boundaries and in the northwestern site corner. Further dense vegetation is present adjacent a drainage ditch located in the centre of the site, running parallel to the western site boundary. Further drainage ditches are present adjacent the western and southern site boundaries. The ground is noted to be grass underfoot and the eastern site boundary and the majority of the site was water-logged.

Figure 4: Photographs of the dense vegetation adjacent to the drainage ditch in the centre of the site (left) and the water logged ground conditions on the eastern site boundary (right)

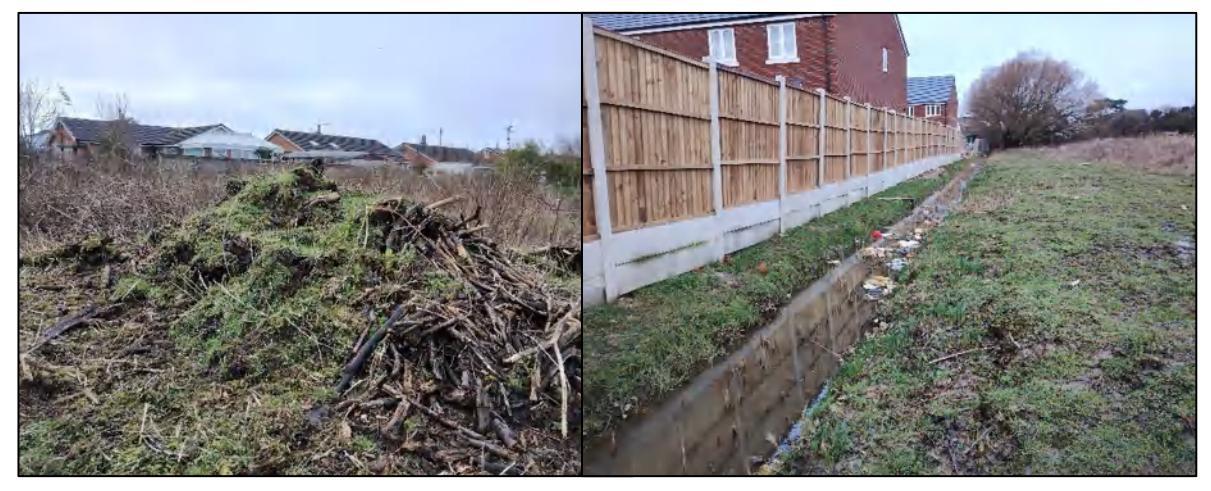
The topography of the site is generally flat. 3 No. mounds consisting of debris from tree clearance are noted in the southern site section. Drainage ditches are present along the western and southern site boundary as well as through the centre of the site though their depth is unknown.

Figure 5: Photographs showing a mound in the southern site section (left) and the drainage ditch along the western site boundary (right)

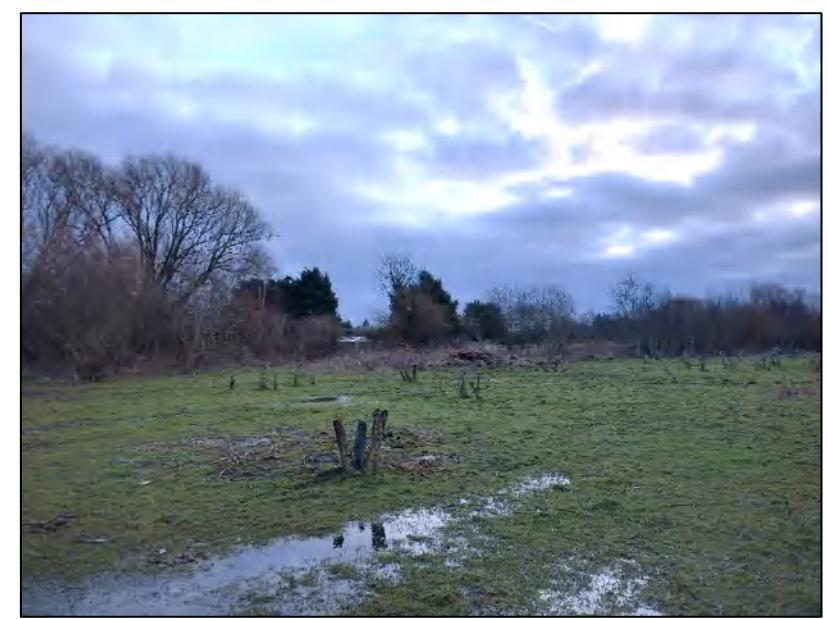
Established trees were noted across the site, particularly in the northwestern corner and along the eastern site boundary. Evidence of tree clearance is present, with mounds of branches and tree stumps observed in the centre of the site.

Figure 6: Photographs showing evidence of tree clearance in the centre of the site.

Soft Spots	Soft spots may be present across the site associated with localised excavations i.e. previous ground investigations, tree removal and open land drains.	Soft spots may cause differential settlement of foundations therefore there will be a requirement for localised deepening of foundations where soft spots are present.	Low to Moderate

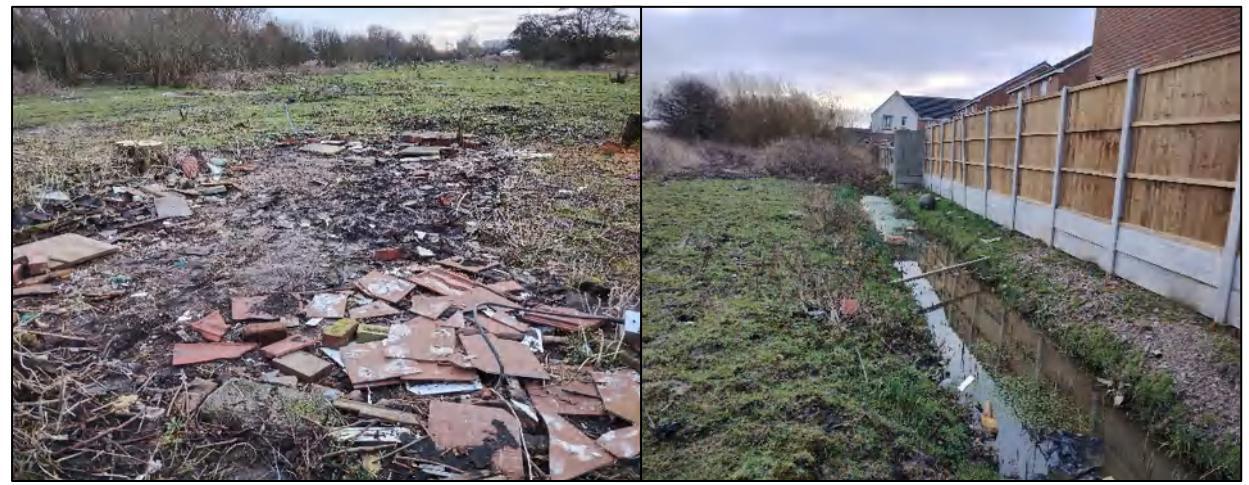
A localised iridescent sheen within a waterlogged area of ground was noted on standing water in the northwestern site section, covering an area of less than c. 6cm². This is anticipated to be a naturally occurring bacterial sheen. Evidence of fly tipping was noted across the site, particularly in the northern site section where a possible fire pit and area of debris was noted containing red brick, concrete slabs, metal panels, plastic sheets, glass and ash. The drainage ditch on the western site boundary contained debris of polystyrene, plastic packaging and metal sheets.

Figure 7: Photograph showing evidence of fly tipping in the northern site section (left) and the debris observed in the drainage ditch on the western site boundary (right).

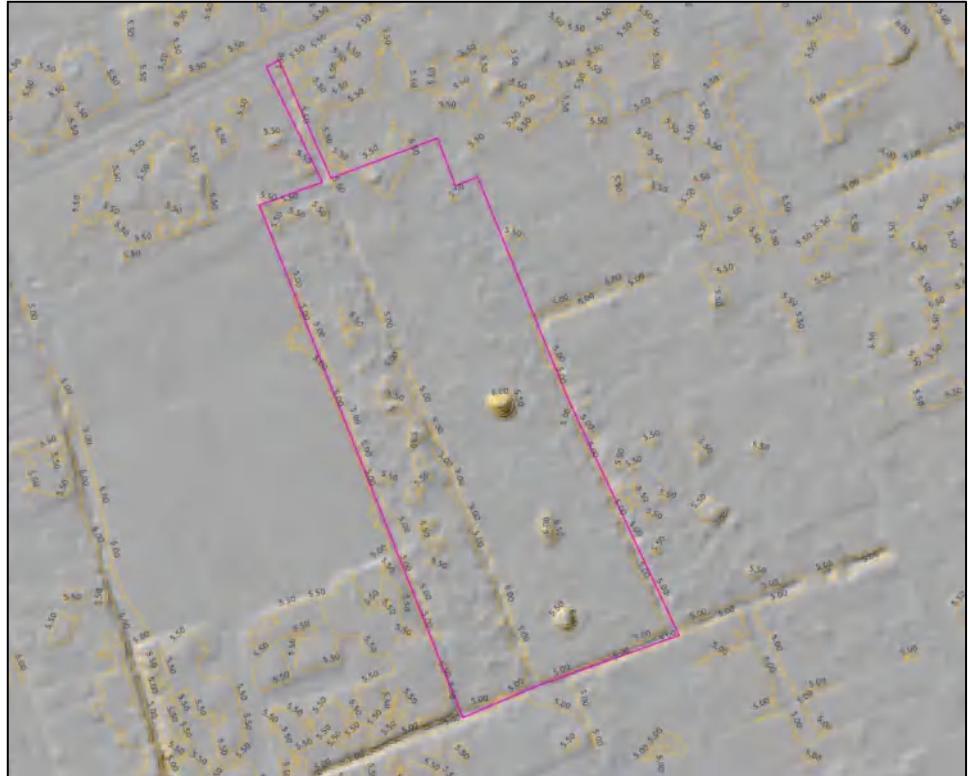
LiDAR data for the site was obtained under Open Government licence from the DEFRA website. The data used is a 1m resolution digital terrain model (DTM) dated 2022. The LiDAR data shows the site is relatively level with an average surface level of c. 5.50m AOD. The data also highlights the presence of linear surface drains present on the site on the southern site section and through the centre of the site. These drainage features had previously been identified on historical mapping. Small stockpiles / mounds are also identified in the south eastern site section; these were identified as branches from tree clearance during the site walkover.

Figure 9: Image of a 1m DTM hillshade LiDAR of the site.

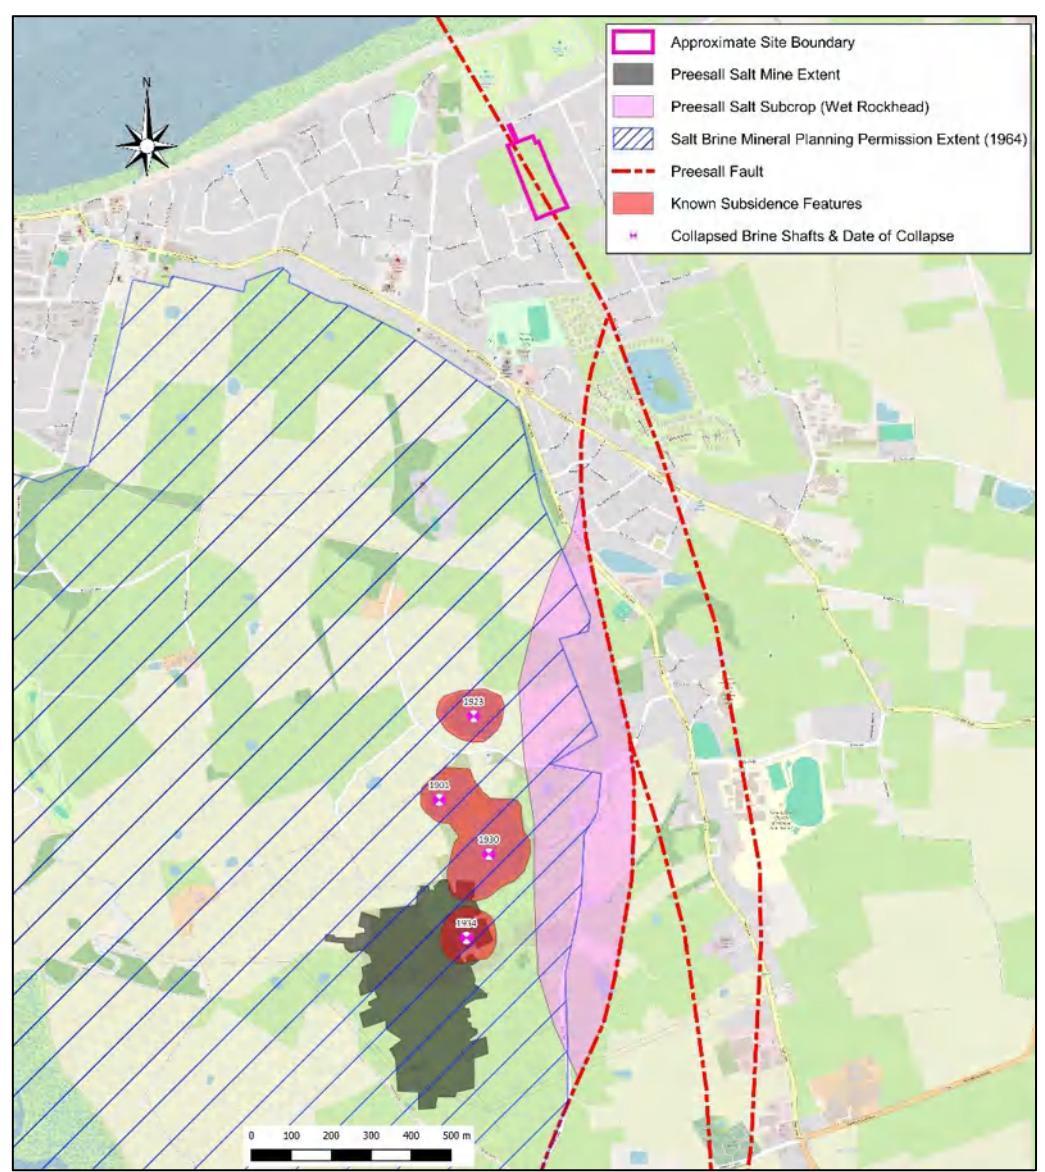
Figure 11: Extract of the Salt Mining & Brine Site Features Plan.

Given the distance and depth of salt deposits in relation to the site, <u>the risk of halite</u> <u>dissolution is deemed low.</u>

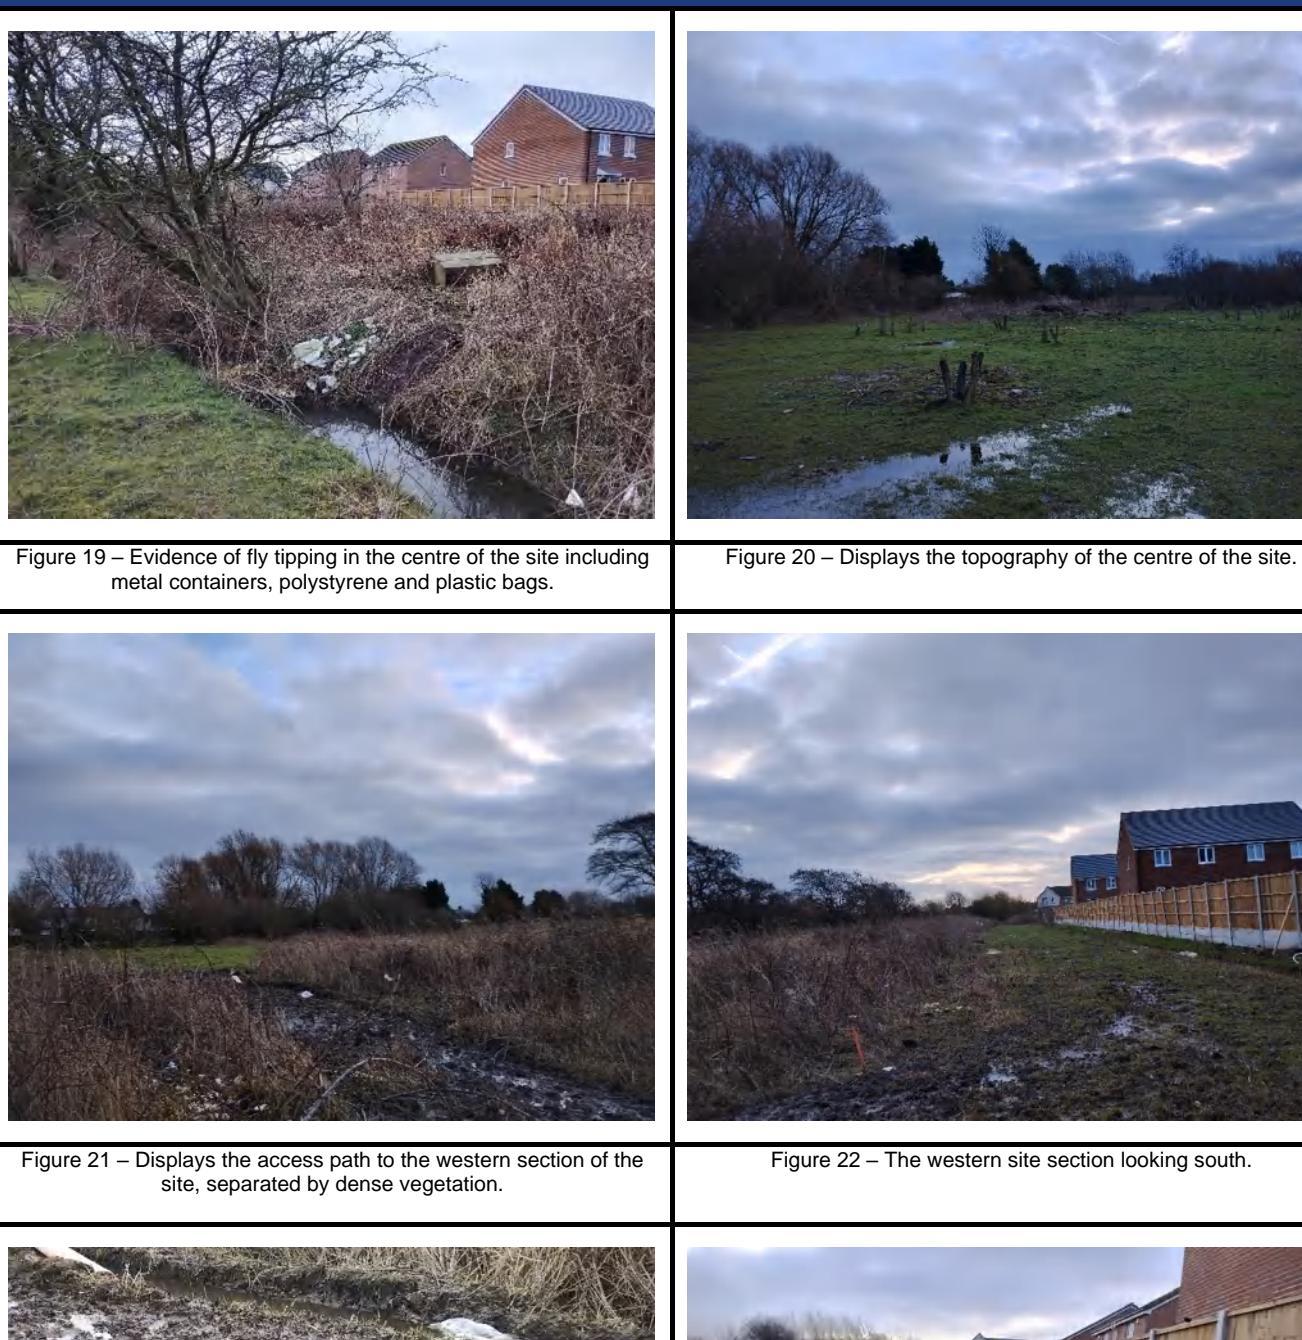
Figure 23 – Shows water sheen anticipated to be a natural organic sheen.

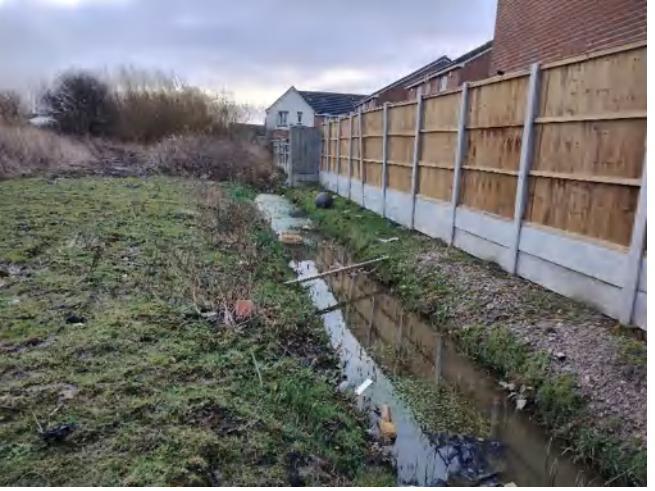
Figure 24 – The ditch along the western site boundary containing plastic sheets, metal, red brick, polystyrene and cardboard.
