**ARBORICULTURAL IMPACT ASSESSMENT &
TREE PROTECTION METHOD STATEMENT FOR
KEDINGTON COMMUNITY CENTRE
GREAT MEADOW
ARMS LANE
KEDINGTON
HAVERHILL
CB9 7QQ
FEBRUARY 2024.**

Arboricultural Solutions LLP

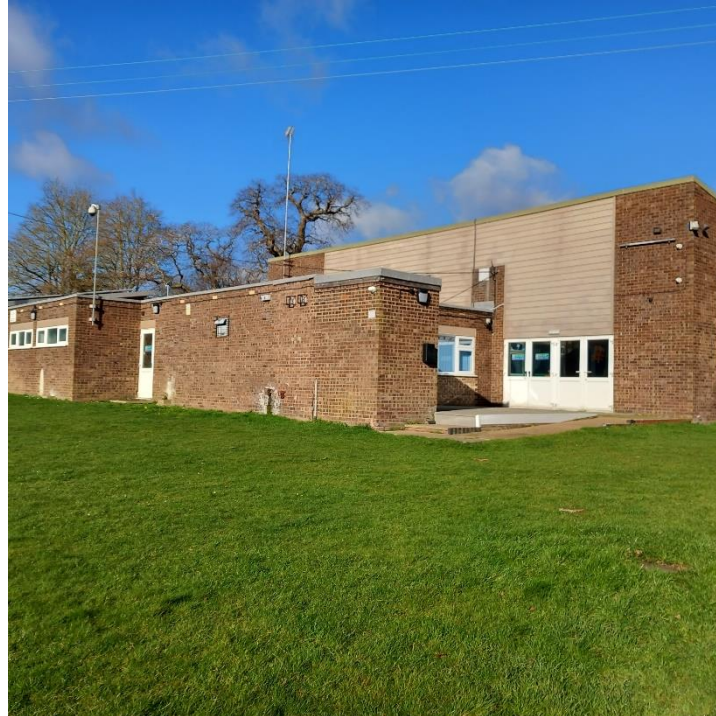
Photograph 2 showing rear (southeast corner) and location of the proposed extension.

6.1.8. The proposed extensions to the rear (east elevation) do not encroach into the RPAs of any of the trees surveyed. Access for construction traffic can be directed around the retained trees.

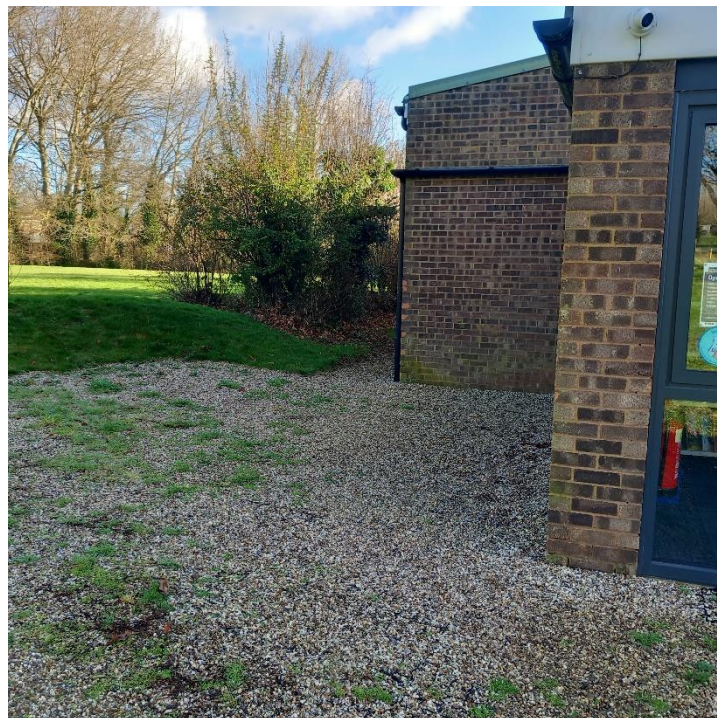
Photograph 3 showing front (northwest corner) and location of the proposed store extension.

6.1.9. The small northwest extension encroaches very slightly into the circular representation of the RPA of tree 4. However, this will not impact on the health and stability of the tree.

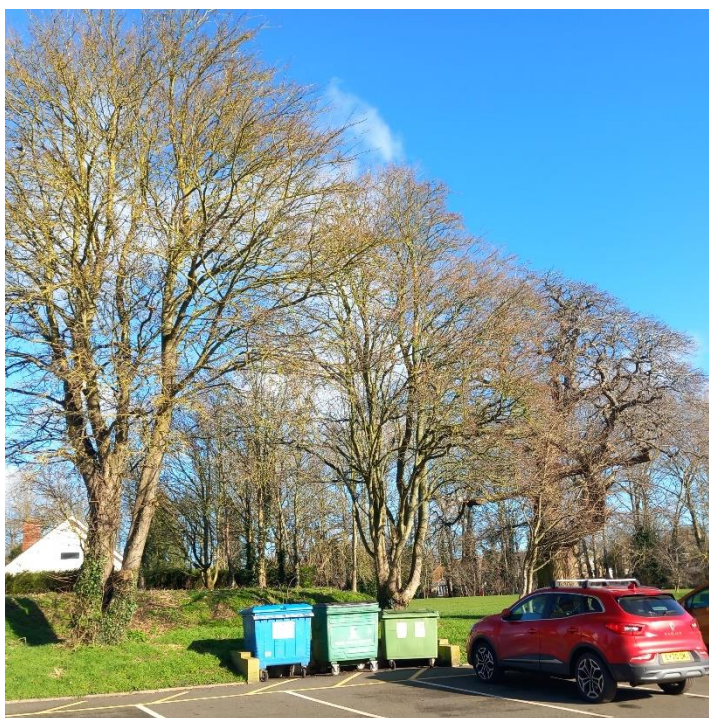
5.1.3. The trees surveyed all stand within the Community Centre grounds and to the front of the Community Centre building. Trees 1, 2 (Field Maple) and 4 (Sweet Chestnut) are all mature trees that predate the construction of the existing Community Centre and car park. Trees 3 (Field Maple) and 5 (Hawthorn) are likely to have grown since the Community Centre was built.

Photograph 5 showing trees 1 to 3 (Field Maple) with tree 4 (Sweet Chestnut) in background.

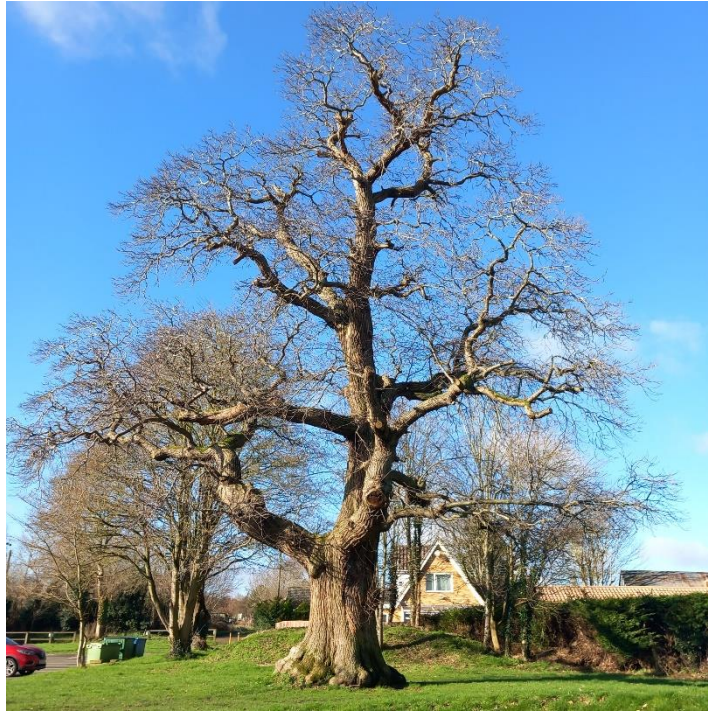
Photograph 6 showing tree 4 (Sweet Chestnut) from east side.

5.1.4. Tree 4 (Sweet Chestnut) is a large, mature specimen. It has been crown reduced in the past and may have shed some branches due to storm damage. There are areas of bark loss behind the larger pruning wounds, and decay developing within the pruning wounds. There are also several wildlife hole visible in the crown. However, the tree is generally in good condition and has the potential to develop as a veteran tree.

8.4.1. The proposed extensions can be constructed on standard strip foundations. All excavations within the RPA of tree 4 will be undertaken by hand digging only. The foundation trench should be positioned as far possible from the tree to reduce the potential for root severance. Clumps of roots less than 25mm diameter (including fibrous roots) will be retained in situ without damage. Where a mass of flexible roots is encountered, it may be possible either to displace the roots to another location temporarily or permanently to avoid areas of excavation. If required, roots to be removed should be cut cleanly with a sharp saw or secateurs approximately 20cm back from the face of the final excavation.

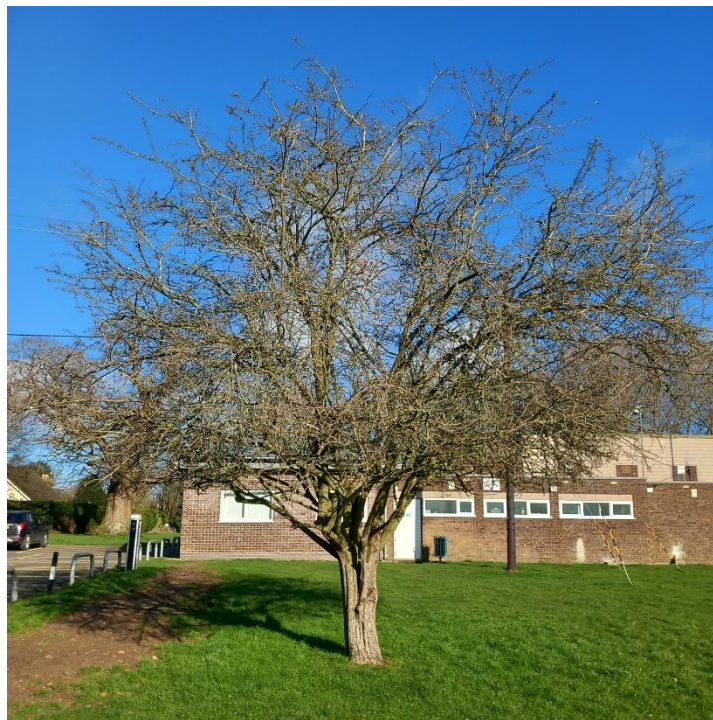
Photograph 7 showing tree 5 (Hawthorn) from south side.
