## Proposed Tree Works

76 - 105 Crofton Close  
Forest Park  
Bracknell  
RG12 0UT

Proposal prepared by Matthew Wilkes - February 09, 2024

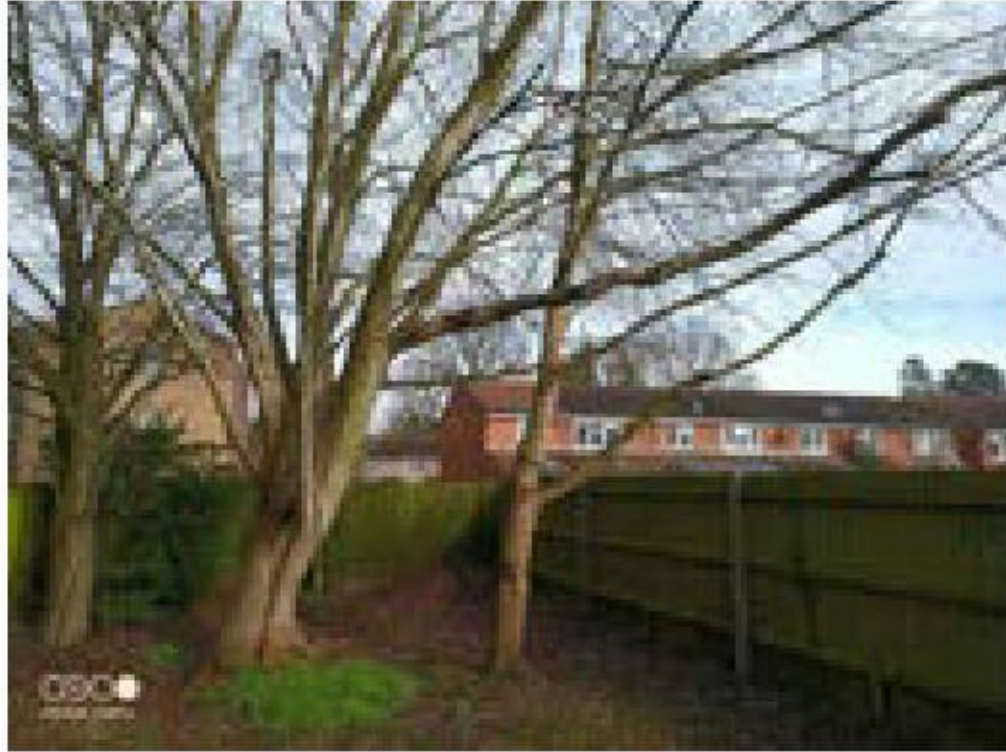
Ref	Species	Photo	Notes	Required works
1	False Acacia	02	In good condition, some branches have been previously removed. Large lower branch encroaching on building.	Remove the lowest branch that extends towards the building.
2	Maple	01	In good condition with tall narrow crown, overhangs car park. Foliage touches tops of vehicles in some places	Remove lowest branch overhanging car park and crown lift to 4m over car park. Crown thin above car park by 20%
3	Maple	01	In good condition, some branches overhang car park	Remove the lowest branch that extends over the car park. Crown lift to 4m above car park. Crown thin above car park by 20%
4	Silver Birch	03	In good condition, leaning towards building. Some branches overhang car park	Remove two lowest branches and crown lift to 4m over car park
5	Sweet Chestnut	04	In good condition. Some branches overhang the car park. Branches and foliage touch vehicles in some places	Remove 3 lowest branches and crown lift to 4m above the car park. Crown thin above the car park by 20%

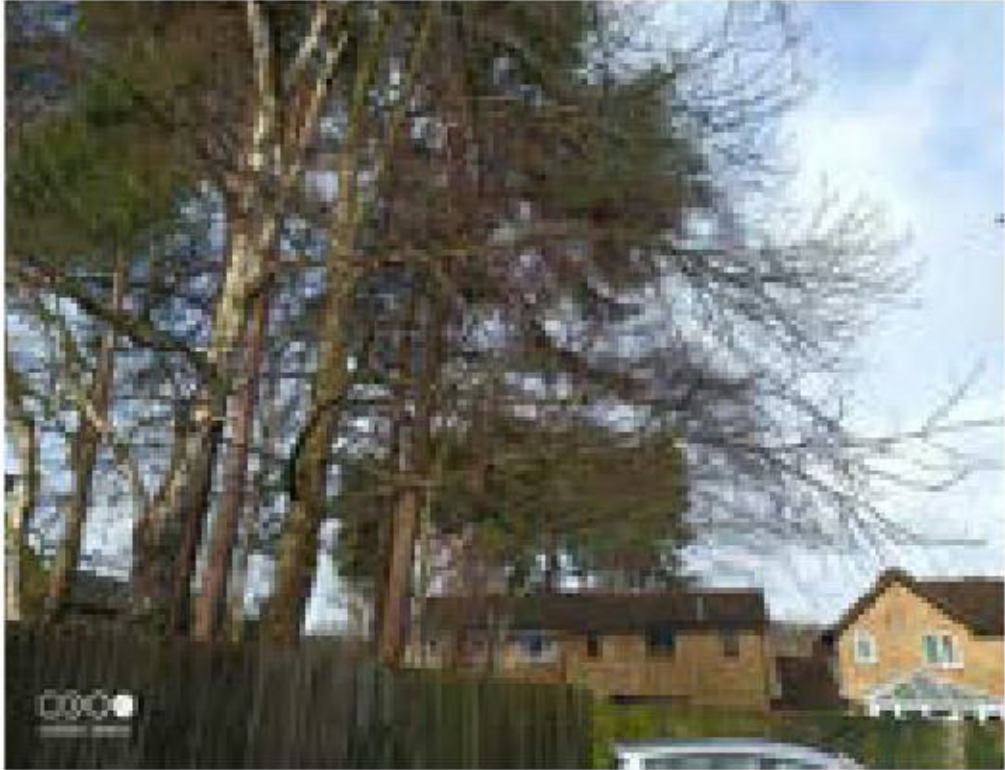
6	Silver Birch	04	In good condition. Some branches overhang car park	Crown lift to 4m over car park
7	Silver Birch	05	In good condition. Some branches overhang car park	Crown lift to 4m over car park
8	Oak	06	In good condition, leaning and lower branches starting to encroach on the building	Remove the lowest 3 branches. Cut back/tip reduce growth to 4m from branches below building gutter height.
9	Silver Birch	07	Small tree in good condition encroaching on building (Not affected by Tree Preservation Order 106).	Fell tree
10	Silver Birch		Dead tree (Not affected by Tree Preservation Order 106).	Fell Tree
11	Silver Birch	08	Good condition, branches starting to encroach on building	Crown lift to 4m

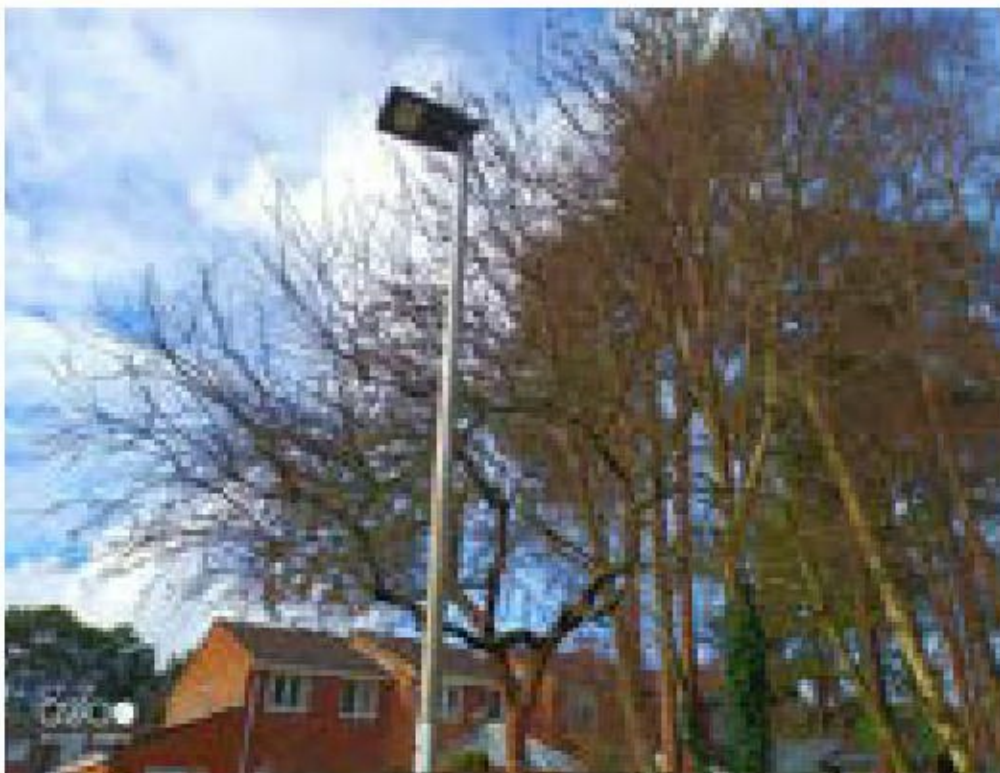
12	Rowan	08	Good condition, branches starting to encroach on building	Crown lift to 4m
13	Crab Apple	09	Good condition, Branches encroaching on street light	Cut back branches clear from street light
14	Goat Willow	10	Previously pollarded. Branches encroaching on the building and touching windows. Tree showing signs of stress due to attack from wood boring beetles	Repollard back to previous points and cut away any dead wood arising from beetle attack. Continue to monitor the health of the tree.
15	Silver Birch		Large tree in good health, branches overhanging paths and car park	Crown lift to 4m
