Heritage, Design & Access Statement
for replacement of 2 No windows at
38 High Street,
Wickwar,
GL12 8NP

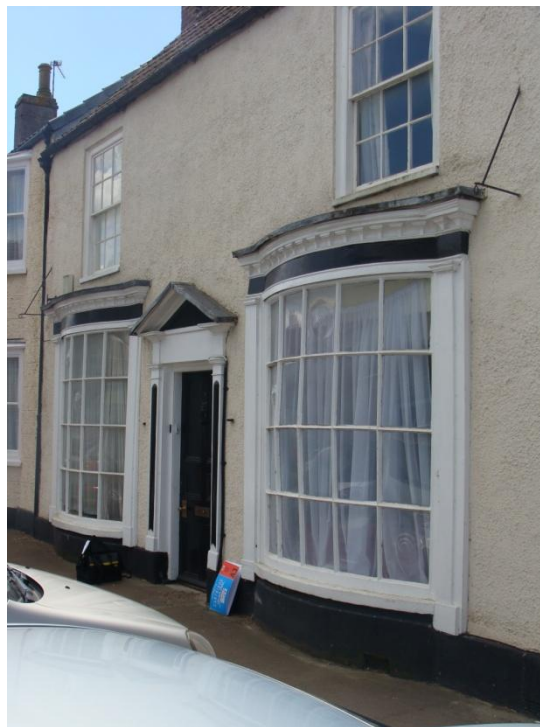
The proposals seek to replace the two bow windows on the front elevation either side of the front entrance door. These shall be referred to as Window 1 (right-hand side of the door) and Window 2 (left-hand side of the door). Both windows are in extremely poor condition and have reached a point where scheduled maintenance is no-longer feasible. It is proposed that these be replaced with new glazing and glazing bars.

Above: image showing the existing windows 1 and 2.

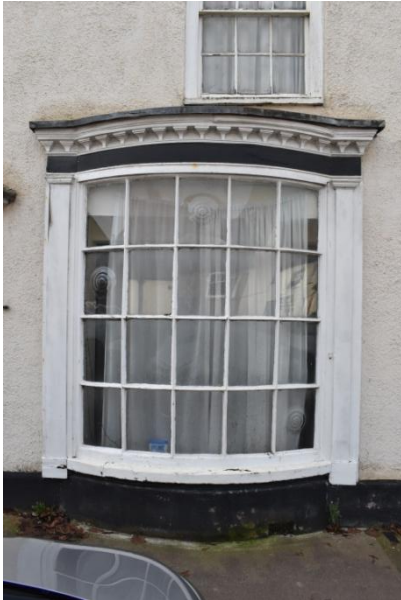
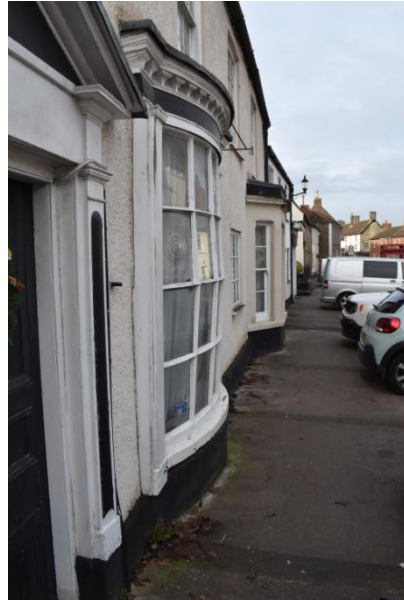
Situated on the right-hand side of the front door, Window 1 consists of hardwood timber glazing bars and 20No. 2mm thick glass panes, three of which have a 'Bull's-eye'.

The age of this window is unknown but appears to date back some time. The window is curved along the horizontal, but also has a convex appearance particularly visible when viewed from the side (see right hand photo above). The frame has begun to buckle under the weight of the glazing. Externally, the timber frame has patches of decay, but it is internally where the extent of decay is more evident. At some point the window has been poorly maintained / repaired with copious amounts of putty, enough to obscure the glazing bars in most cases (please see photo appendix (1 of 2)). The putty has since become brittle and loose and a number of window panes are secured purely with duct tape. A number of the panes are also cracked.

Both windows are in very poor condition, with the timber being rotten both inside and out. Numerous historical repairs and maintenance on the windows is evident. On Window 1 there is little of the original timber integrity holding the panes in place.

Given the significance the current windows have on the appearance of the property and on the street scene, it is proposed the replacement windows match those of the existing as closely as possible whilst also upgrading the fabric to improve the thermal performance. Aiming to keep the timber frames as slim as possible, it has been proposed to use 6mm laminated glass rather than the much heavier double-glazed units. The replacement windows will then feature slim timber glazing bars to match the existing as closely as possible. In a bid to improve ventilation naturally, the windows will feature opening casements on either side of each window. By placing the casements closest to the front wall of the building, this will make them less prominent within the street scene (see Proposed Windows Details drawings and Proposed Front Elevation).

The window frames will feature sustainably sourced hardwood timber (species to be confirmed) and new glazing will be fitted into place using putty in the traditional manner.

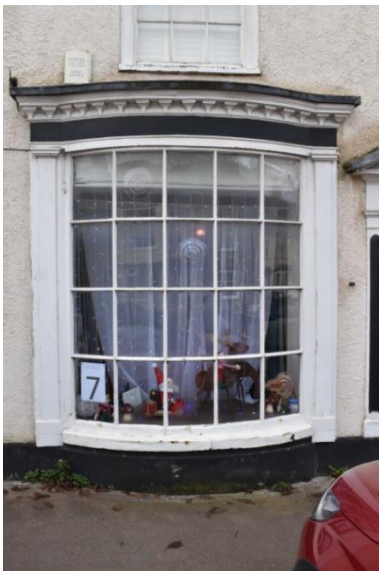
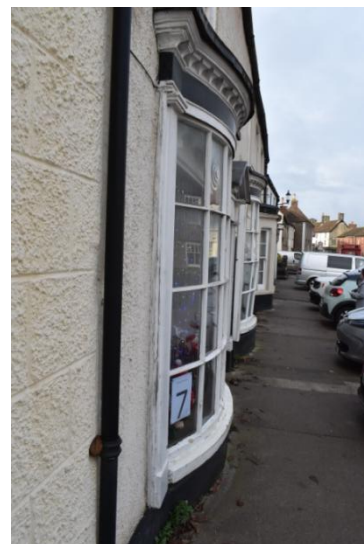
Window 2 is situated on the left-hand side of the front door.

Window 2 appears to be more recent than Window 1 and is estimated at circa 30 years old, probably having been substantially repaired, if not replaced, when the property was converted into a dwelling. The window still features 2mm glass panes, three of which are bulls-eye, so it is possible that although the frame / timber-work is more recent, the original glass may have been retained. Despite the frames being more recent they are in a similar state of disrepair to Window 1. A number of the panes are also cracked. Please see Photo Index (2 of 2)
