**Arboricultural Impact Assessment
Wigton Heath Farm
Manor House Lane
Alwoodley
Leeds
LS17 9JD**

Report Reference: 1739-1-AIA
28 June 2023

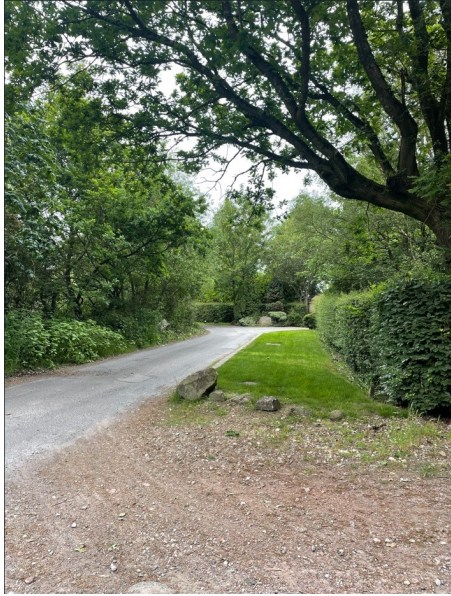
Photograph 1- Northerly Aspect When Exiting Wigton Heath

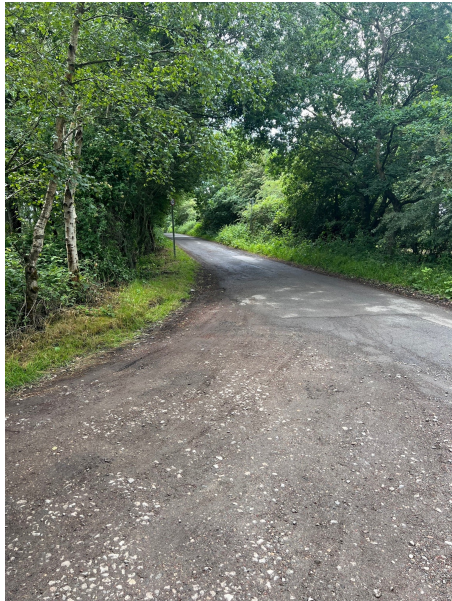
Photograph 2- Southerly Aspect When Exiting Wigton Heath

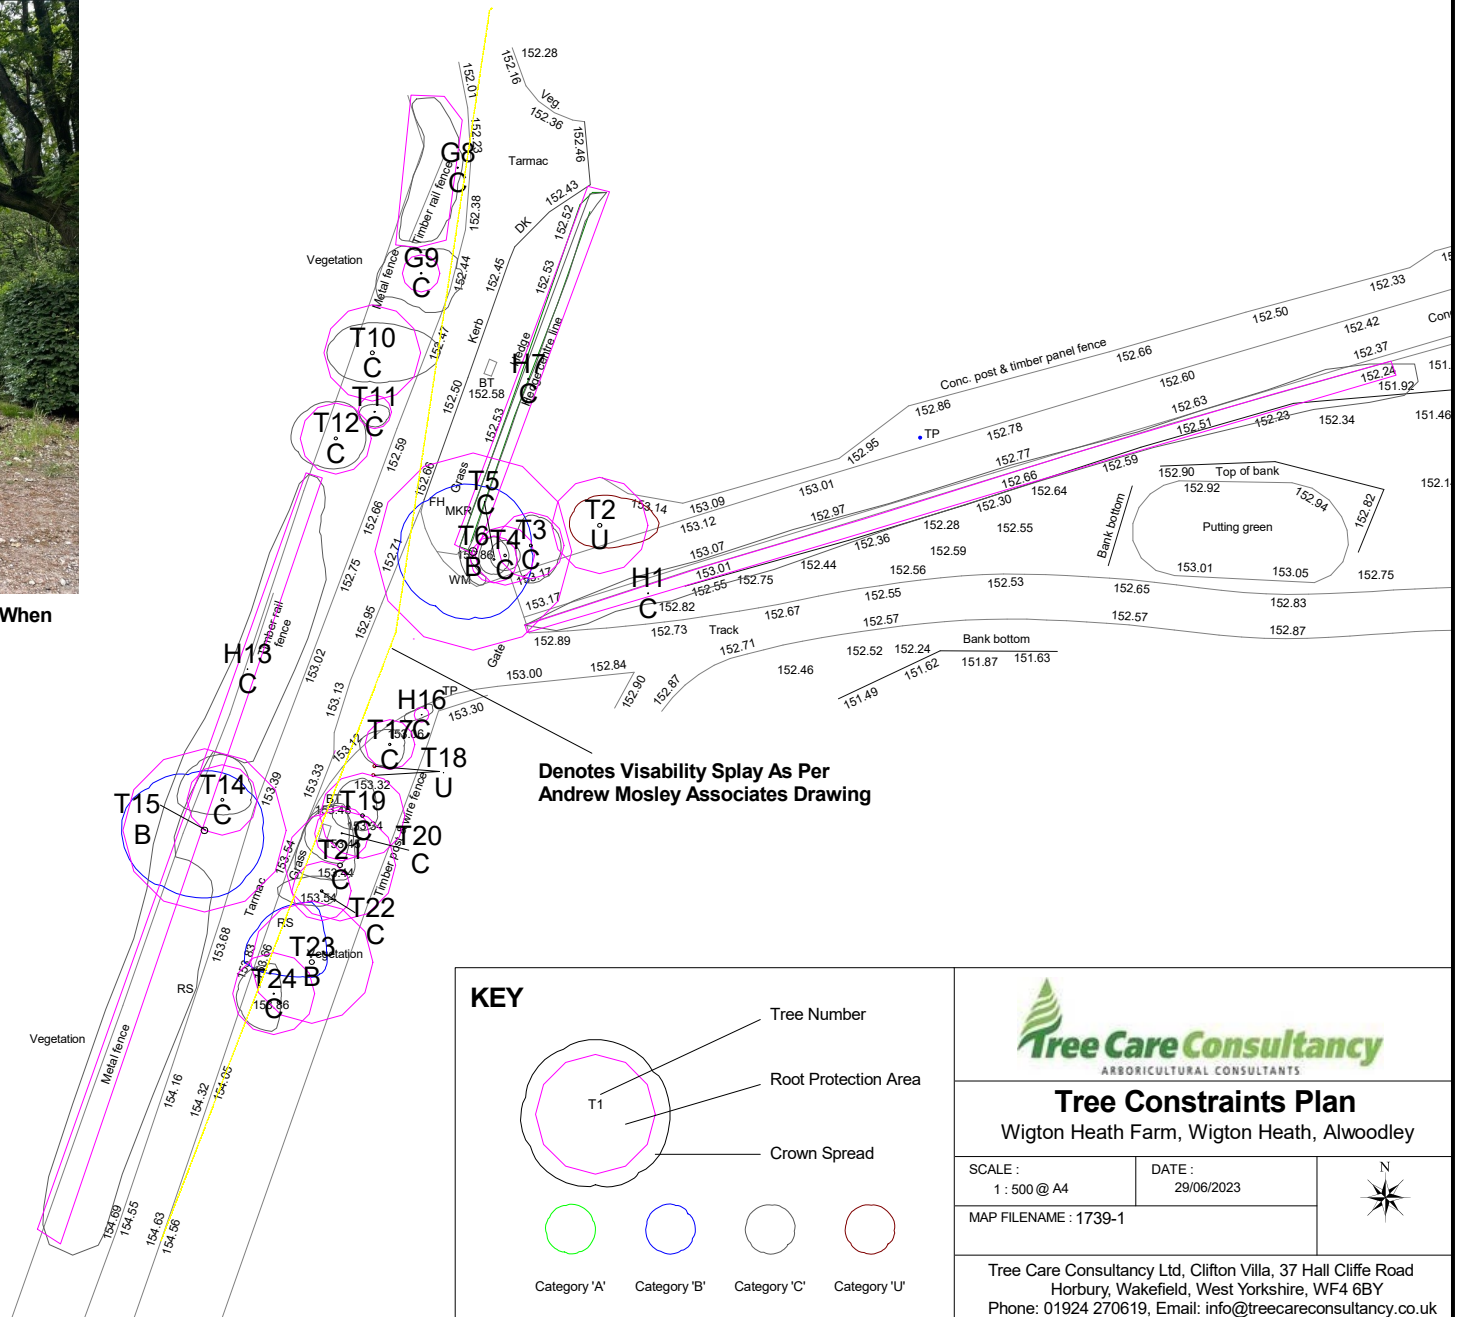
Tree Constraints Plan
Wigton Heath Farm, Wigton Heath, Alwoodley

- 3.3.1. As recommended in BS5837 we have plotted the RPAs onto the attached Tree Constraints Plans (TCP) taking full account of the surrounding structures, topographical factors, tree condition and the probable root disposition.
- 3.3.2. The proposed visibility splays at the junction of Wigton Heath and Manor House Lane will not create any adverse impacts upon retained tree and hedgerow material.
