**BAT PRELIMINARY ROOST
ASSESSMENT
CRIEFF RD LIDL
RAPLEYS LLP**

8/03/2022

Crieff Rd Lidl

P22071

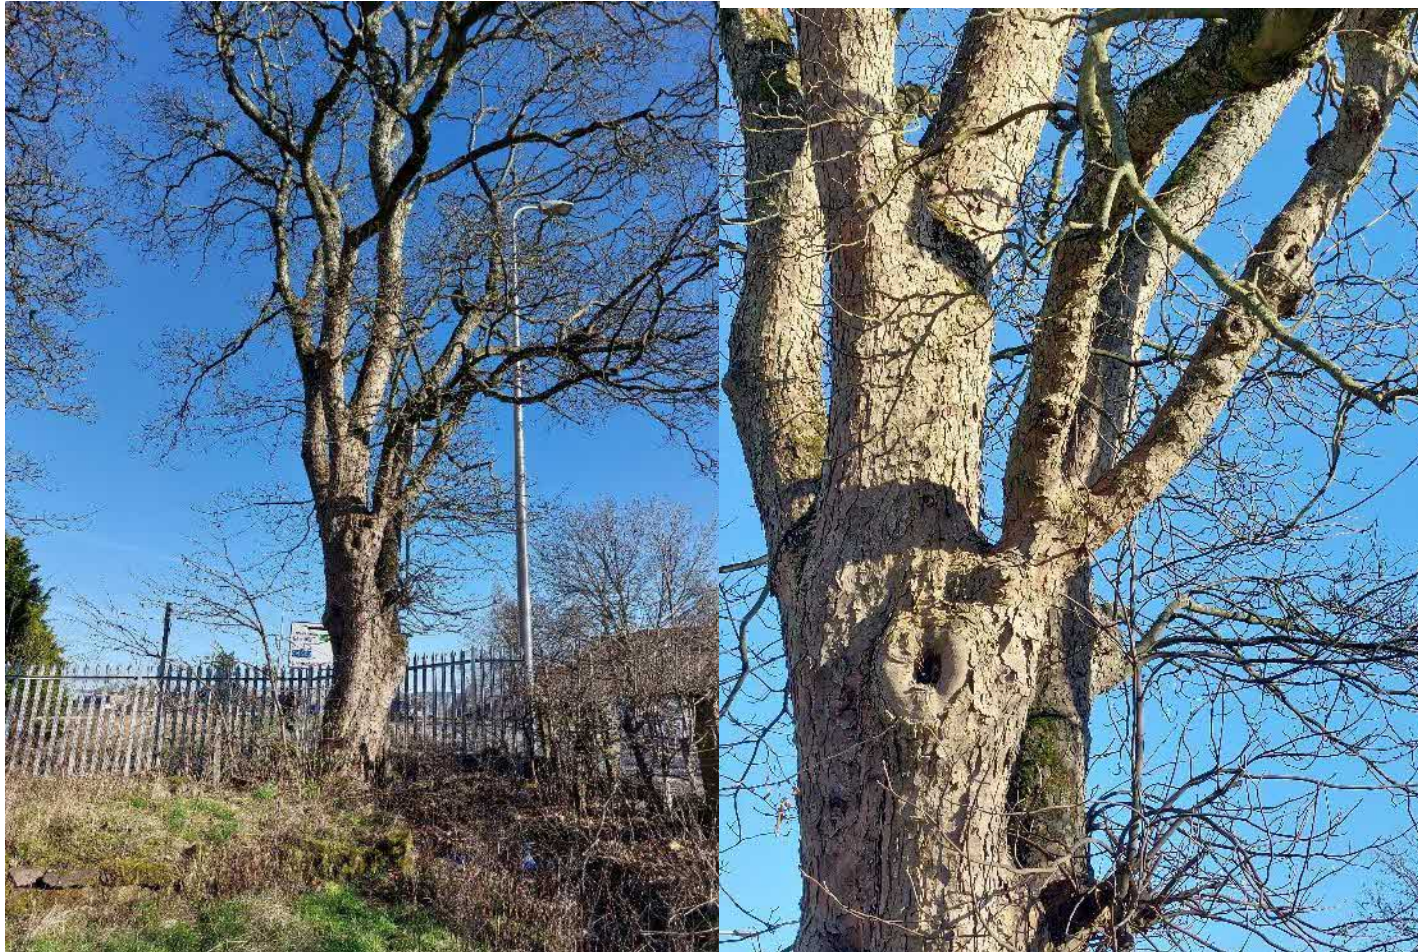
Photo 1 - Tree 5225 with cavity on western side

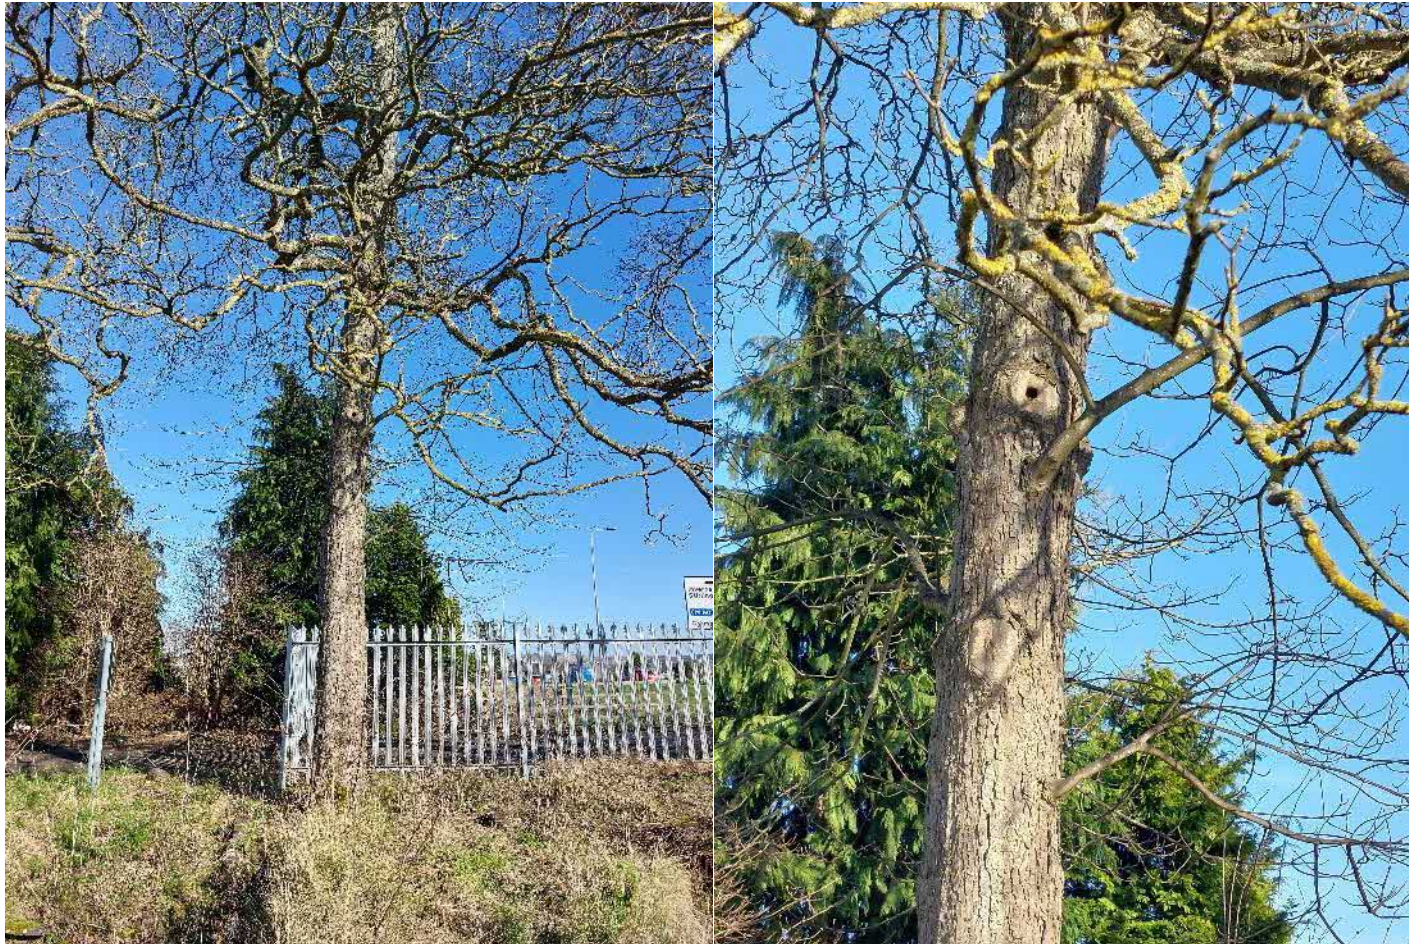
Photo 2 - Tree 5226 cavity on western side of trunk

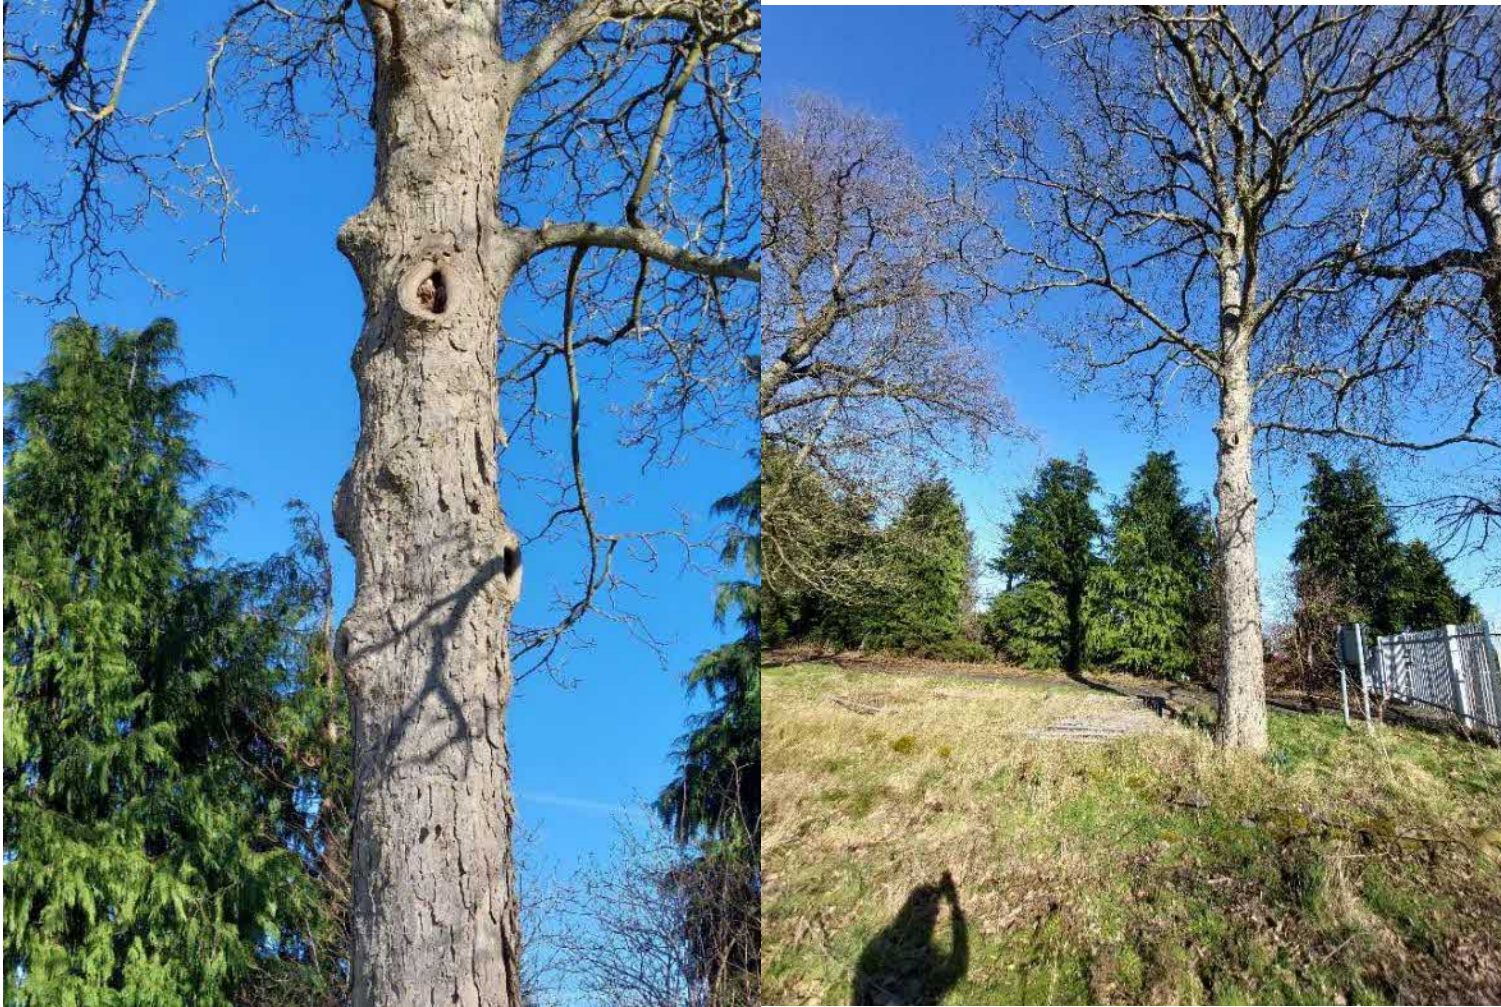
Photo 3 – Tree 5227 multiple cavities on trunk. Tree deemed moderate suitability

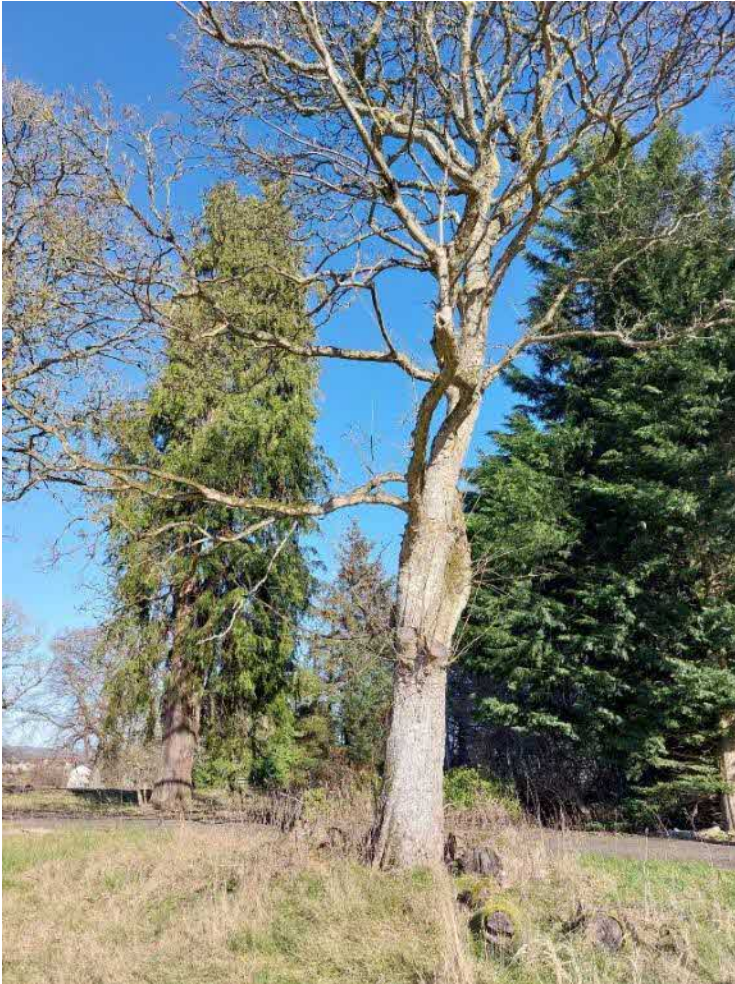
Photo 6 – Tree 5233 cavity on western side of secondary branch

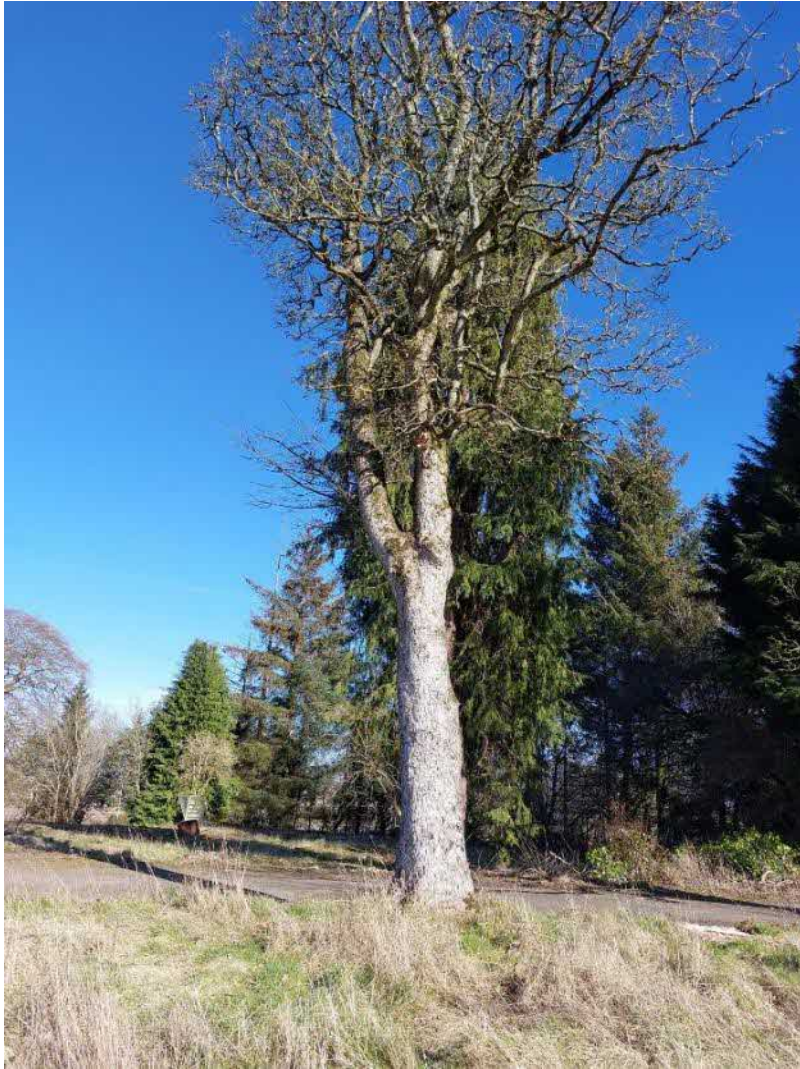
Photo 7 – Tree 5234 cavity on western side off secondary branch

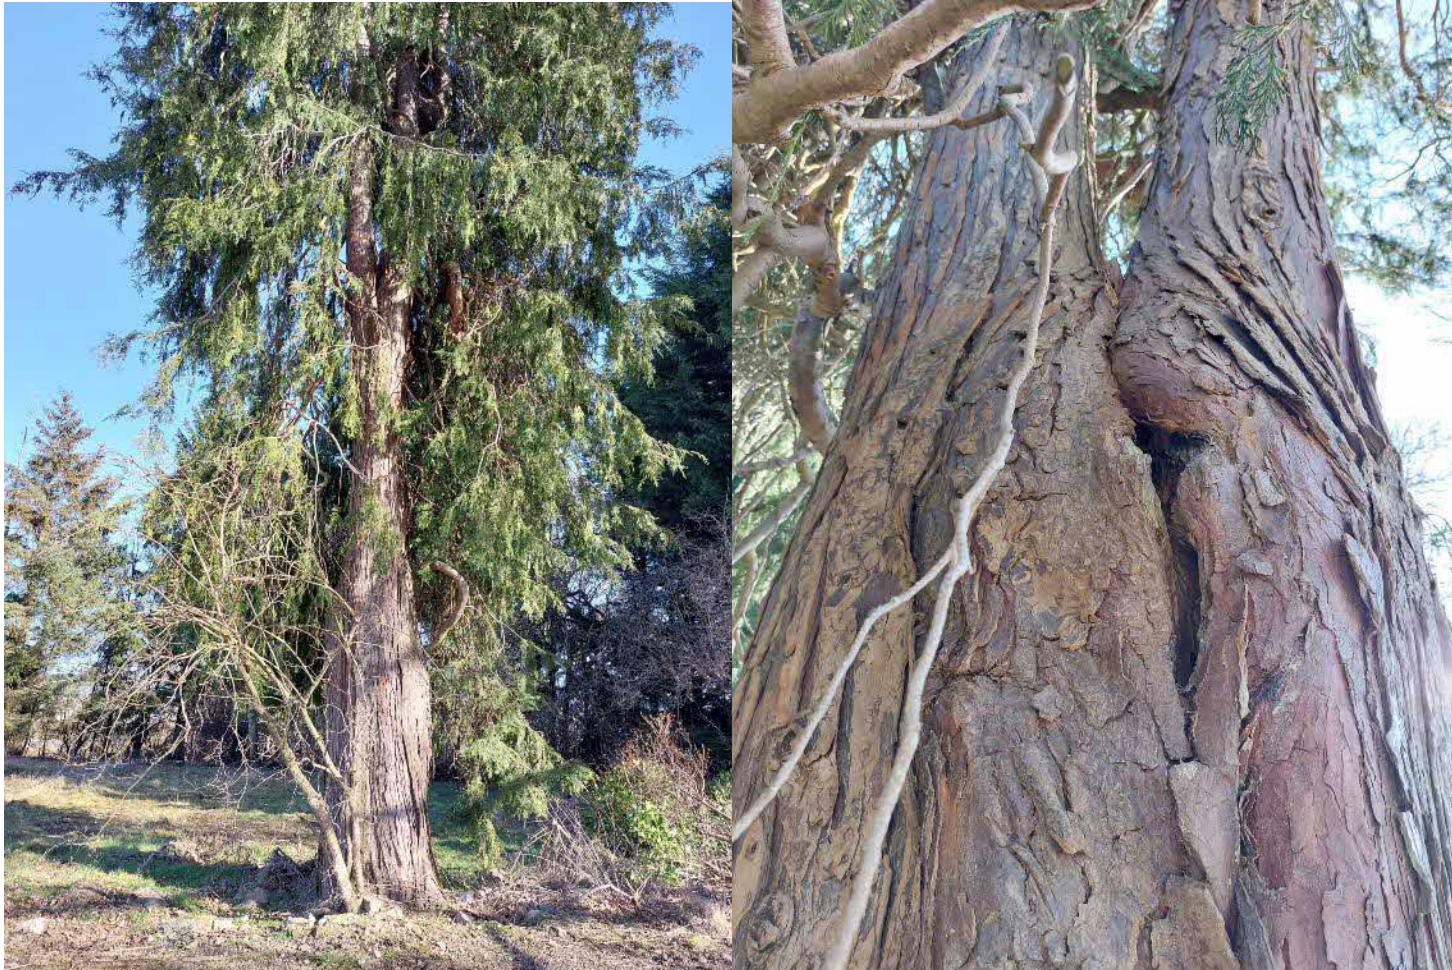
Photo 8 – Tree 5235 Large crack in northern side of trunk

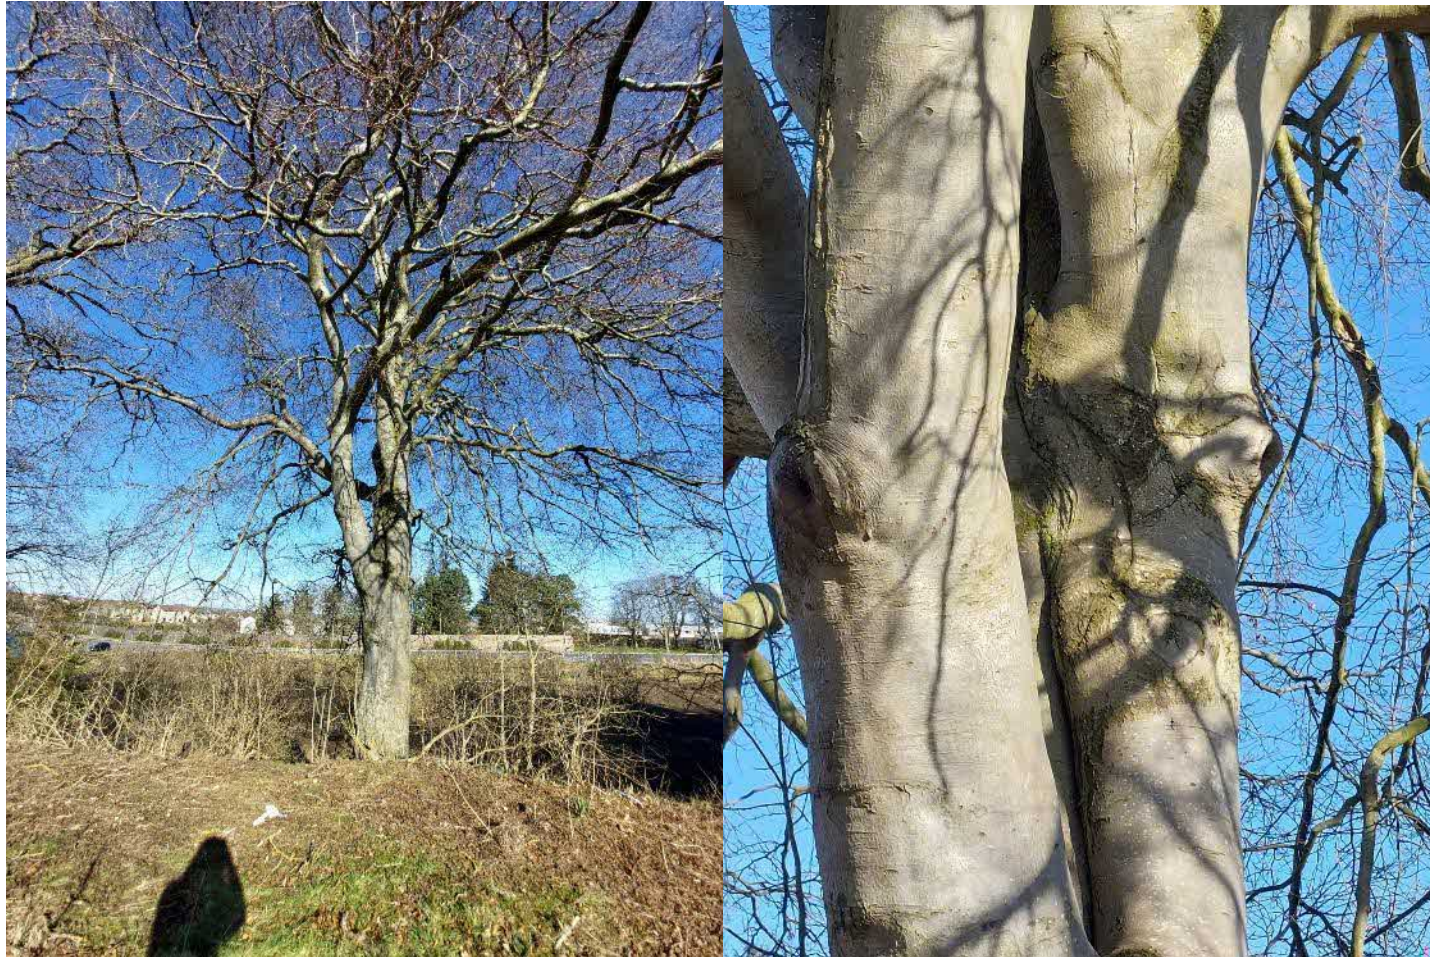
Photo 9 – Tree 5244 multiple cavities in trunk and secondary branches

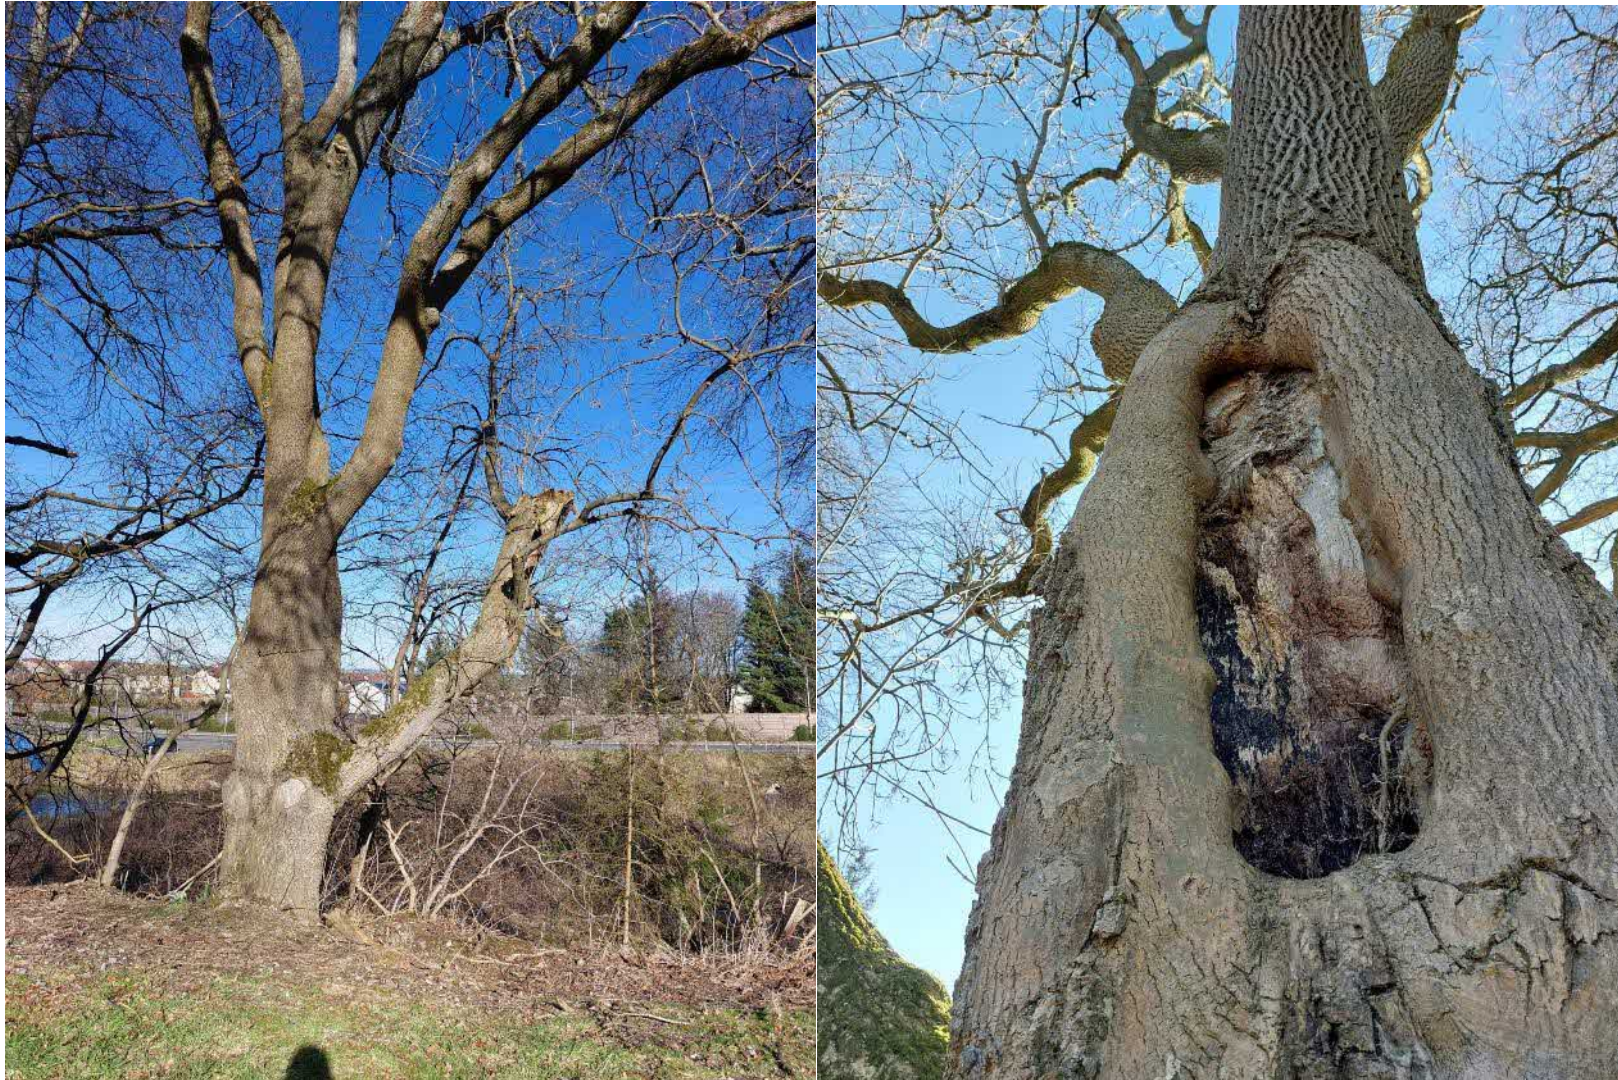
Photo 10 – Tree 5245 large cavity on eastern side

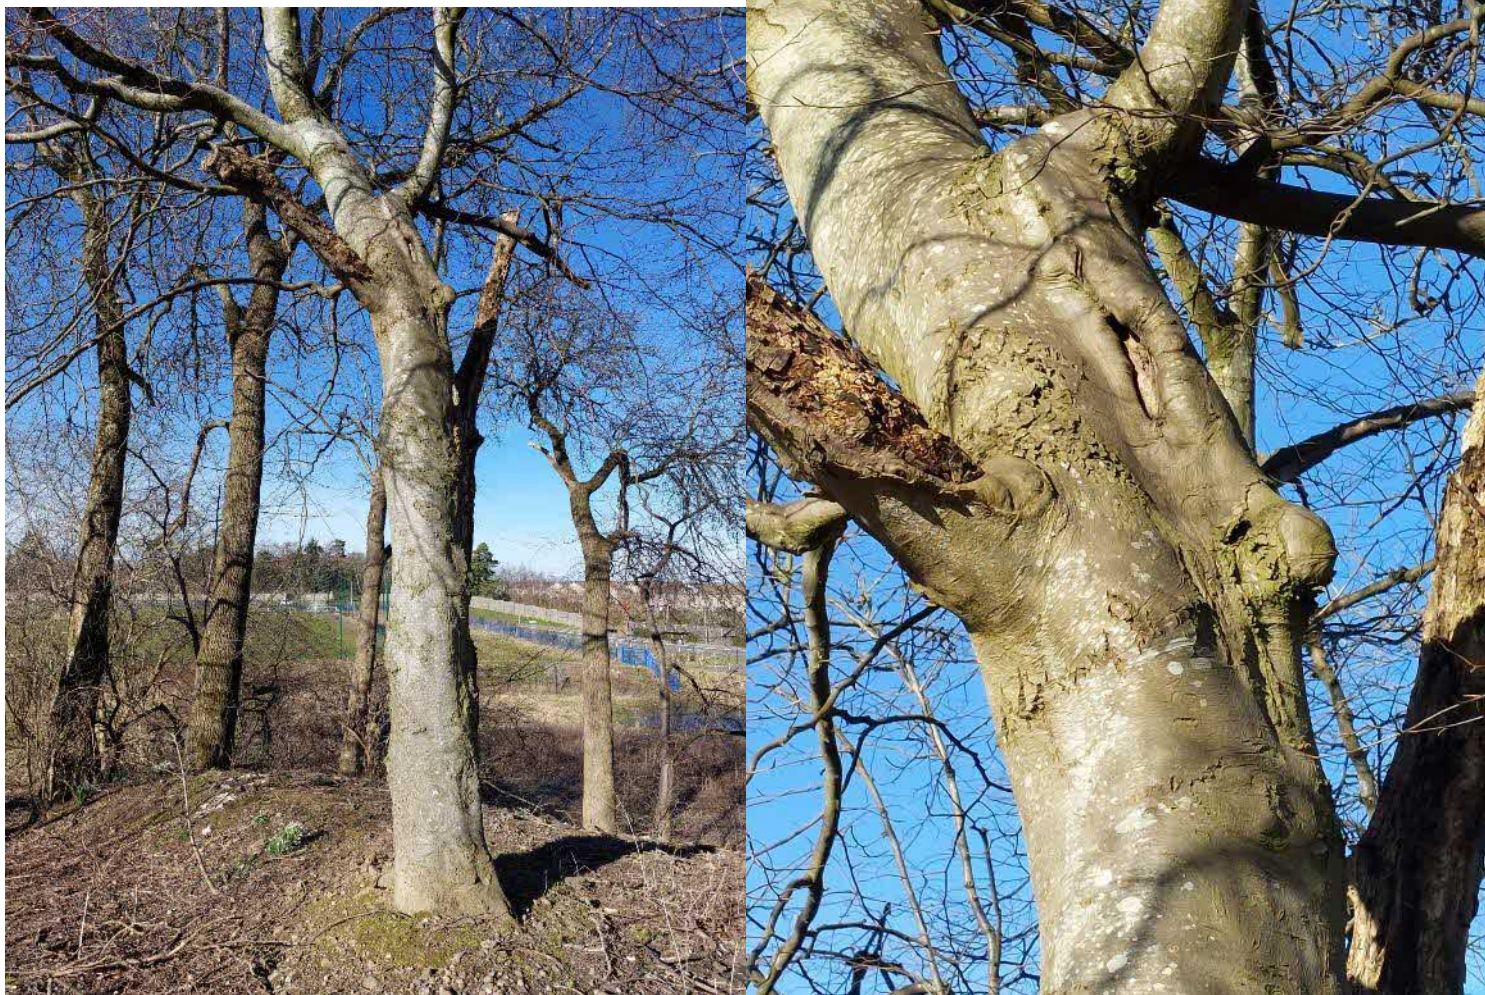
Photo 11 – Tree 5247 small cracks on southern side of trunks

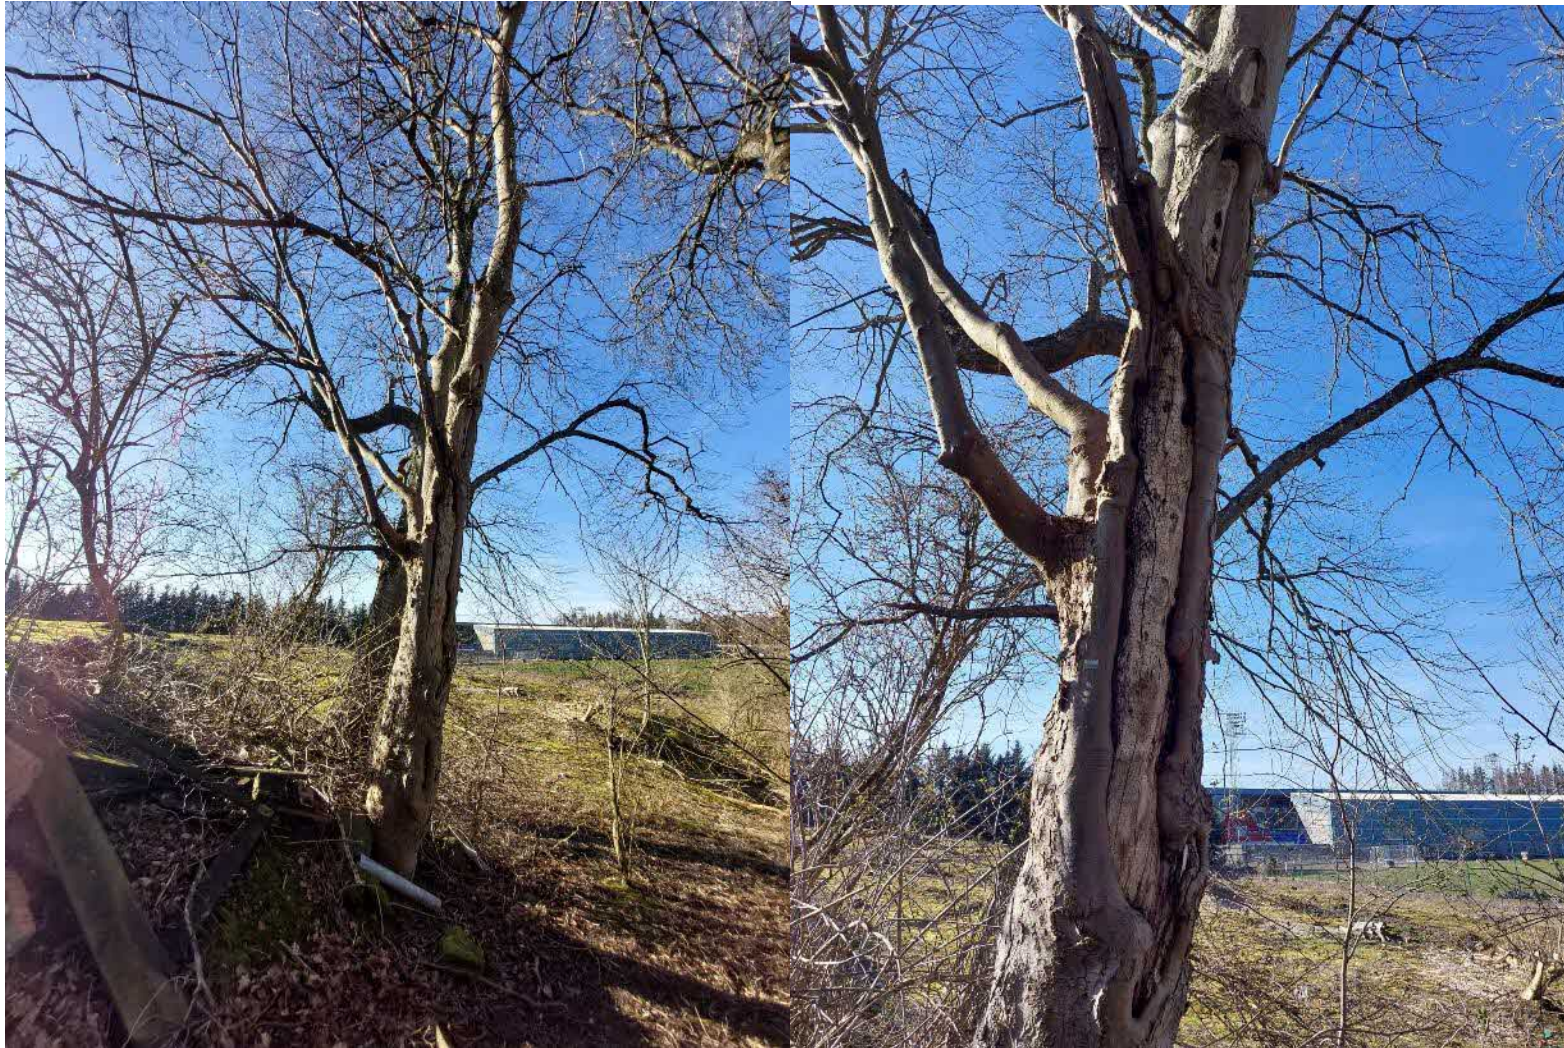
Photo 12 – Tree 5248 crack one eastern side of trunk

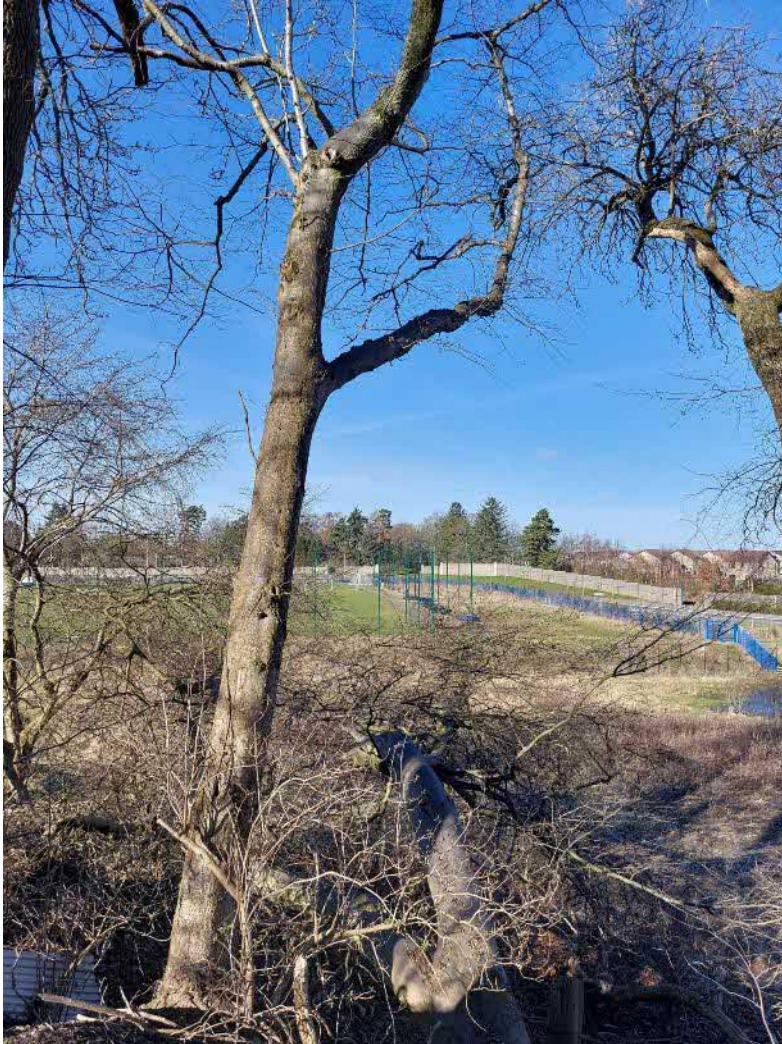
Photo 13 – Tree 5254 cavity on secondary branch on southern side
