DESIGN AND ACCESS & HERITAGE STATEMENT

7 King Street

Recovering of roof, removal of render and structural repairs to brickwork

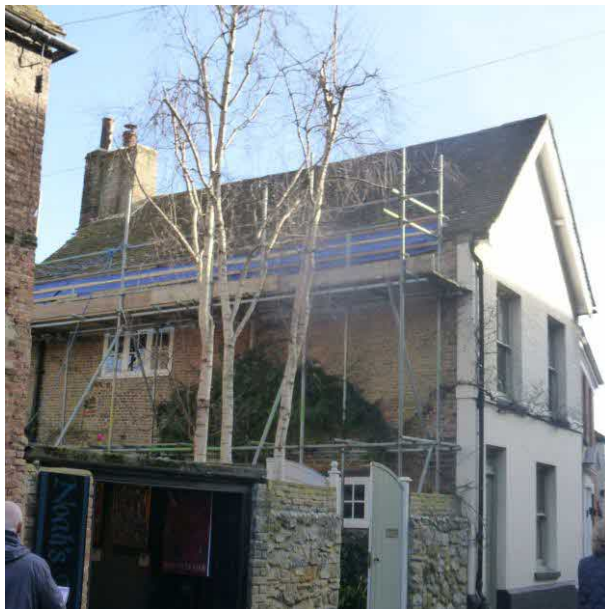
The roof covering is unfortunately now at the end of its useful life. The battens are completely rotten as seen within the roof structure and there is no underfelt. Continuous patch repairs have been carried out but due to the extent of rot to the battens complete recovering of the roof is necessary as during high winds, tiles are frequently dislodged and blown into the street below.

The proposal is to strip all the existing Kent Peg tiles and to salvage as many as possible. The roof will then be recovered with a modern underfelt, tanalised battens and then recovered with Kent Peg tiles.

Several repairs are required to the rafters and sole plate at the same time as the recovering where these are rotten.

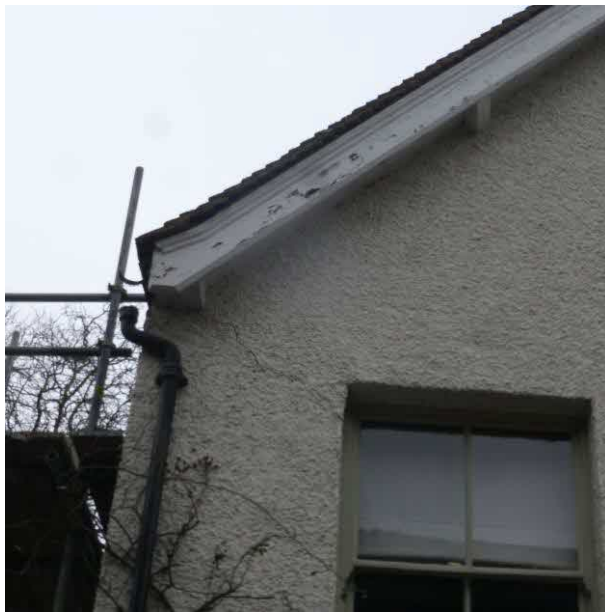
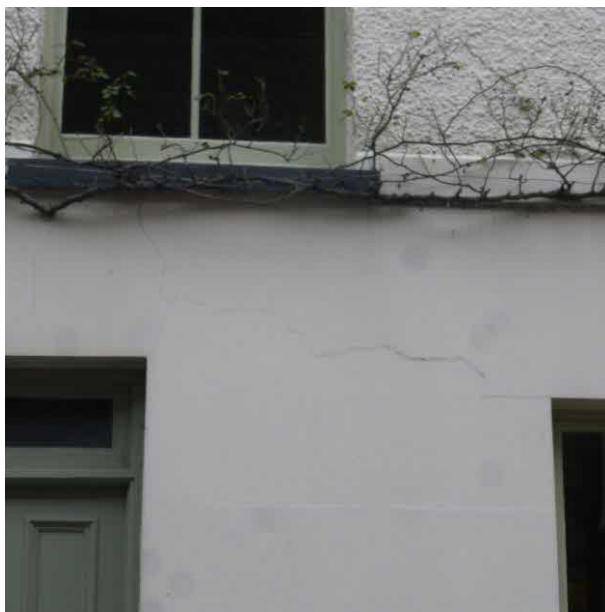
There are diagonal cracks in the render to the front elevation notably to the top left hand side over the bedroom window and to the mid-level as shown on the below photographs and accompanying drawings.

It is anticipated that the repairs to the cracking will be carried out using helical (twisted) stainless steel rods which can be concealed in the mortar joints and then be unseen. The extent of the cracking can be assessed once the render has been removed, in small areas to be agreed with the Conservation Officer of Dover District Council.

It is also proposed to completely remove the smooth render at ground floor and pebble dash render at first floor to expose the existing red stock brick work. The brickwork will then be cleaned using DOFF system and the brickwork repointed in a lime based mortar mix.
