# Arboricultural Report

Title: Arboricultural Impact Assessment, Arboricultural Method Statement and Tree Protection Plan, for the development of: 'Nostra Domus', Lyme Road, Uplyme DT7 3XA.

Date: 9 February 2024

Reference: APPA100124/1

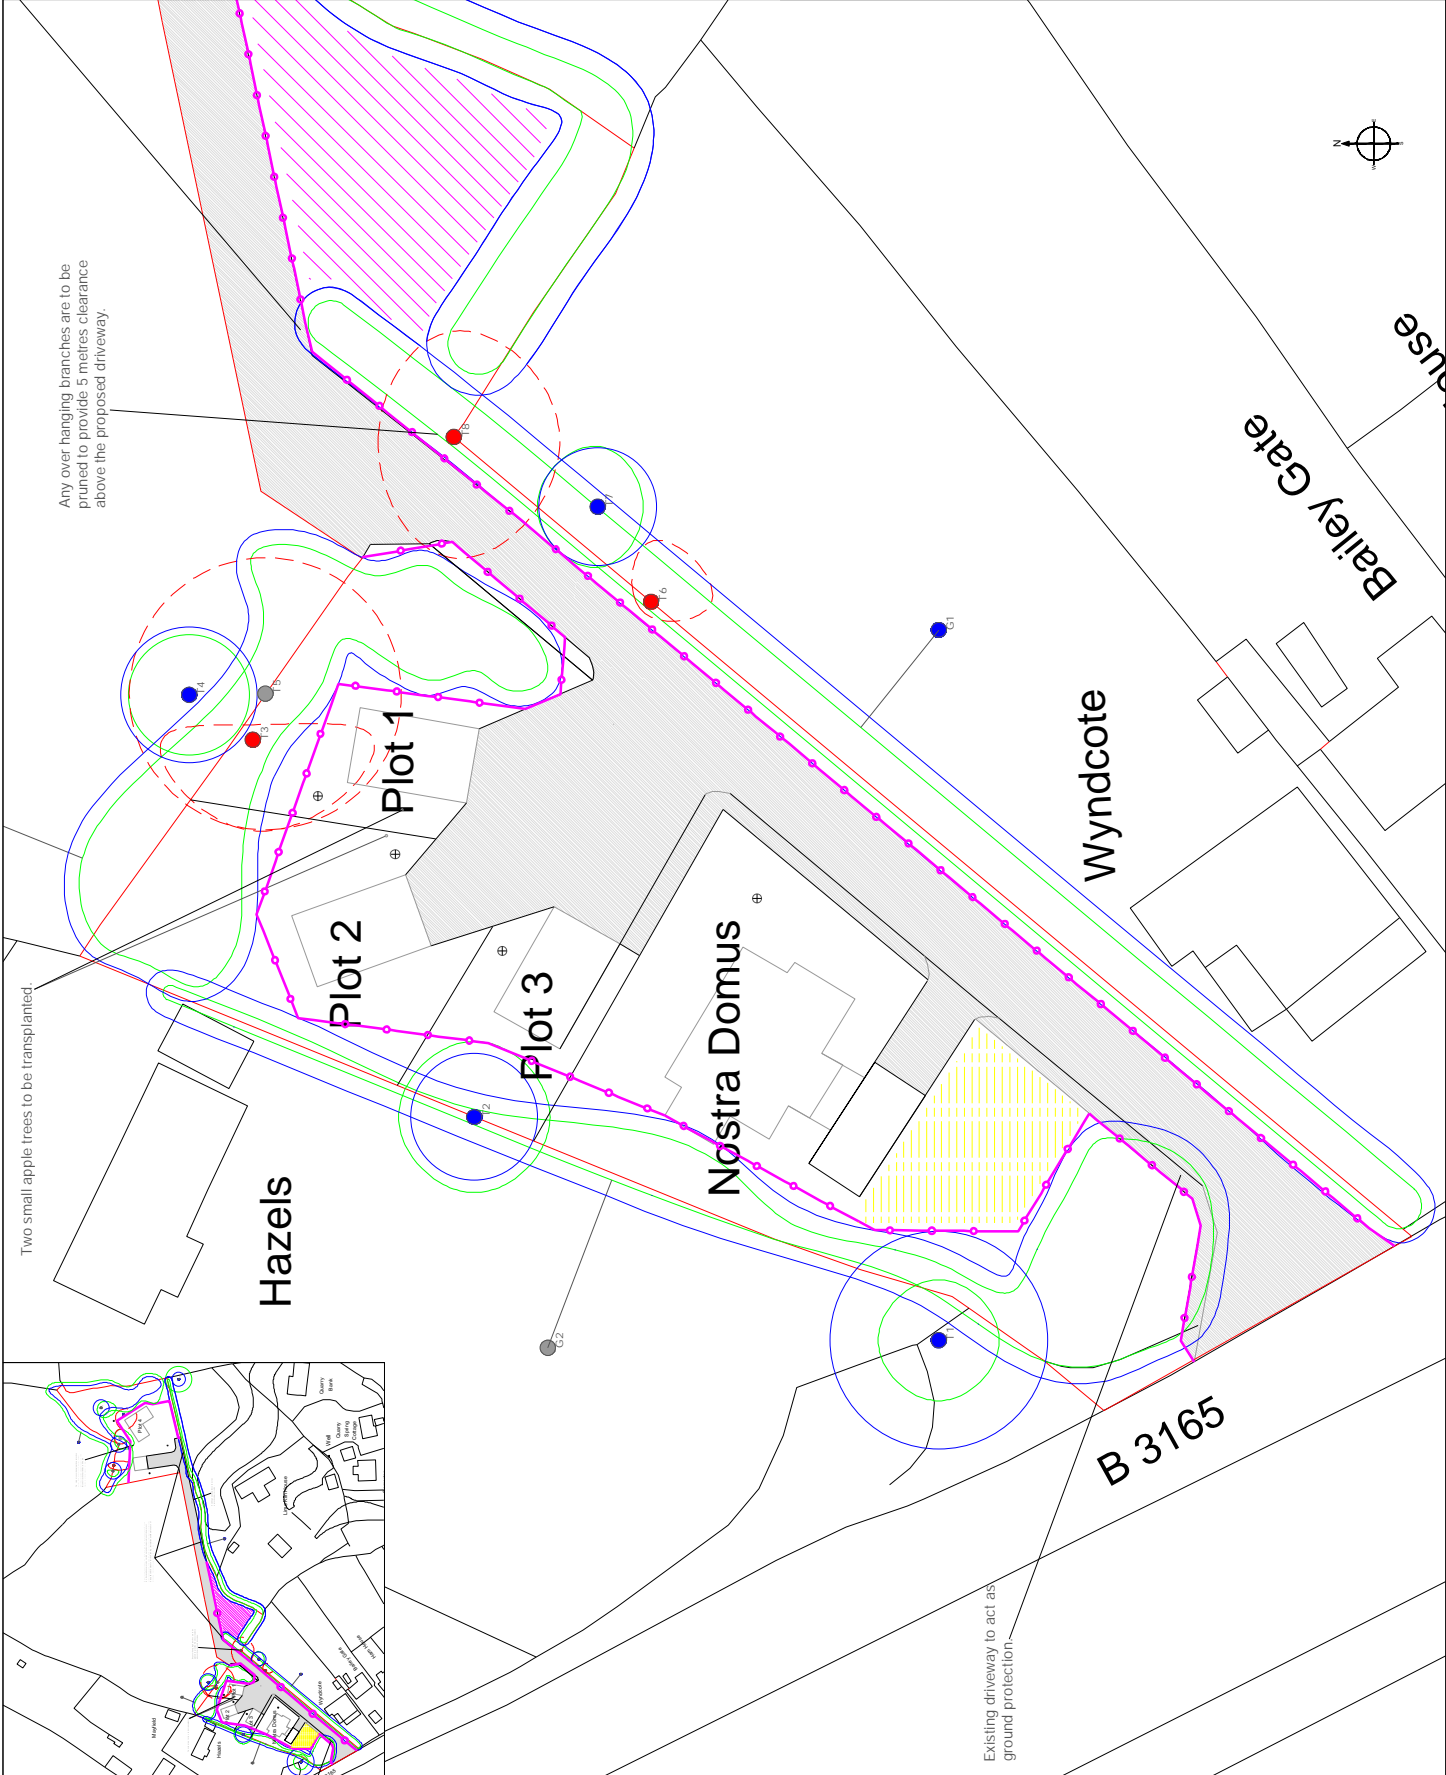
Site: 'Nostra Domus', Lyme Road, Uplyme DT7 3XA. 1:250 @ A2  
 Drawing Title: Tree Protection Plan (East elevation) February 2024

Tree crown is over hanging the protective barrier. However it is at 8 metres height which will provide adequate space below for construction activities, with a low likelihood of damage occurring.

Minor incursion of the access road into the root protection area of G1 and G4. Excavations are to be carried out under supervision of the project arboriculturist, and following the guidance set out in National Joint Utilities Group (NJUG) Guidance for the Planning, Installation and Maintenance of Utility Apparatus in Proximity to Trees - Issue 2.

Existing boundary fence to act as protective barrier to G4.
