Ref 24004 – Harbour Hotel & Spa, St Ives

## DESIGN AND ACCESS STATEMENT

**ON:** RETAINING WALL TO EAST OF HARBOUR HOTEL, ST IVES, TR26 2BN

**FOR:** THE HARBOUR HOTEL & SPA (T/A THE PORTHMINSTER HOTEL COMPANY)

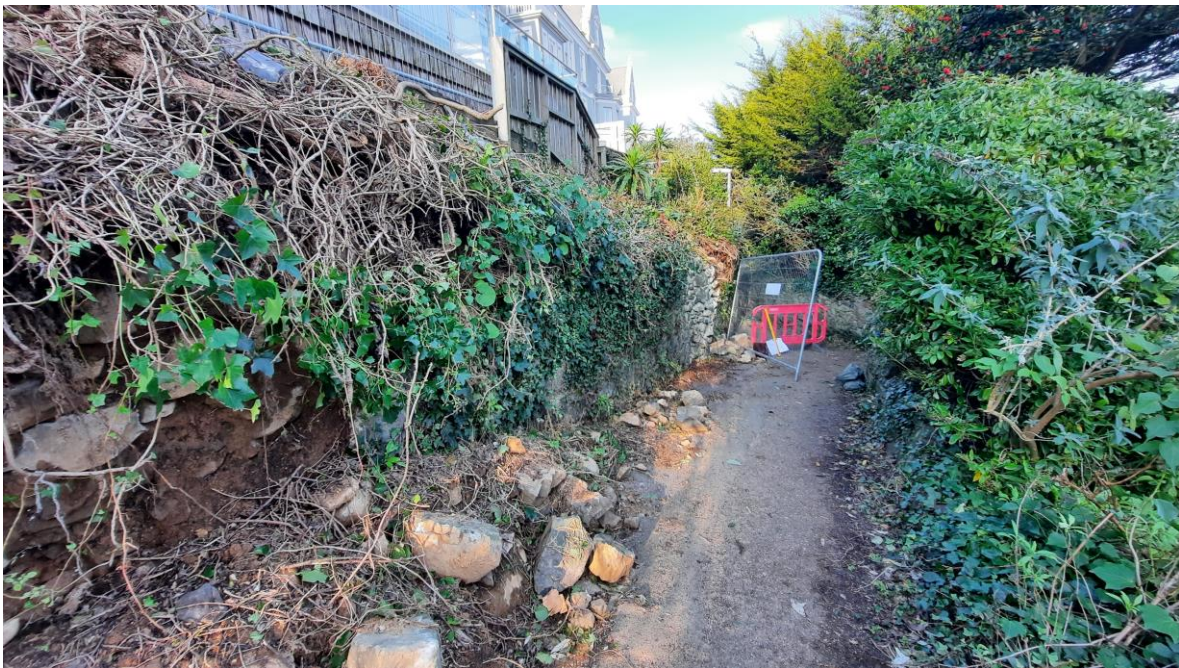
Figure 1 - Photograph showing section of collapsed boundary retaining wall.

To ensure continued safe access along the public pathway to the East of Harbour Hotel, it is proposed to reconstruct a section of the boundary retaining wall. Existing stone on site will be sorted and cleaned for re-use and will face the proposed retaining structure. In order to maintain a safe working site, it will be necessary to close the public path throughout the duration of the works.

The proposed retaining wall position will match that of the original.

The height of the retaining wall will closely match that of the original.

The retaining wall will be finished with existing stone using a lime-based mortar. The top of the retaining wall will be finished with a stone coping to closely match existing, where formerly present. The glass balustrade close to the failed section of the retaining wall will be temporarily removed and re-installed following remedial works.

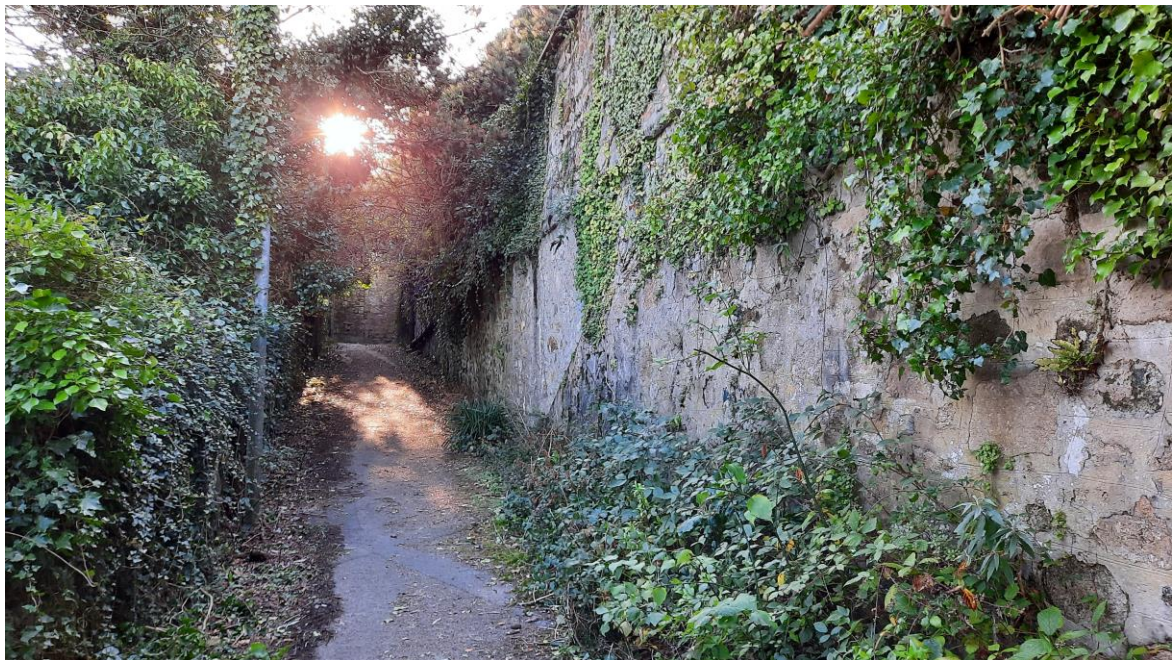
Figure 3 – Photograph showing existing retaining wall to the south end of the footpath.

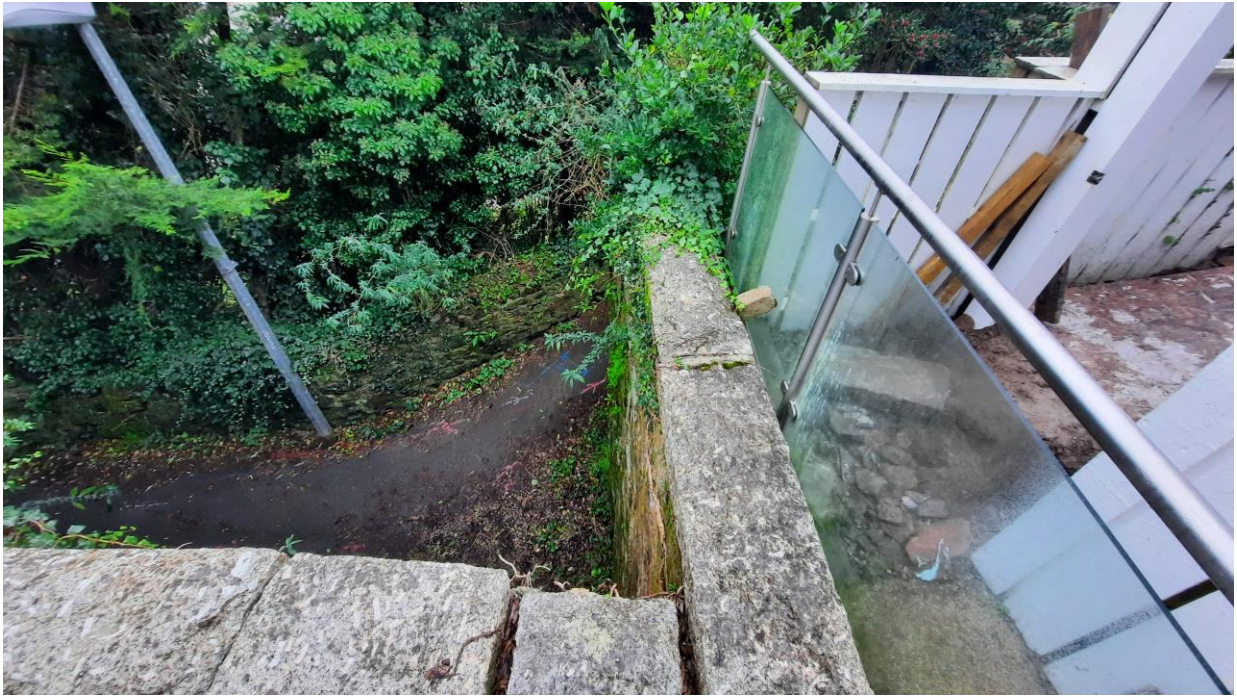
Figure 4 - Photograph showing existing coping stones and glass balustrade.
