Arboricultural Report (ver 1)

Holiday Lodges

Yoke Fleet Cottages

January 2024

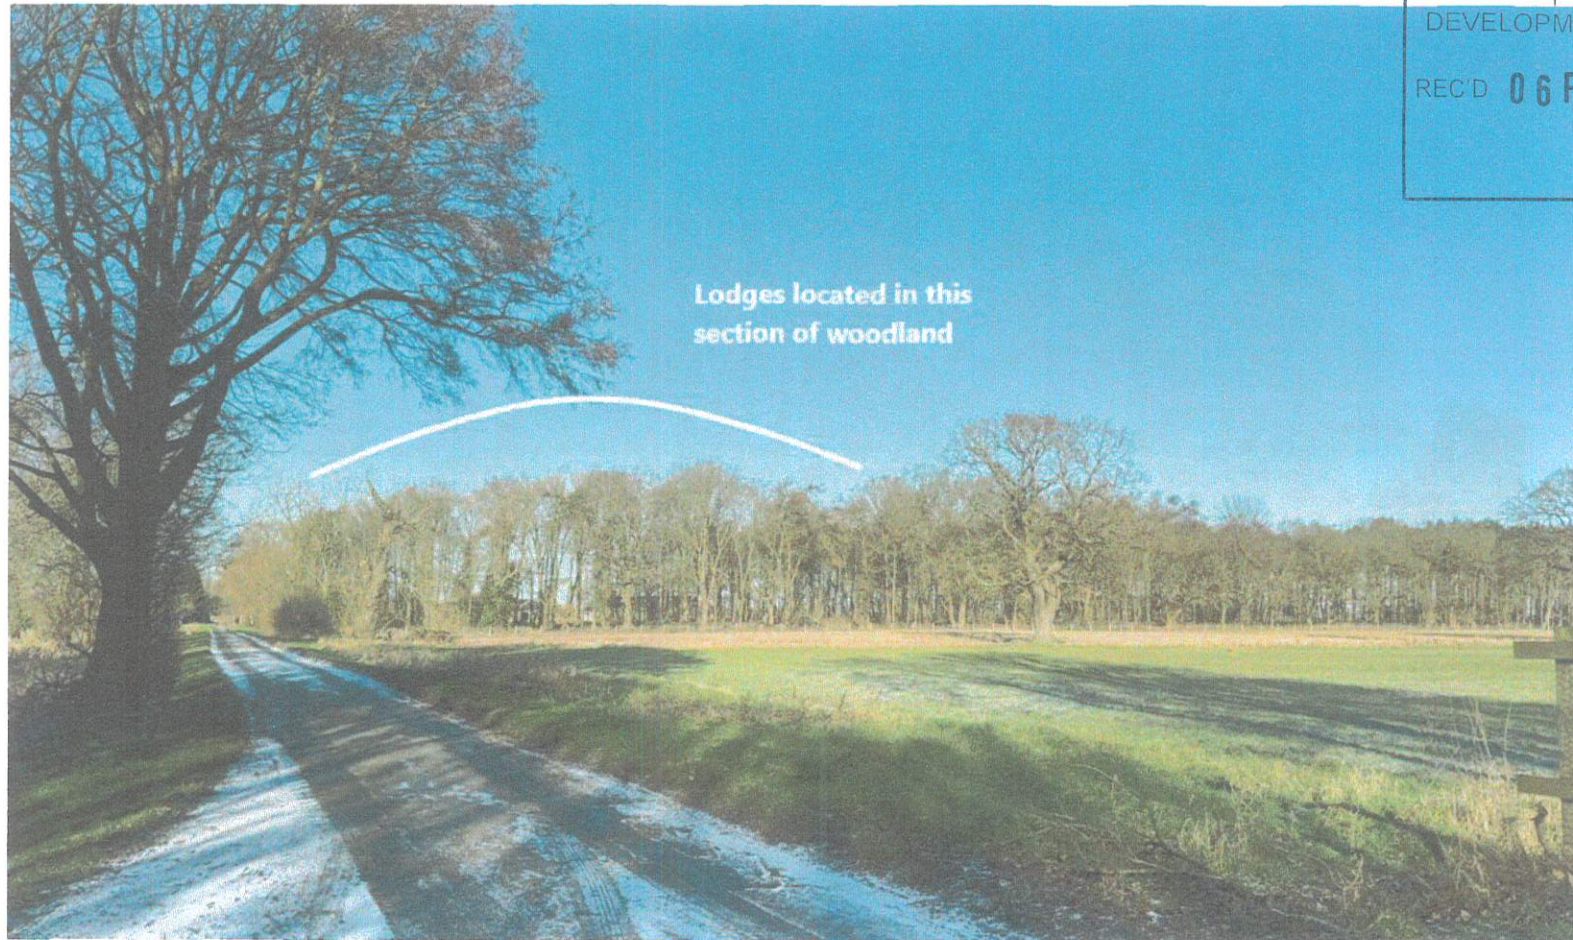
Woodland Setting - The lodges are located within a mixed woodland area dominated by mature broadleaf trees dominated by oak and ash but with other species of trees including, sycamore, willow, larch, Scots pine, birch and rowan. The lodges would be located within the wood and would not be prominent when viewed from the road.

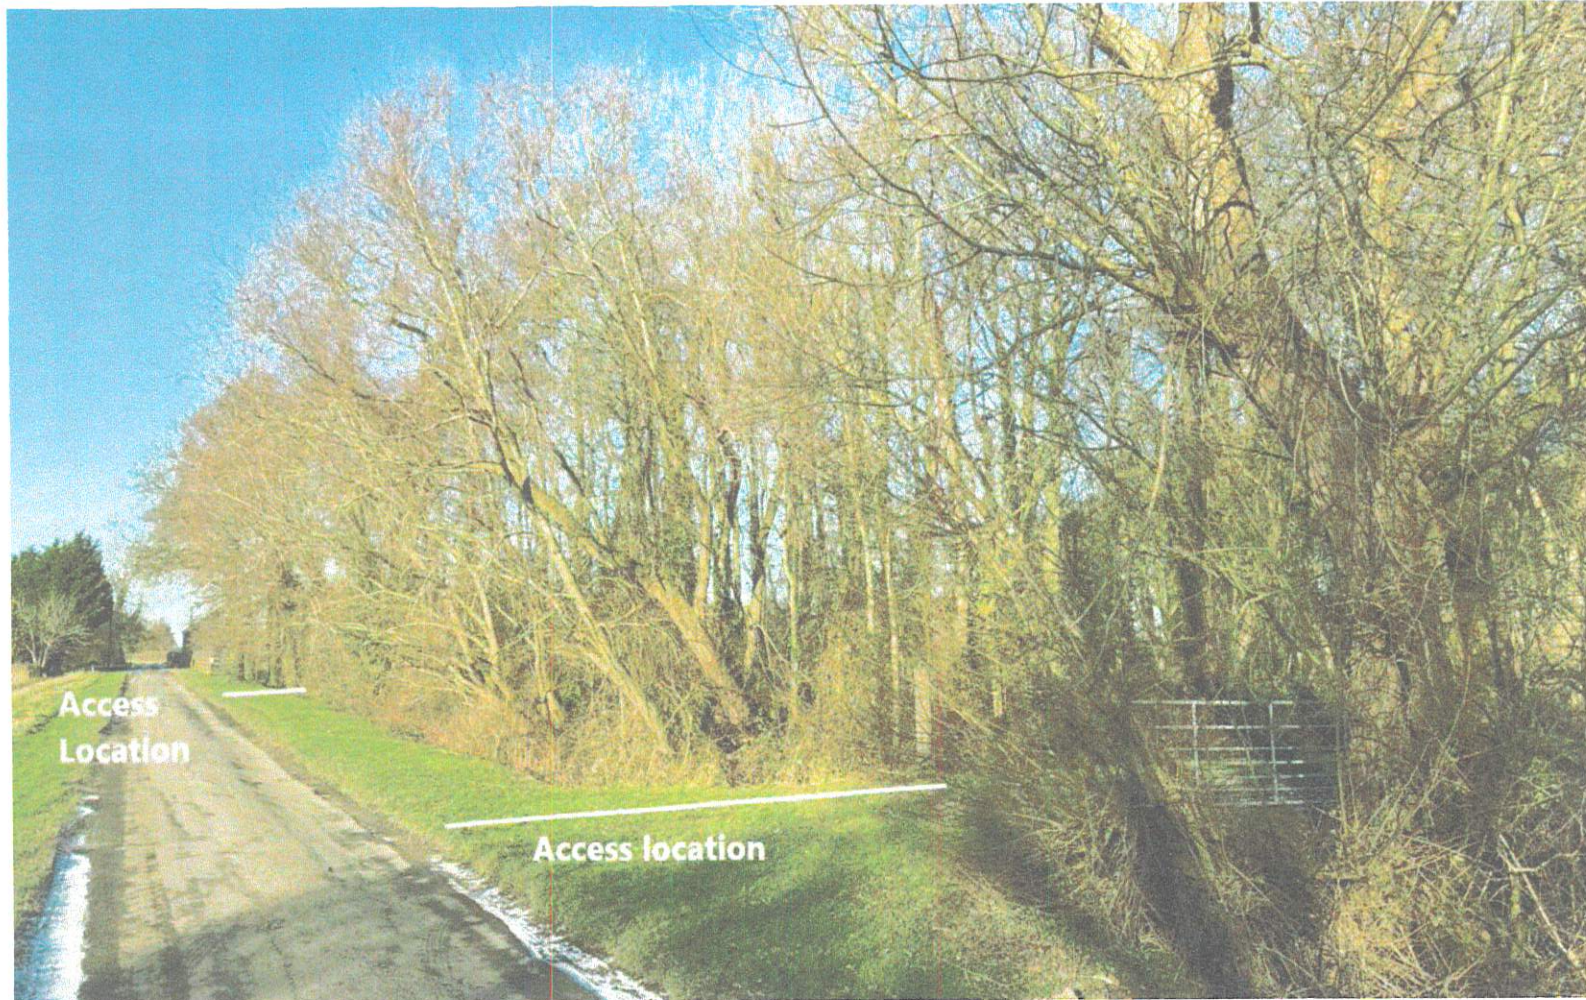
4.3 **Access Points** - The boundary to the site with the highway is dominated by willow adjacent to a field ditch. Existing access points from the highway would be used for the two access tracks.

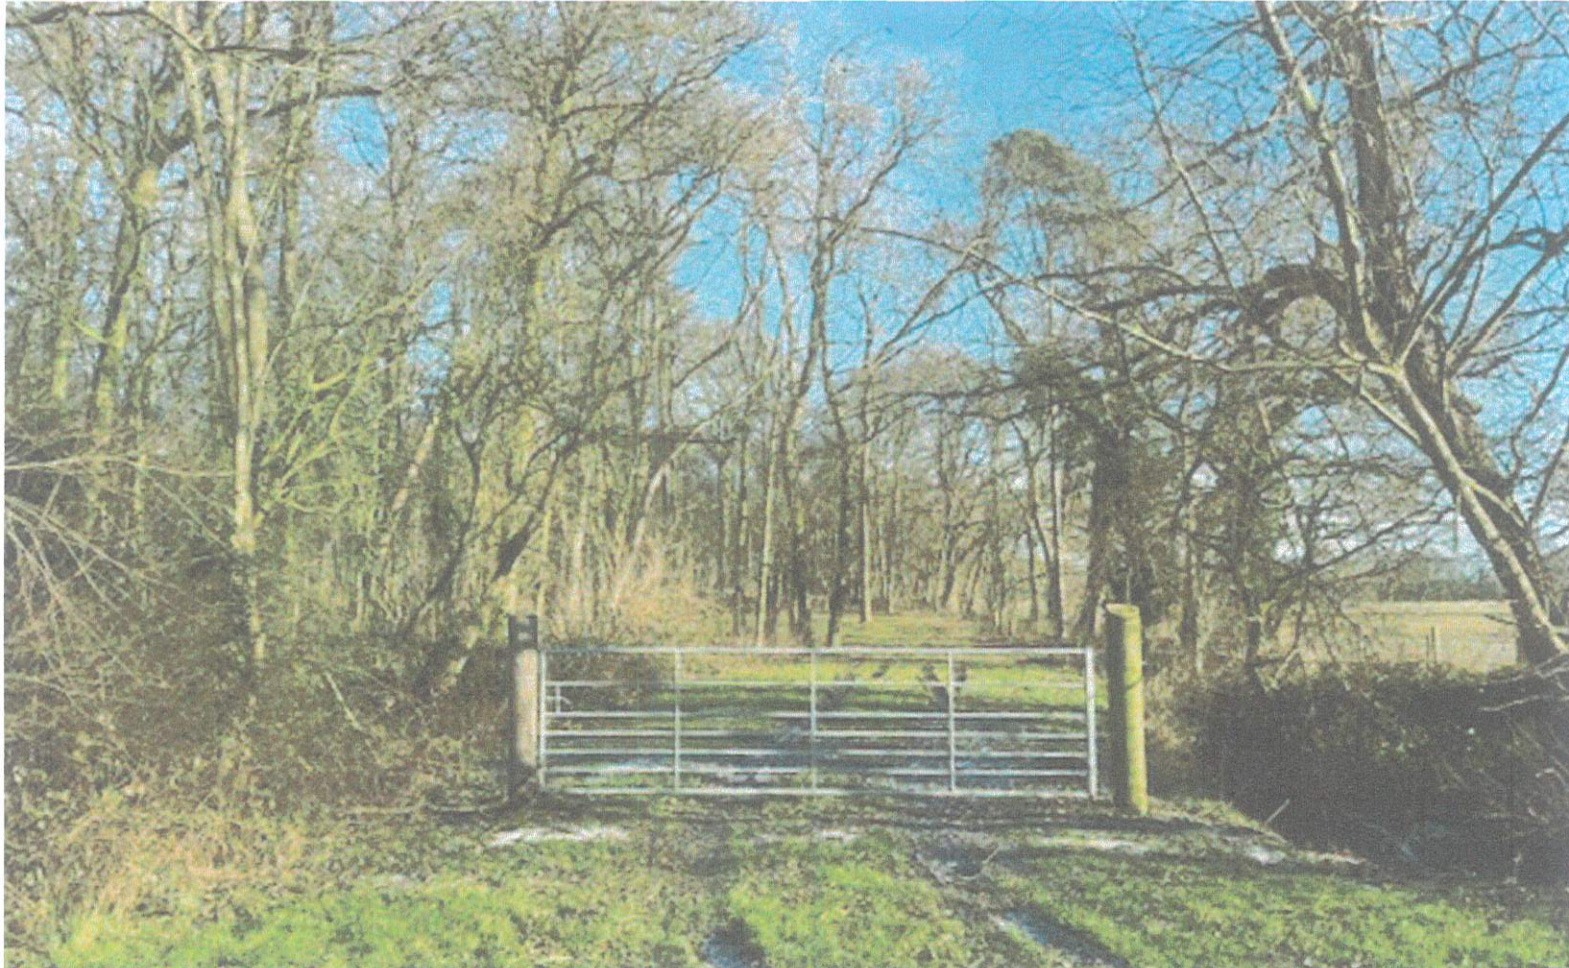
4.4 **Access Tracks and Paths** - The access tracks and paths are also located in open sections of the wood, hence the reasons no trees are to be removed. The access tracks and paths to utilise the low invasive technique, (no dig) as illustrated in appendix A. It is recommended that the access drives have a 200mm construction depth and paths 100mm.

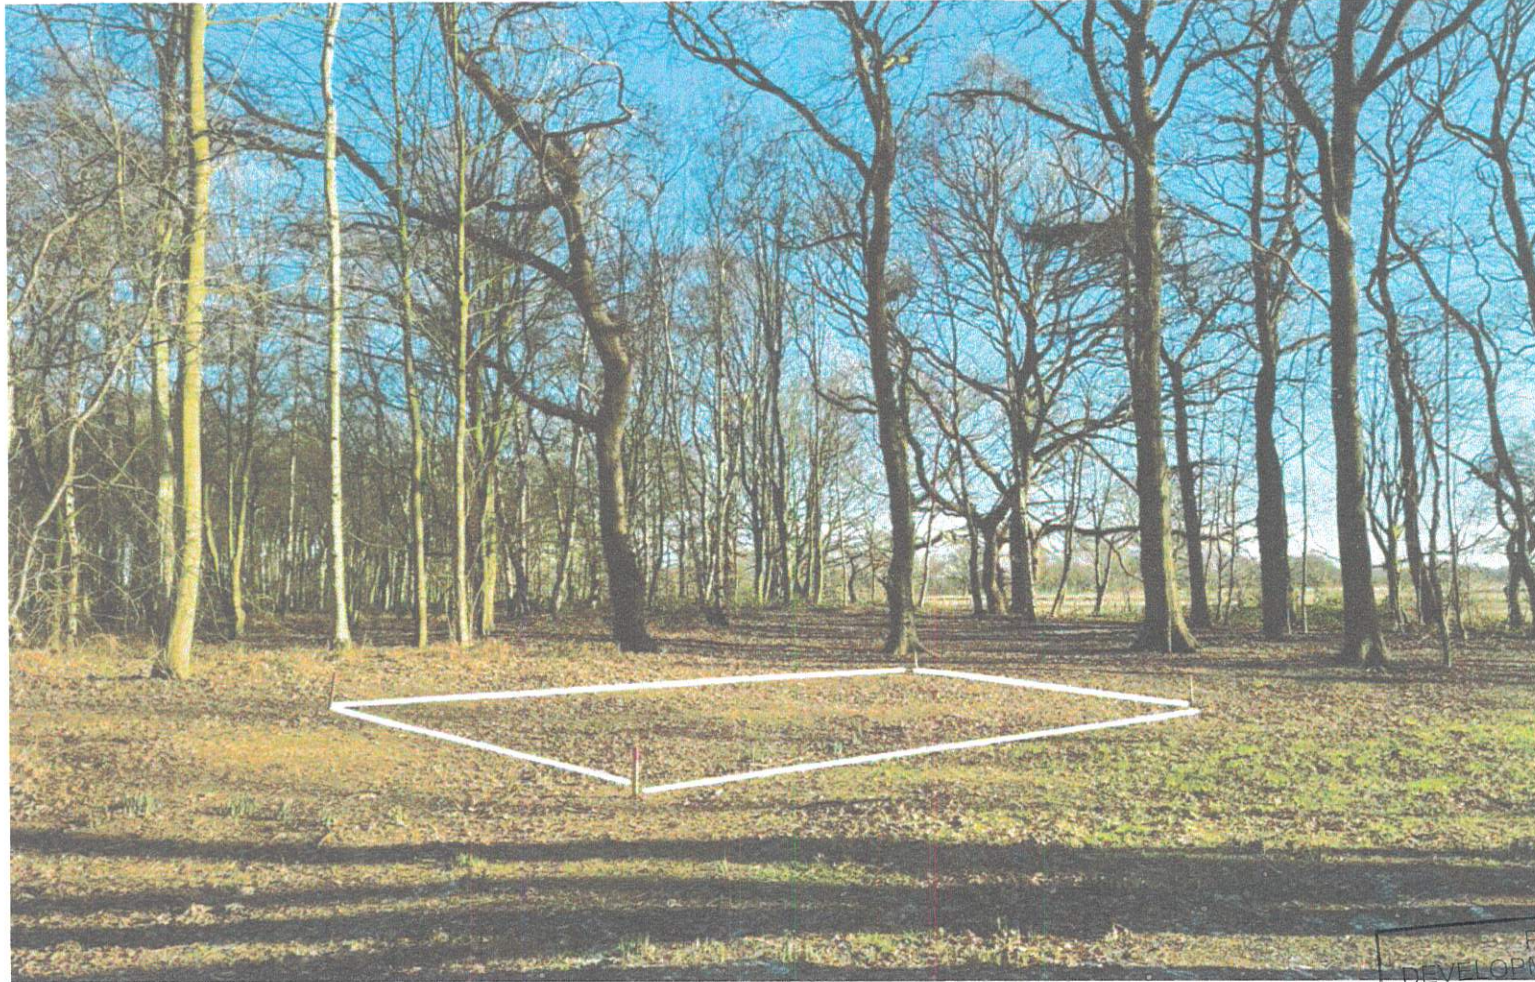
4.5 Lodge positions within the Wood - The lodges have been located within existing open areas within the woodland. The main trees adjacent to the lodges have been surveyed and are listed in the tree schedule and shown on plan 2A. The root protection areas for some of the trees does extend beneath the lodges. However, none of the root protection areas are significantly impacted by the location of the lodges and the design of the foundations of the lodges has taken into account the roots of the trees, see section 4.6 for further information.

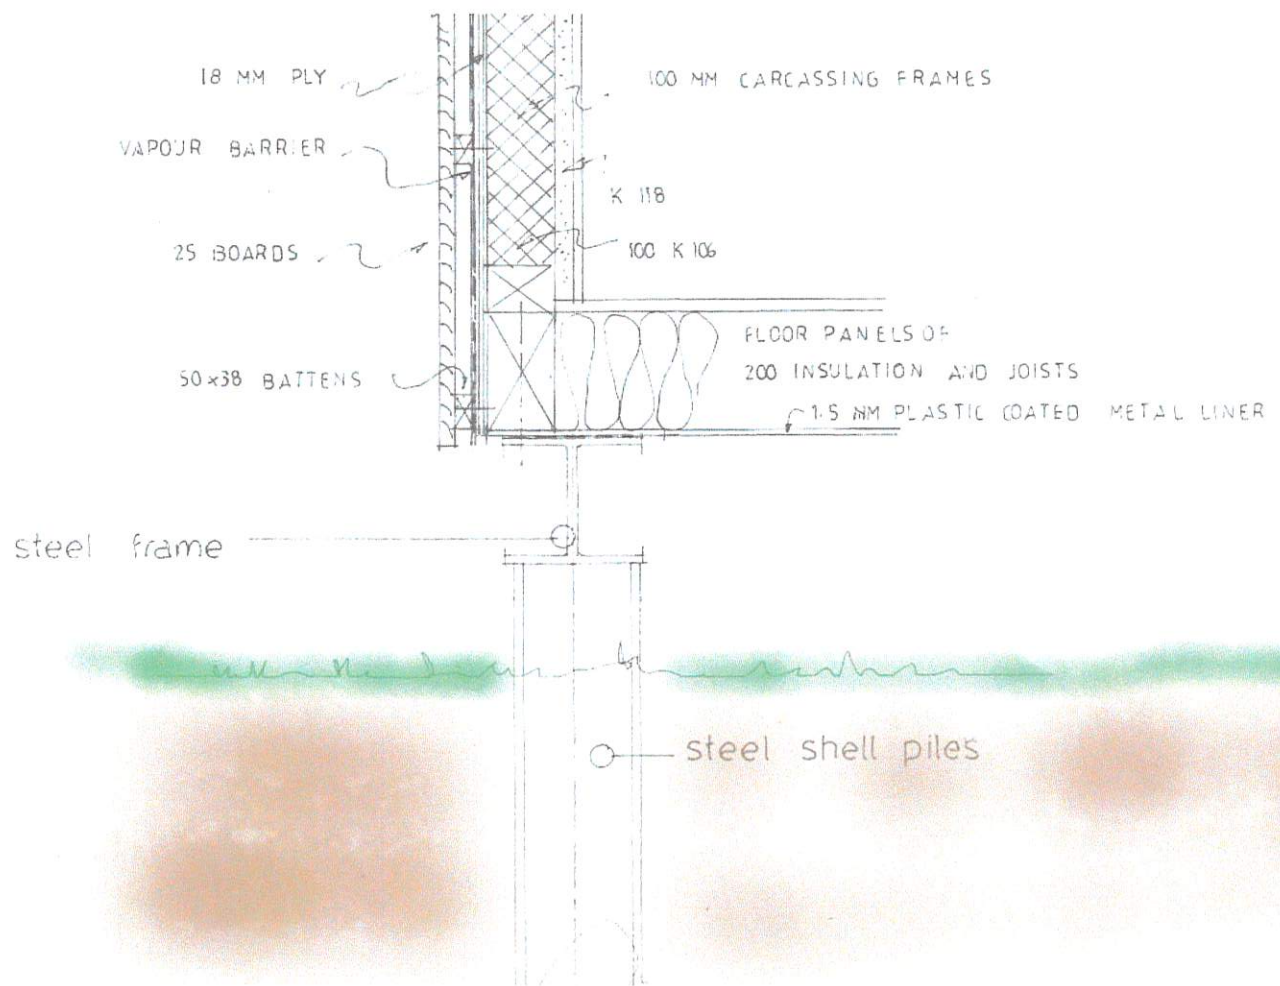
The lodges have been located in existing open areas within the woodland designed to have minimum impact on the roots of trees with steel piles supporting the frames of the lodges in an elevated position above ground as illustrated in the plan below. Other than the small piles no excavations will be required for the foundation work.

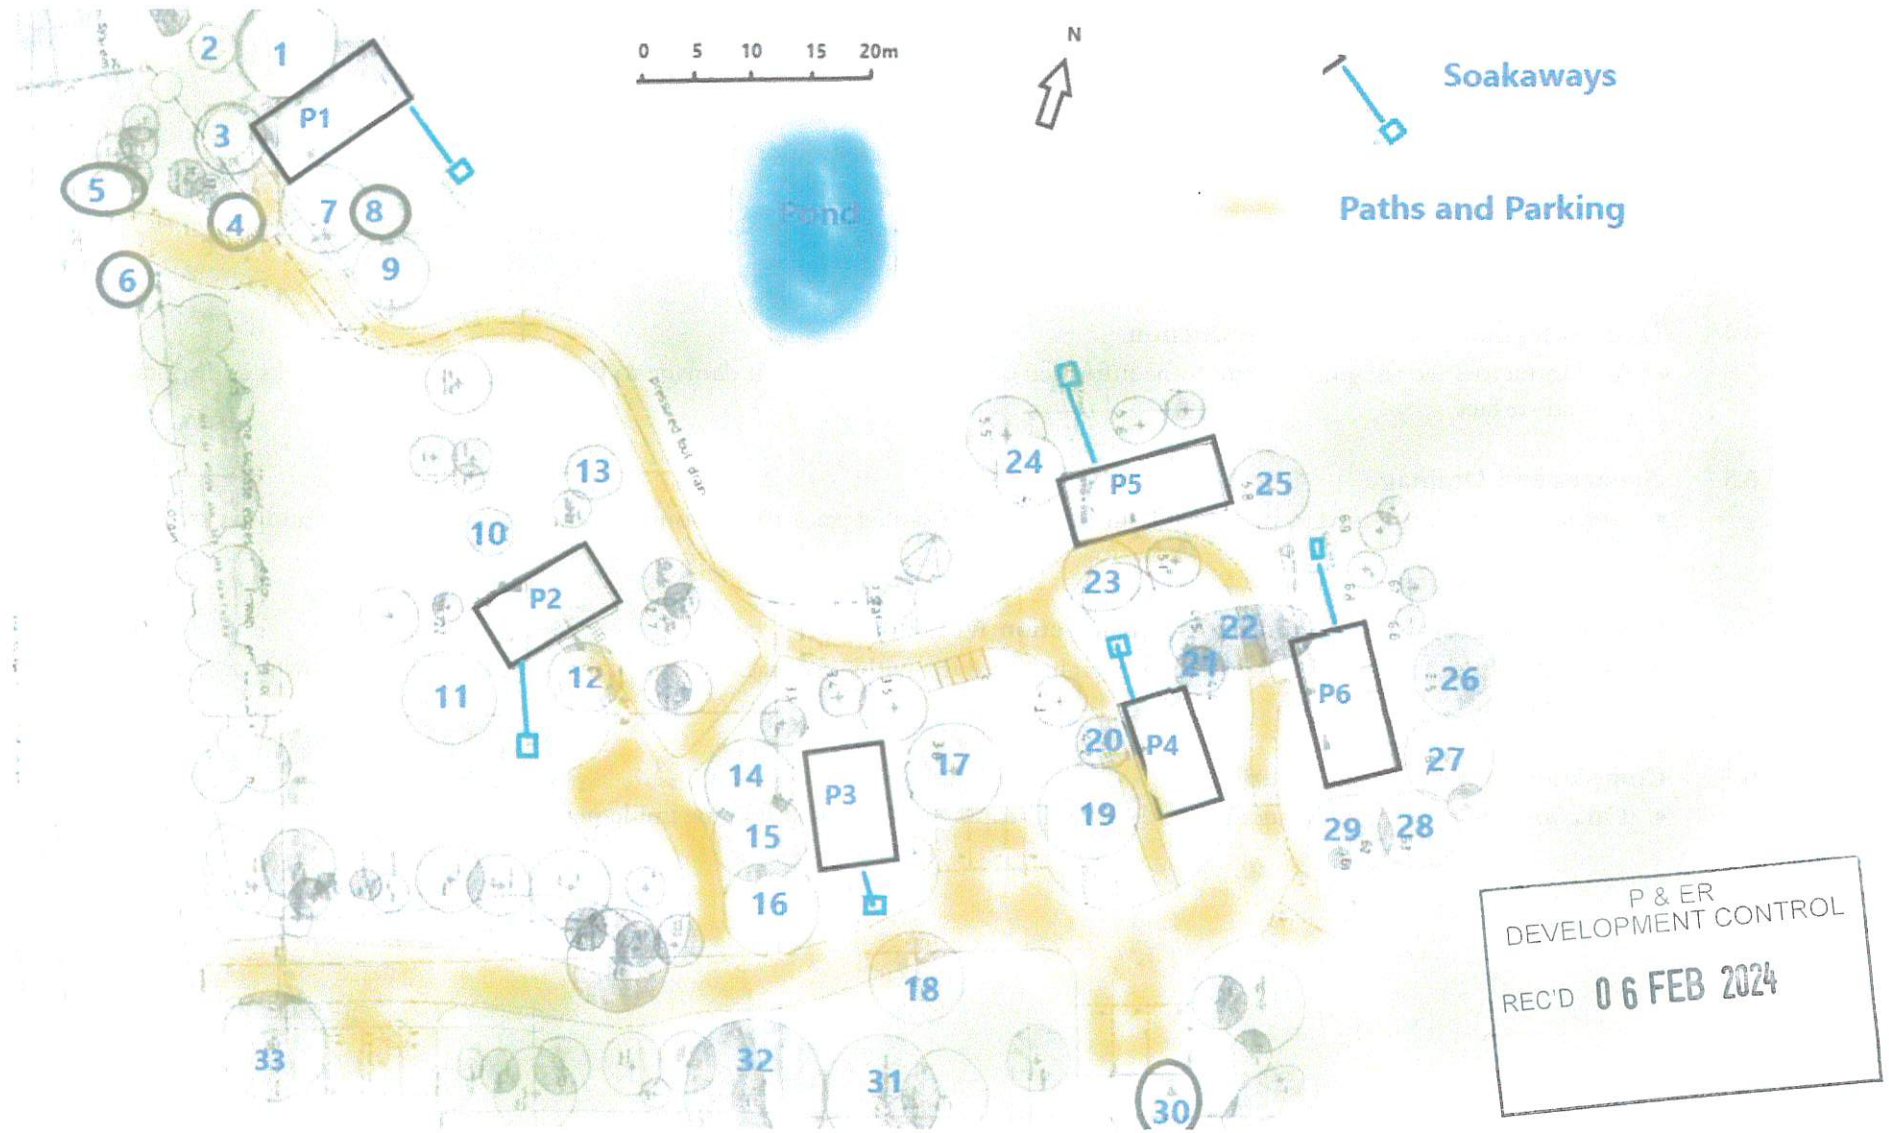
5.0 TREE PROTECTION (Plan 3A)

Given the wooded nature, layout and construction methods the use of traditional tree protection fencing would not be practical. The most appropriate method would be to ensure the care of trees through information provided to contractors at the pre-commencement and planning meetings.

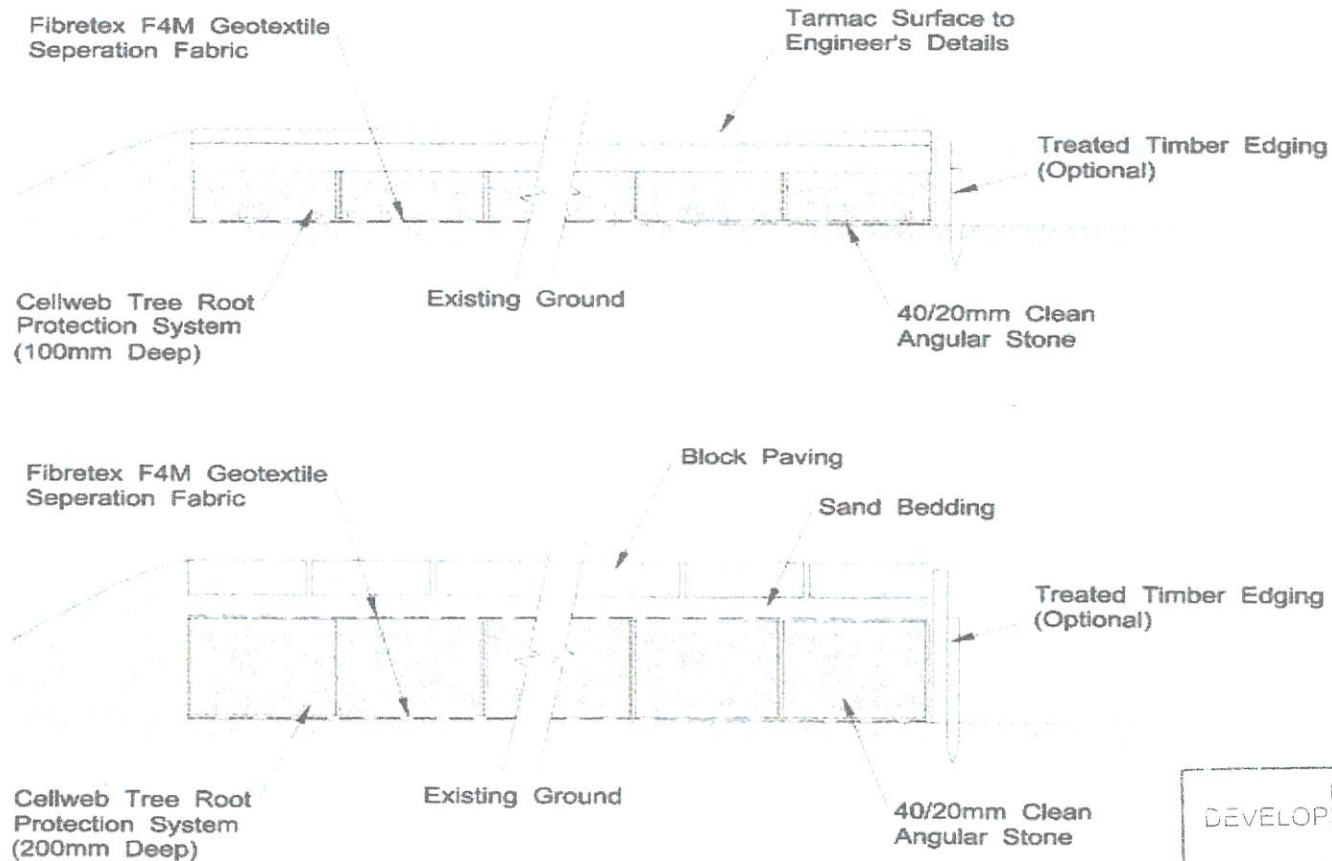
Appendix A - Creation of Low - Invasive Vehicular Access

The access drive construction to comply with **British Standard 5837:2012 'Trees in relation to construction'**. Low-invasive vehicular access in proximity to trees. One such product that is suitable is the CellWeb, tree root protection system that allows for a variety of surface materials although crushed stone in this instance would seem a suitable finished material. Examples of the CellWeb construction system are shown below. A 200mm deep construction depth would be required to allow for construction vehicles.
