Arboricultural Impact Assessment

Tree Survey at:

York Road
Wilberfoss
York

Job Ref: 23019

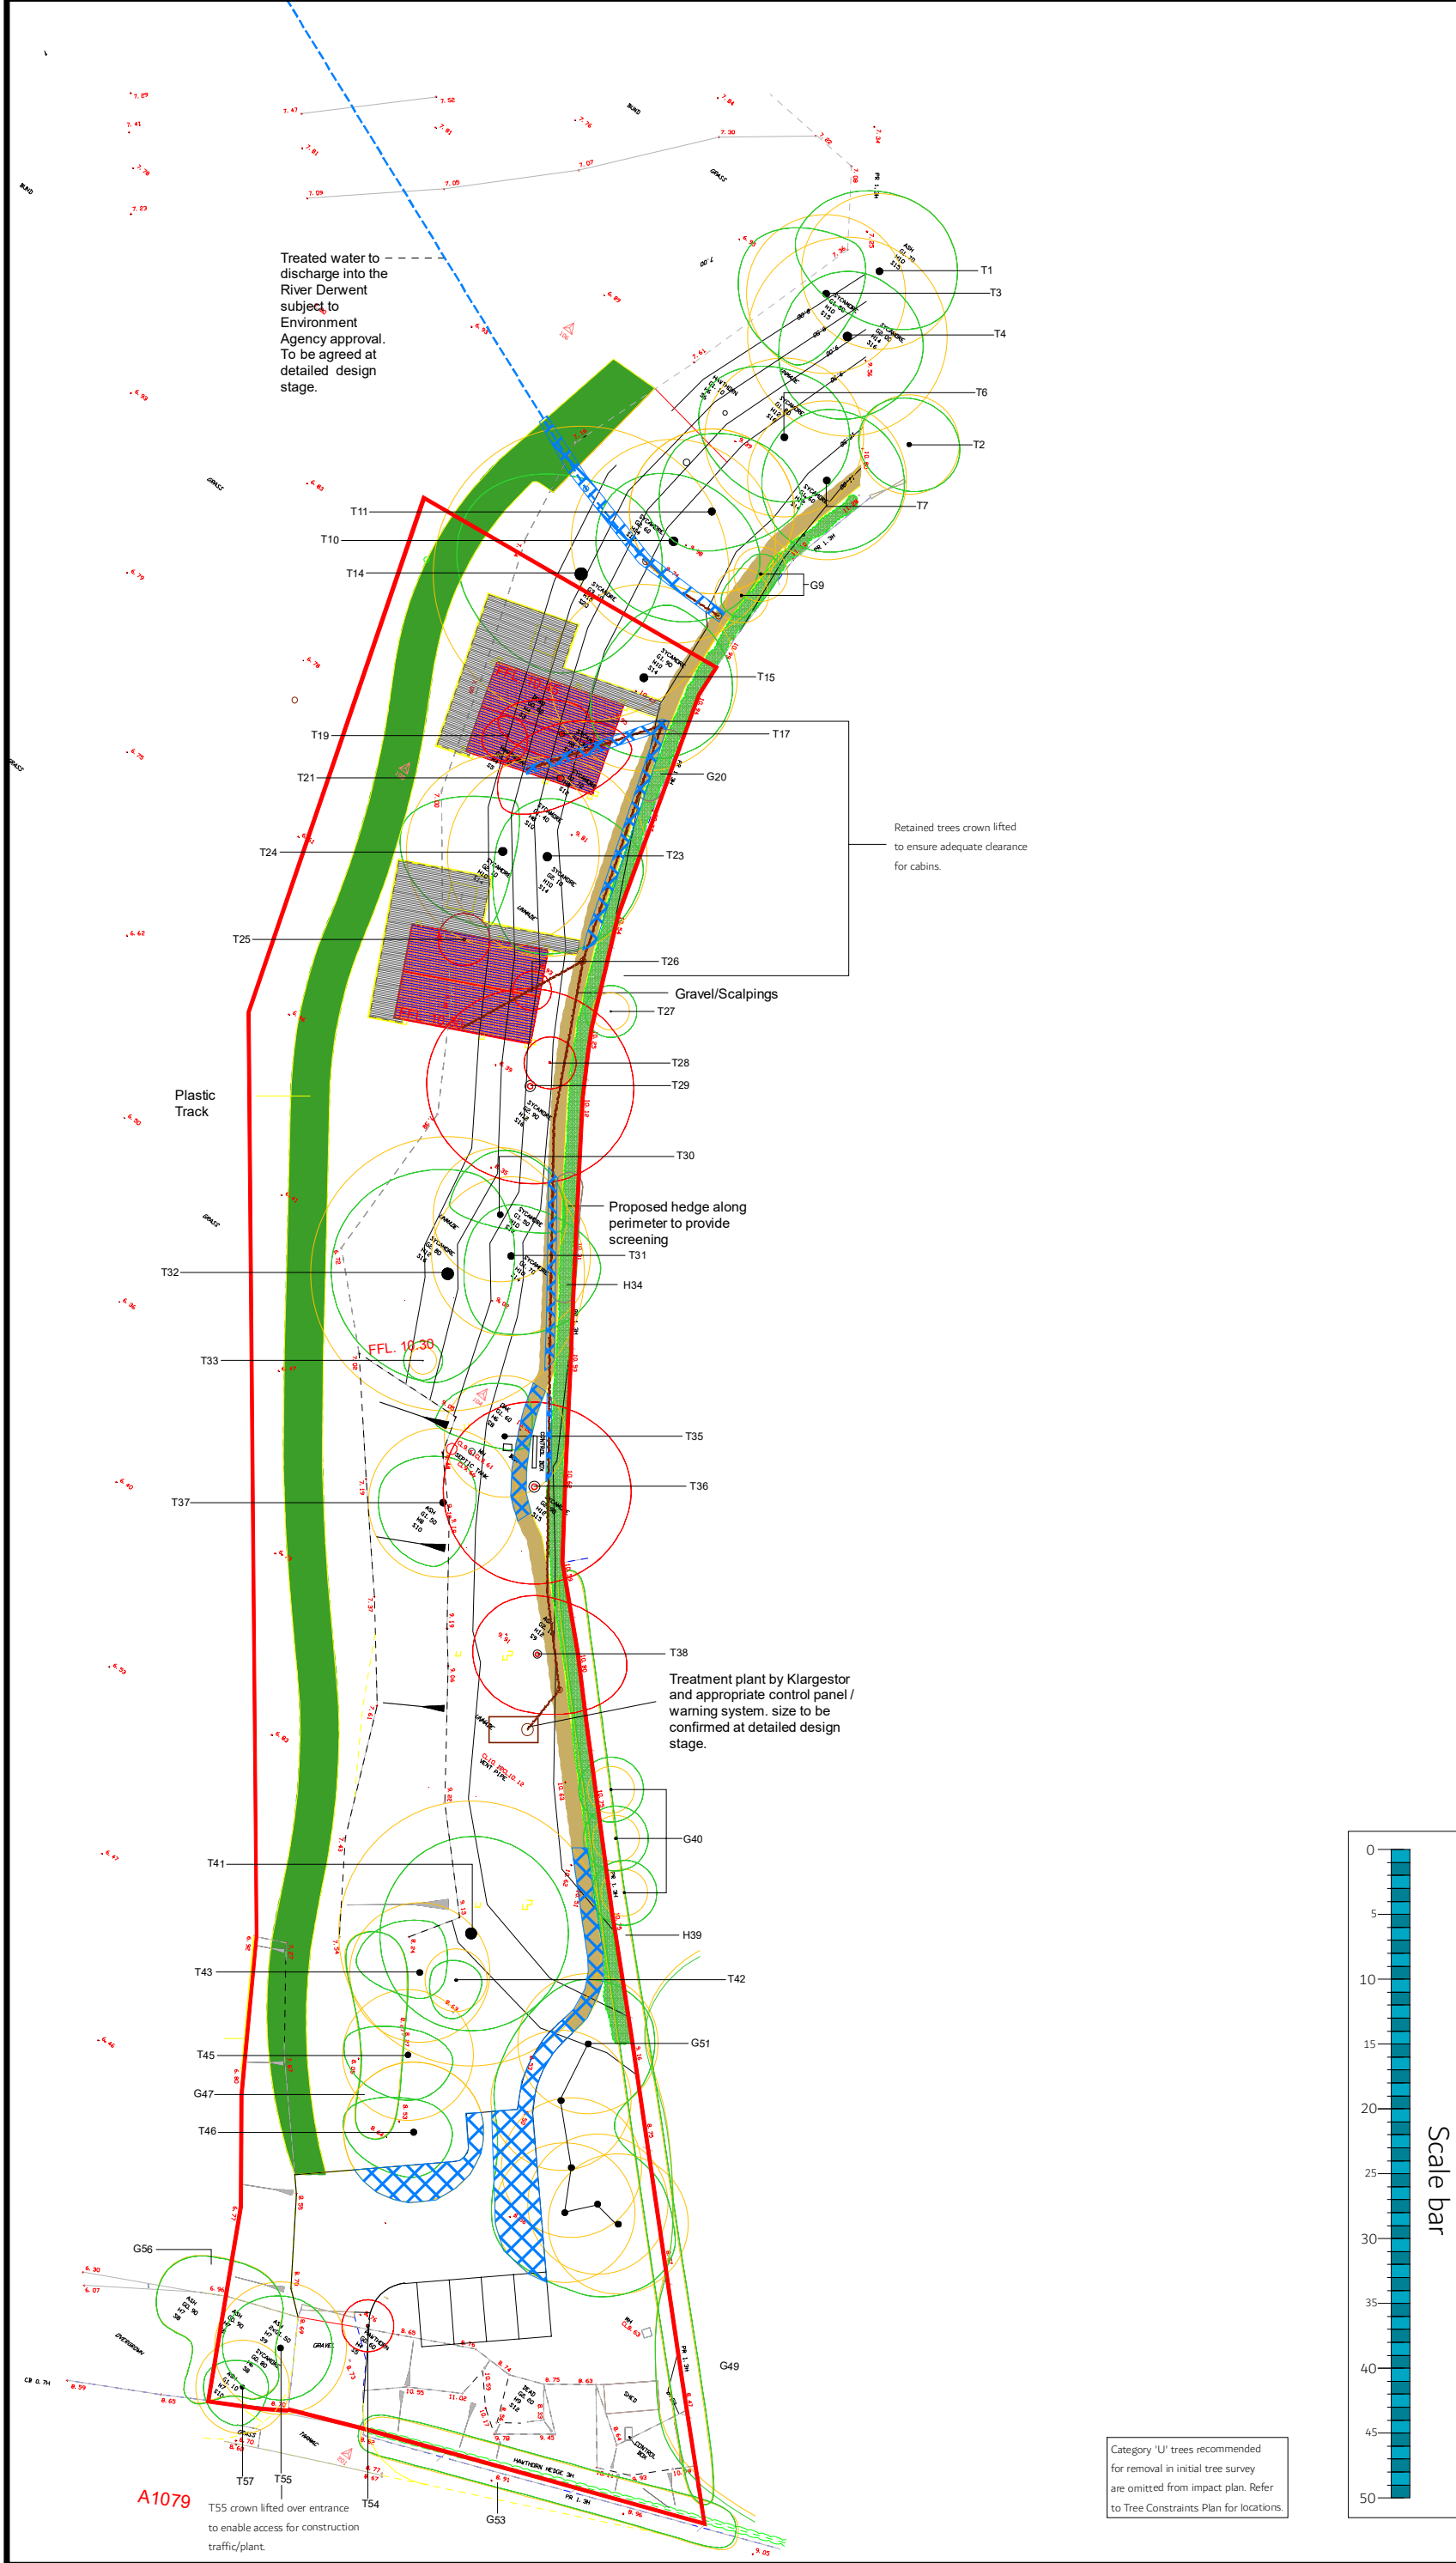
Appendix 2: Tree Impact Plan

Retained trees crown lifted to ensure adequate clearance for cabins.

A1079 T55 crown lifted over entrance to enable access for construction traffic/plant

Category 'U' trees recommended for removal in initial tree survey are omitted from impact plan. Refer to Tree Constraints Plan for locations.

- 6.1 In addition to the removals, some tree works are required to facilitate the development. T14, T15, T23 & T24 will be crown lifted to a height of 3.5m, to provide suitable clearance for the proposed cabins.
- 6.2 T55 is located immediately adjacent to the entrance of the site and will be crown lifted to a height of 5m. Given the existing high crown of this tree, this work is unlikely to adversely affect its health in the long term. This work is required to facilitate access for the vehicles, construction plant and machinery required for the development.
- 6.3 Where the proposed drainage run is routed through the RPA of trees (but their retention is still viable), hand digging with root pruning will be undertaken, under supervision by the appointed arboriculturist. This will impact the following trees: G9, T10, T11, T14, T15, G20, T23, T24, T30, T31, T32, H34 & T35.
