Tree Constraints Survey

Chestnut Farm Old Wood Skellingthorpe LN6 5UA

On behalf of: Fytche-Taylor

Ref: TCR-FT-CFS-0224-1

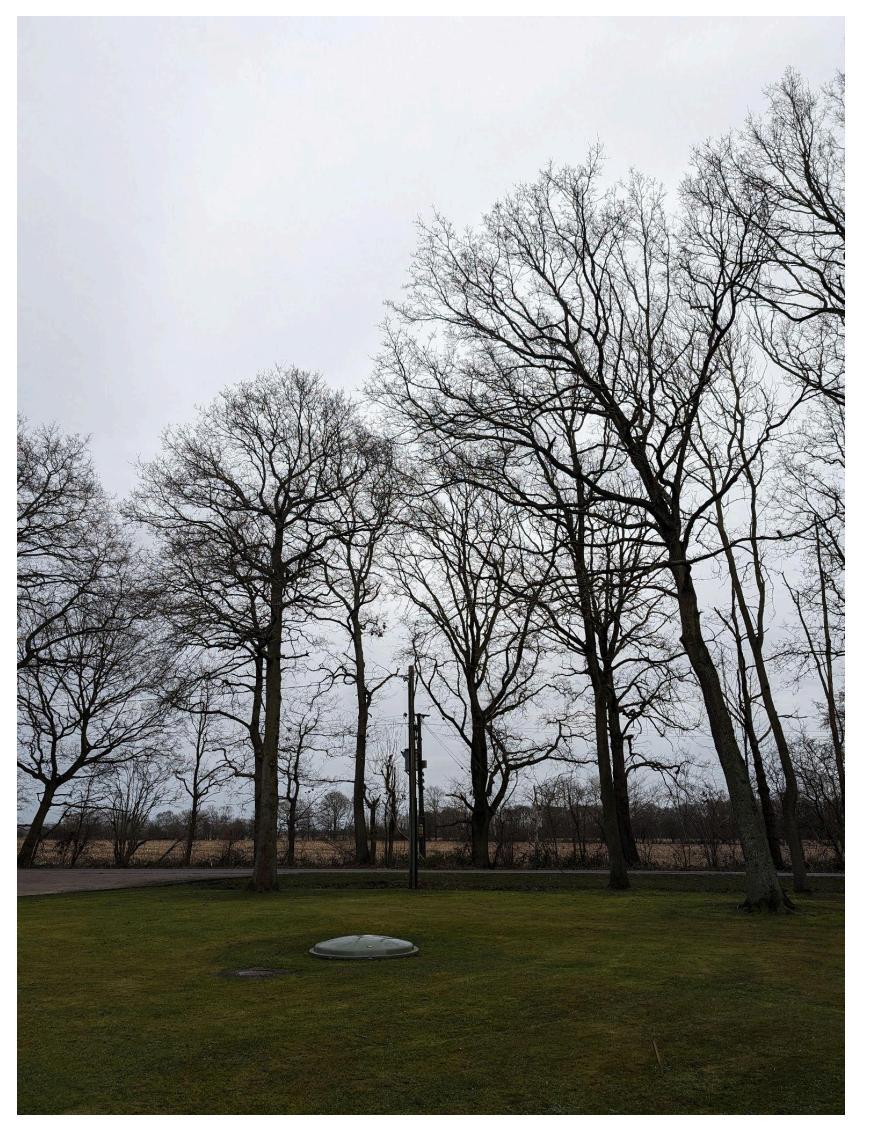
Picture 1: Looking southeast into a group of trees at the end of the property.

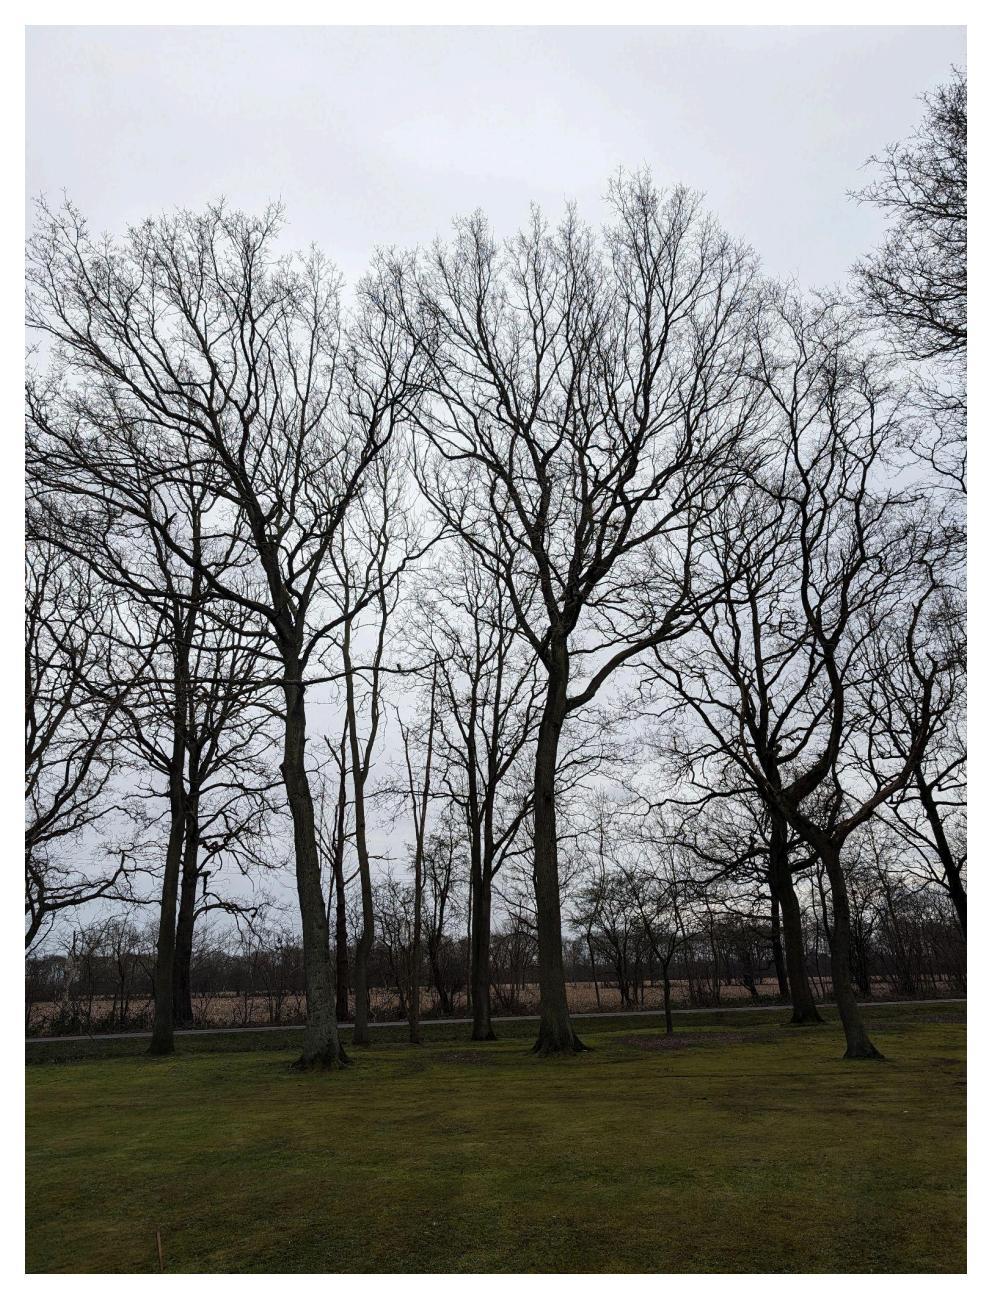
Picture 2: Looking southeast into a group of trees at the end of the property.
