Arboricultural Impact Assessment

23 Grantham Road, Bracebridge Heath

OAS 23-366-AR01

February 2024

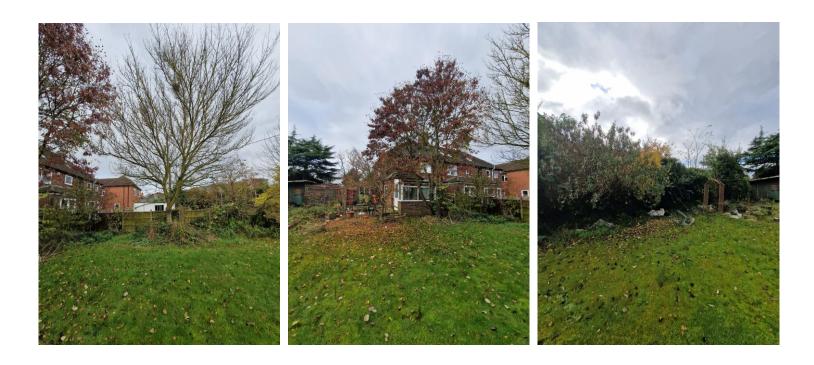
Views of T5, T5 & T6 and G1

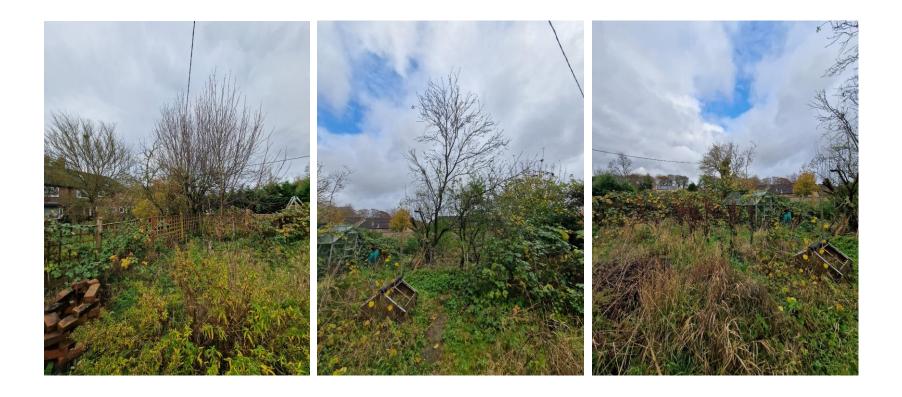
Views of T11 & T12, T8 and T10

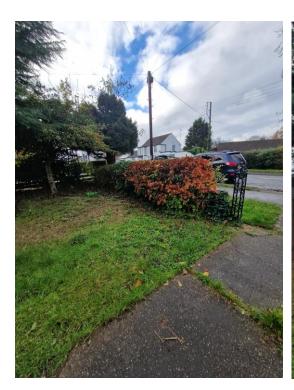
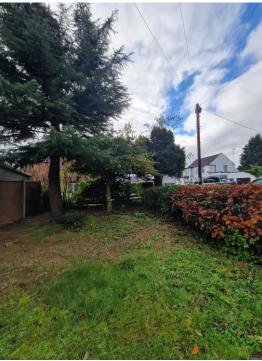
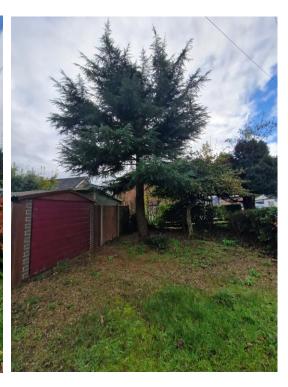
3.1.2 The proposal will see the removal of T1- T3 to accommodate the layout, all are of low overall value and their removal would have no impact on arboricultural or landscape values of the area.

Views of T1- T3
