Application for listed building consent
10/02/2024
Volker & Luise Seeker

Repointing

Installation of a ventilation system in the upstairs bathroom

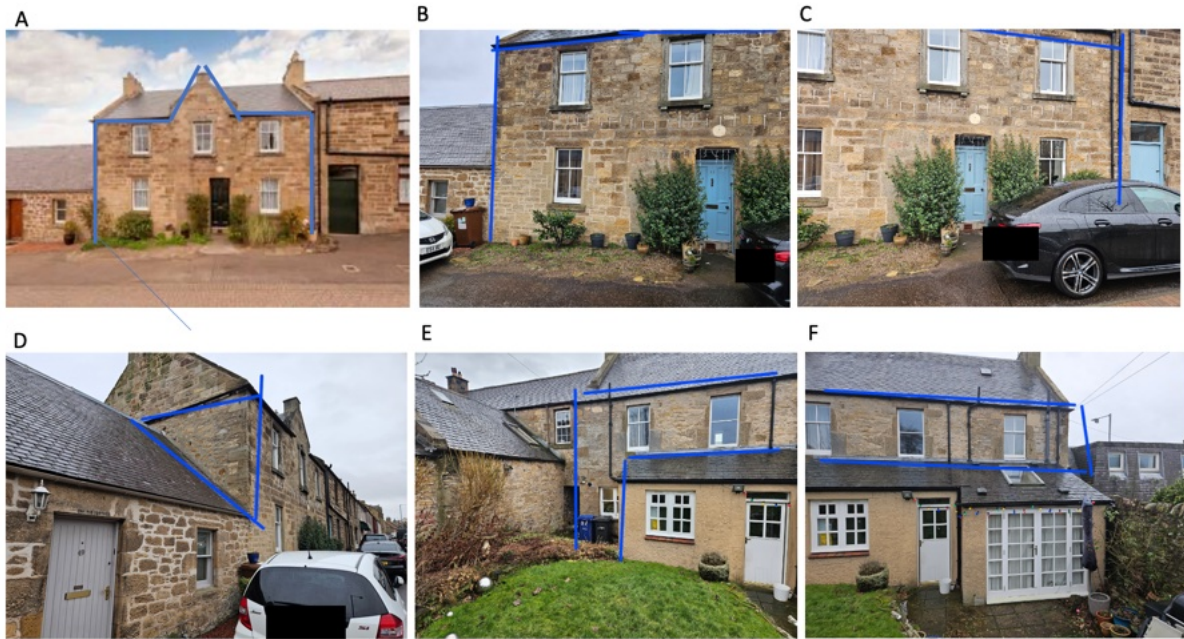
The blue areas in the photos below will be addressed by the stonemasons. They include the entire front elevation, two triangular areas underneath the gutters on the left side of the building (the area above the gutter was correctly repointed with limestone mortar when the chimney was repaired years ago), the entire original back elevation of the building, the right side of the building including inside the vennel. Below, we also show more detailed photos of the current condition of our house's stonework.

Figure 1: Areas of the house that require re-pointing. (A-C) Front elevation. (D) Left side of the house. Two equal triangular areas underneath the gutters require re-pointing, whereas the area above the gutters is correctly pointed with limestone mortar. (E-F) Back elevation. The extension does not require re-pointing.

We received two quotes from expert stonemasons to scrape away the concrete pointings, replace them with limestone mortar and repair broken sandstones all around the building. The concrete pointings trap the humidity inside the walls and do not allow them to ever completely dry. New pointings will over time allow humidity to evaporate and the walls to dry.

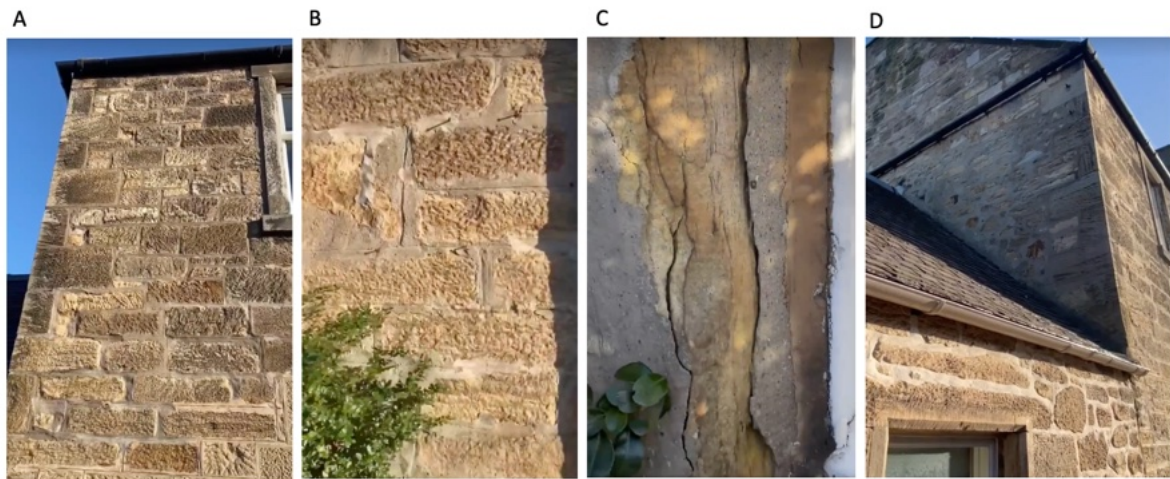
Figure 2: Concrete pointings. (A-D) Very wide concrete pointings that in some areas cover the sandstone and in others are severely cracked.

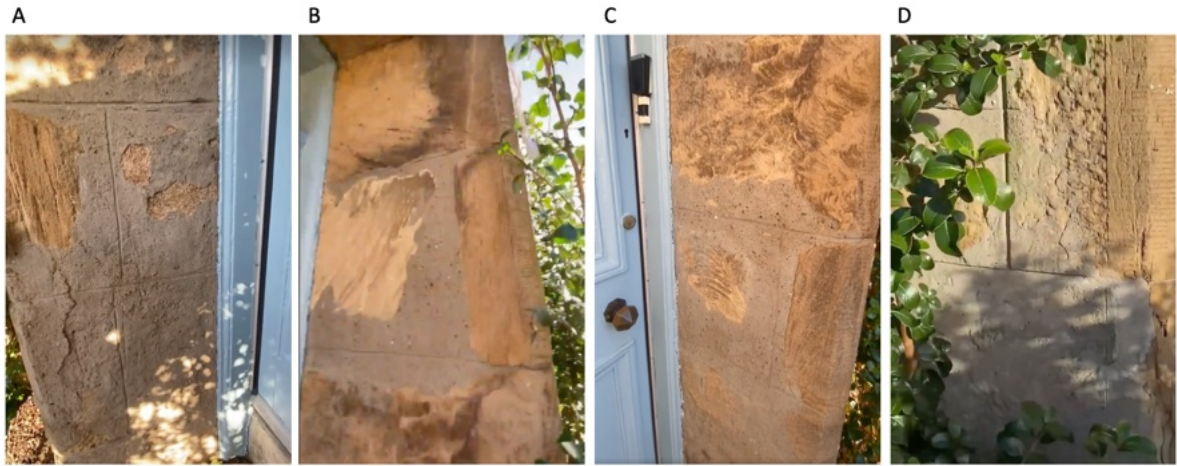
Figure 3: In several areas, the concrete covers whole stones which is for example apparent around the entrance door (A-D).

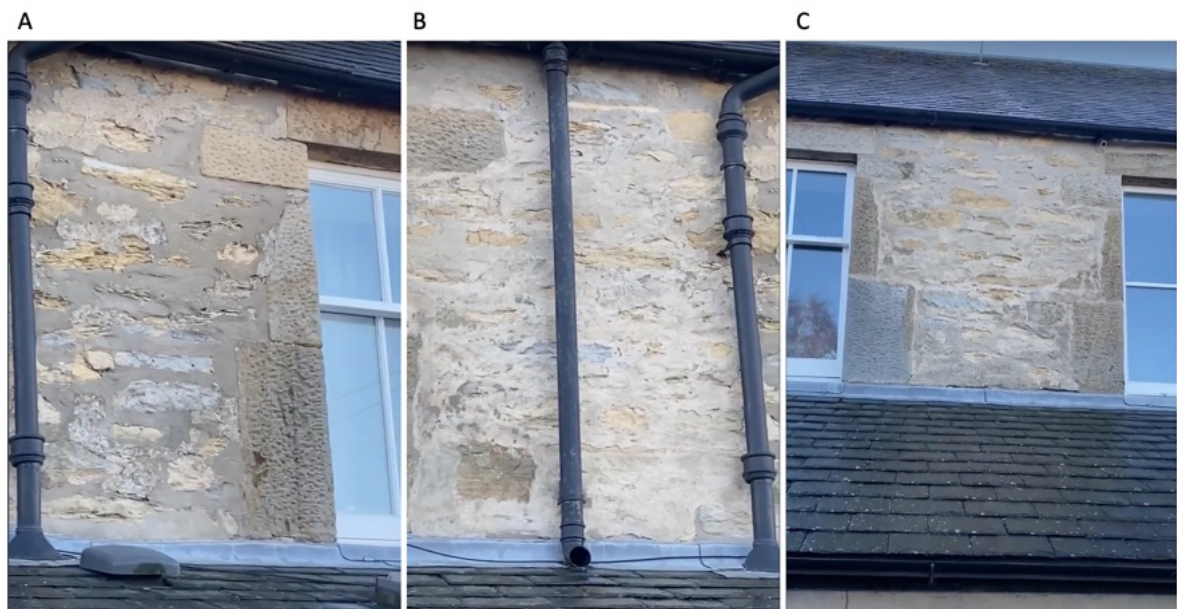
Figure 4: The rear elevation shows very wide concrete pointings that in areas cover considerable proportions of the sandstone.

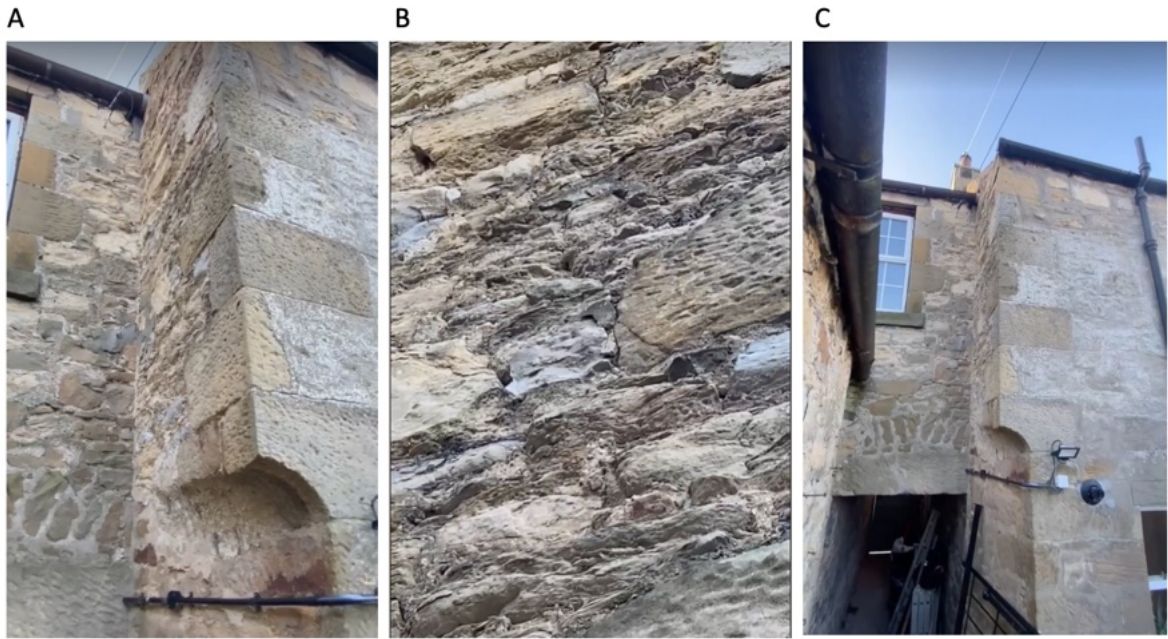
Figure 5: In certain areas, the stones are eroded and need to be repaired (A-C). C shows the entry of the Vennel that also requires re-pointing.

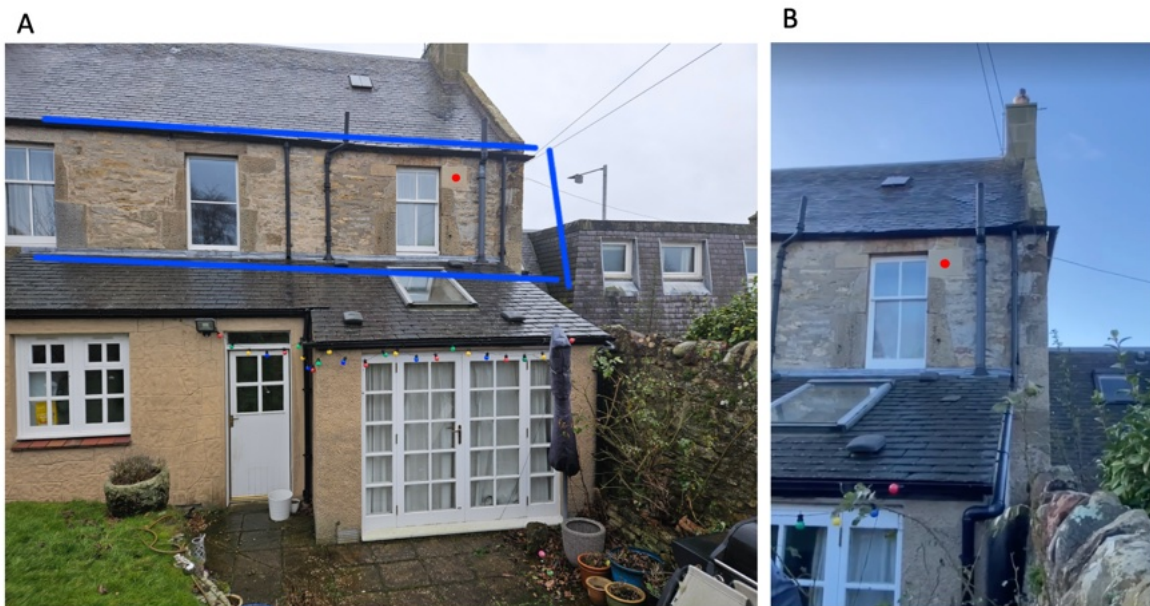
The dampness report pointed out that the ventilation in the upstairs bathroom should be improved. We currently have an electric vent in the bathroom which, however, vents into the loft where humidity can cause further problems.

Figure 7: Position of the proposed vent in the rear elevation marked as red spots. The diameter will be 100 mm.

We plan to replace the old fan with a continuously running humidistat fan (envirovent) that vents in a 100 mm thin duct directly outside. The photos below show where the external part of the vent will be positioned in the rear elevation.

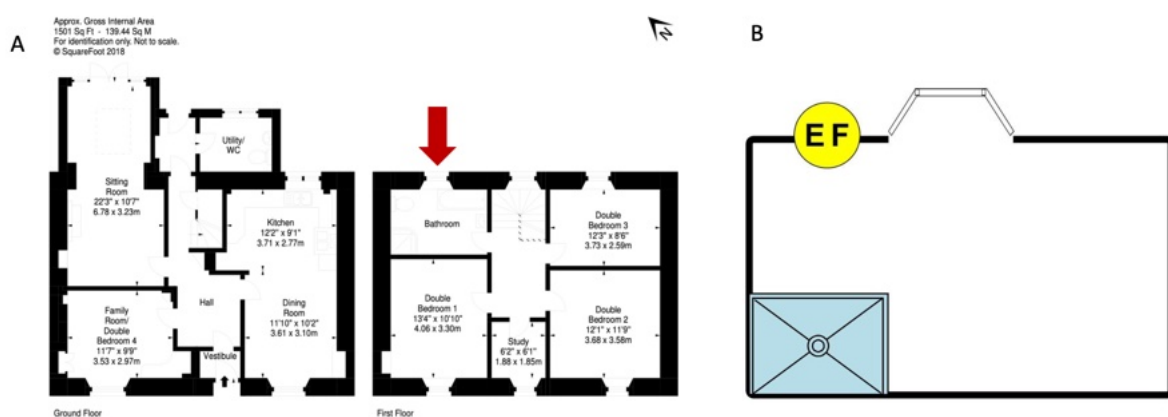
Figure 8: Floor plans. (A) Floorplan of the house. The red arrow points to the bathroom where the extractor fan will be installed. (B) Upstairs bathroom. EF: Extractor fan.
