**Bluegate Works
Stanley Way
Skelmersdale
WN8 8EA**

**Full Arboricultural Assessment
for
Development
(BS 5837:2012)**

February 2024

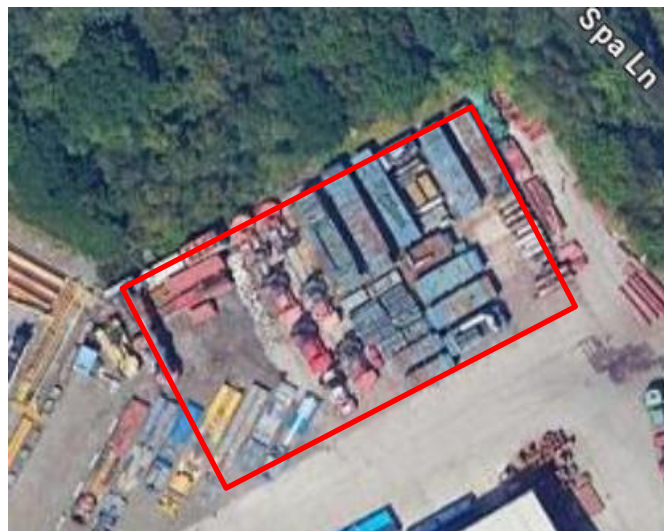
5.1.1 The area to be built on is already surfaced with a thick concrete apron for the most part and compacted crushed stone in other areas. Due to the amount of time this surfacing has been present and the age of the surrounding trees it is unlikely that there will be any root growth of significance beneath this surfacing. The below aerial view and the photos within Appendix Two shows the current use, surfacing and boundary trees:

5.1.2 The above data table indicates that there could be some encroachment within the RPA of G3 & G4. However, the RPA is based on maximum diameter of the trees within the groups and there aren't many directly to the rear of the boundary fence. There is hardly any encroachment over the fence and the narrow grass verge on the site side of the fence will remain intact. The above box illustrates the approximate location for the building.

5.1.3 Therefore, due to the heavily existing compacted area and lack of any significant overhang there is considered to be no material impact on surrounding trees. In addition, this is an industrial development where common tree nuisances are never really an issue.

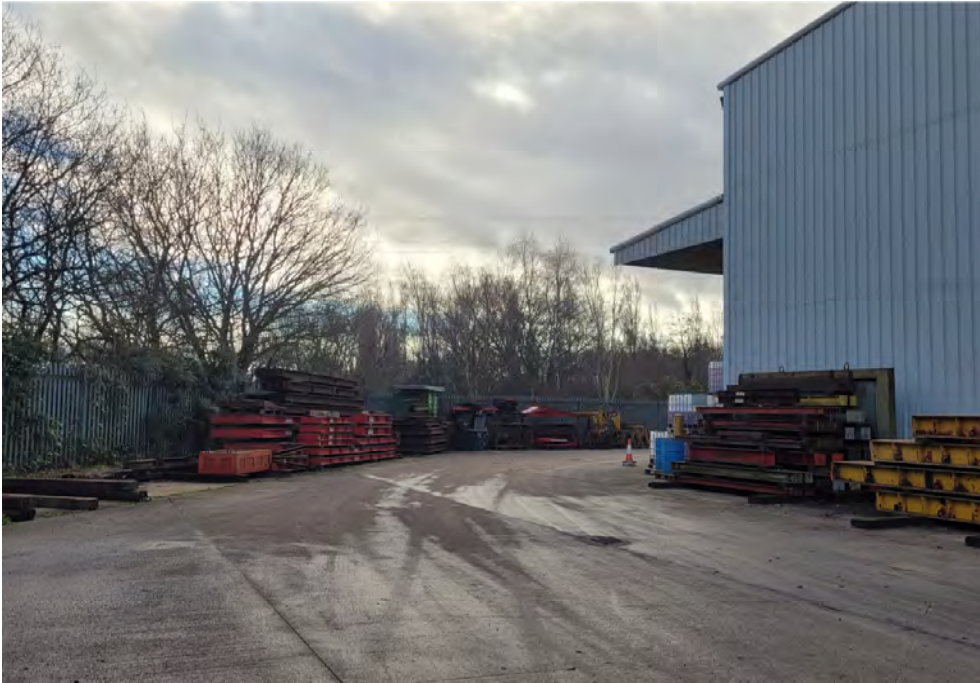
G3	Group - Oak, Willow, Alder & Silver Birch	<600	<15	SM-EM	6	6	6	6	1	B	A mixed group on bank area beyond perimeter fence sloping down to road. Some minor limb failure and typical deadwood present. Pre-dominantly Silver Birch with several larger Oak trees present, particularly to the south of the group. Previous pruning over road. Minor encroachment over site. Minor snapped Willow limbs. Several stems swamped in Ivy.	n/a	20+	B2	<162.86	<7.20
G4	Group - Oak, Willow, Alder & Silver Birch	<600	<15	SM-EM	6	6	6	6	1	B	A mixed group on bank area beyond perimeter fence on higher ground, which appears man made. This is the edge of a much larger group with no real overhang or significant trees close to fence.	n/a	20+	B2	<162.86	<7.20
