Arboricultural Impact Assessment

Old Brickyard Farm, Great Horwood Road, Winslow

Bloor Homes South Midlands

JBA 21/303 AR01 Issue C

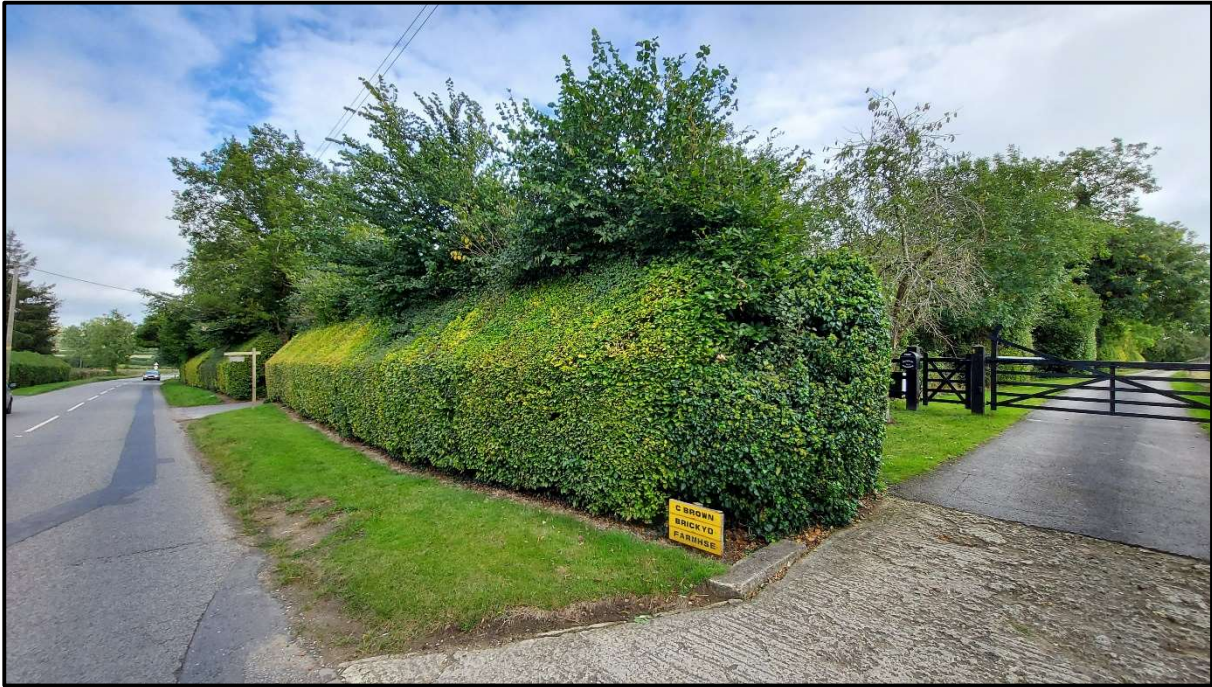
Photograph 1 (above). H1, mixed species (centre), located to the north of the main site entrance. Viewed looking towards the north-east.

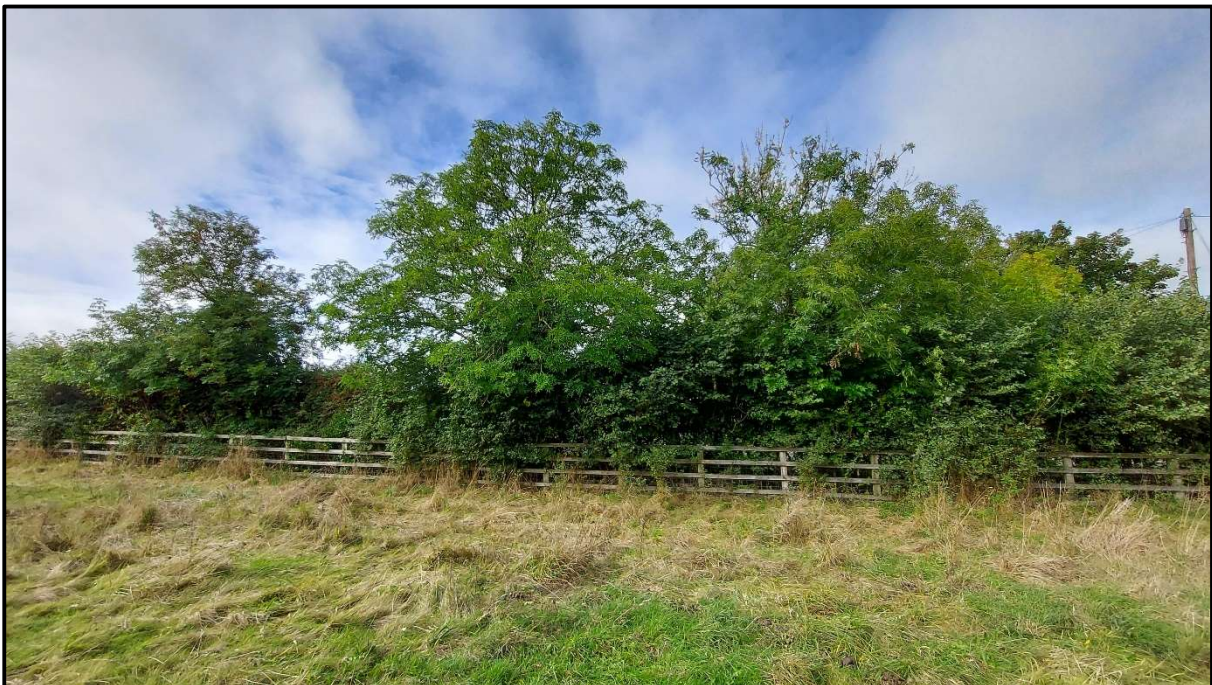
Photograph 2. G3, ash, located to the north of H2, elm, ash, hazel and blackthorn. Viewed looking towards the south-west.

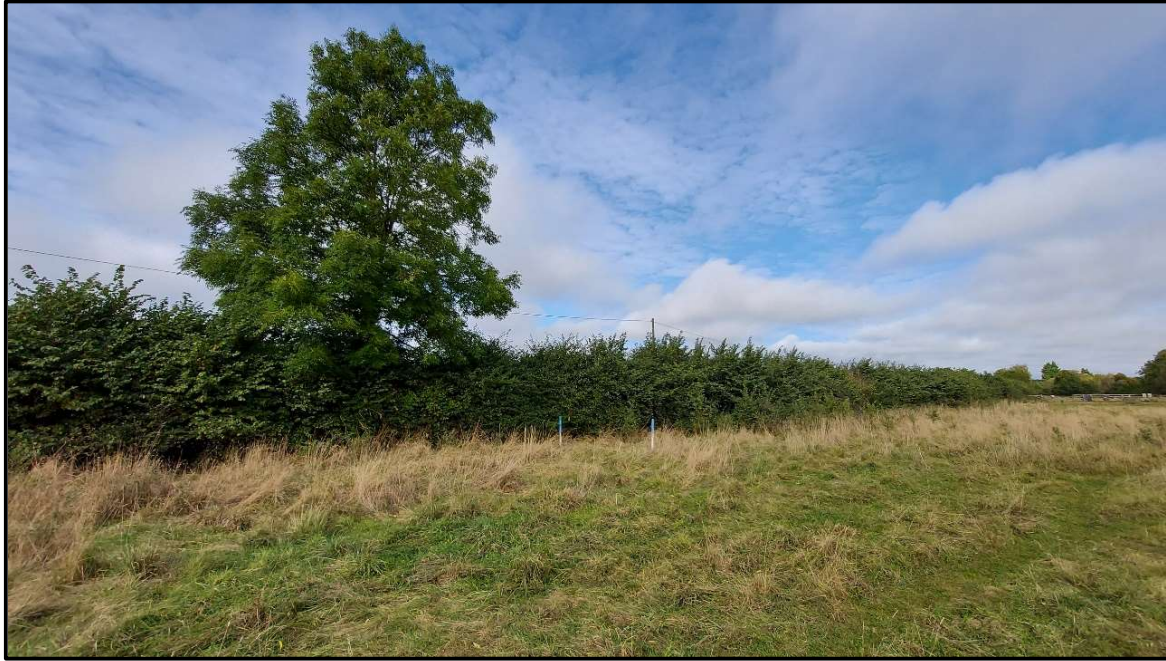
Photograph 3 (above). T4, ash, located to the south of H2. Viewed looking towards the north-west.

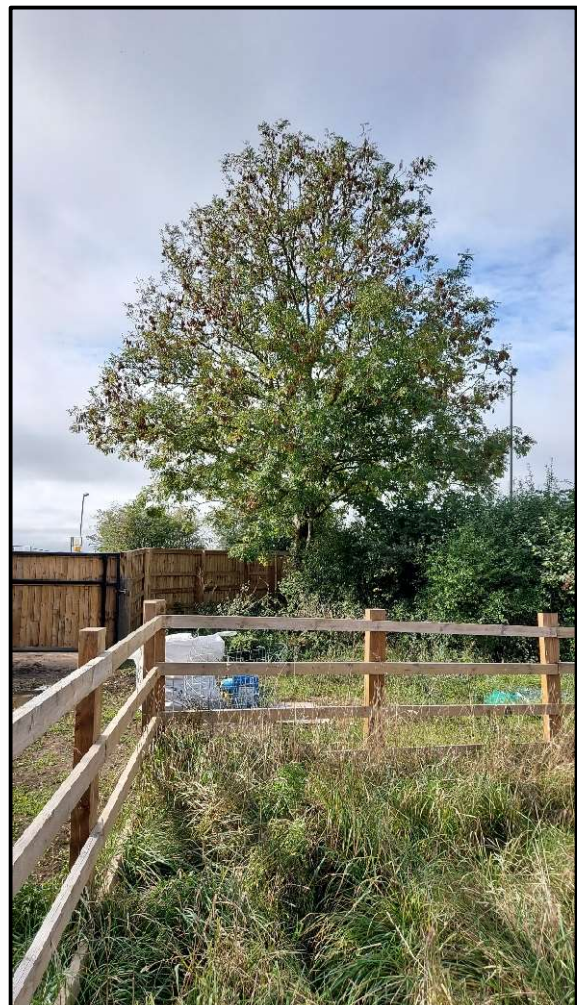
Photograph 4 (right). T6, ash, located in the southwest corner of the site. Viewed looking towards the west.

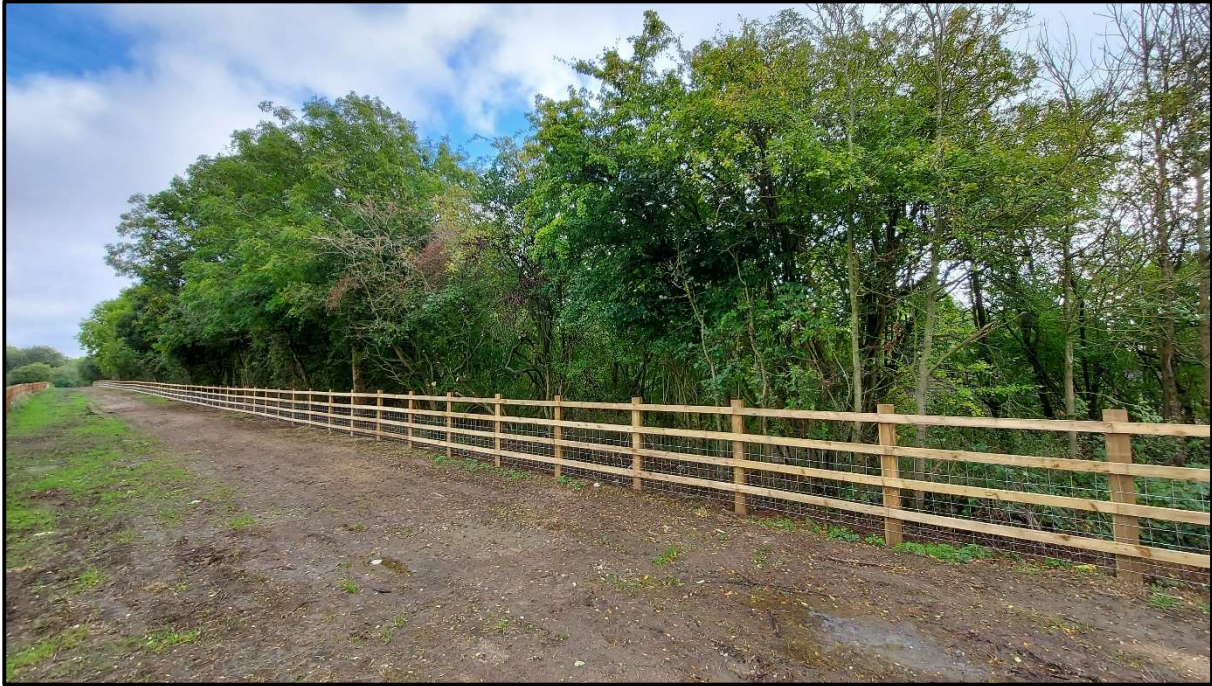
Photograph 5 (above). Woodland W7, mixed species, located along the southern boundary, showing T8, ash, (centre). Viewed looking towards the east from the far south of the site.

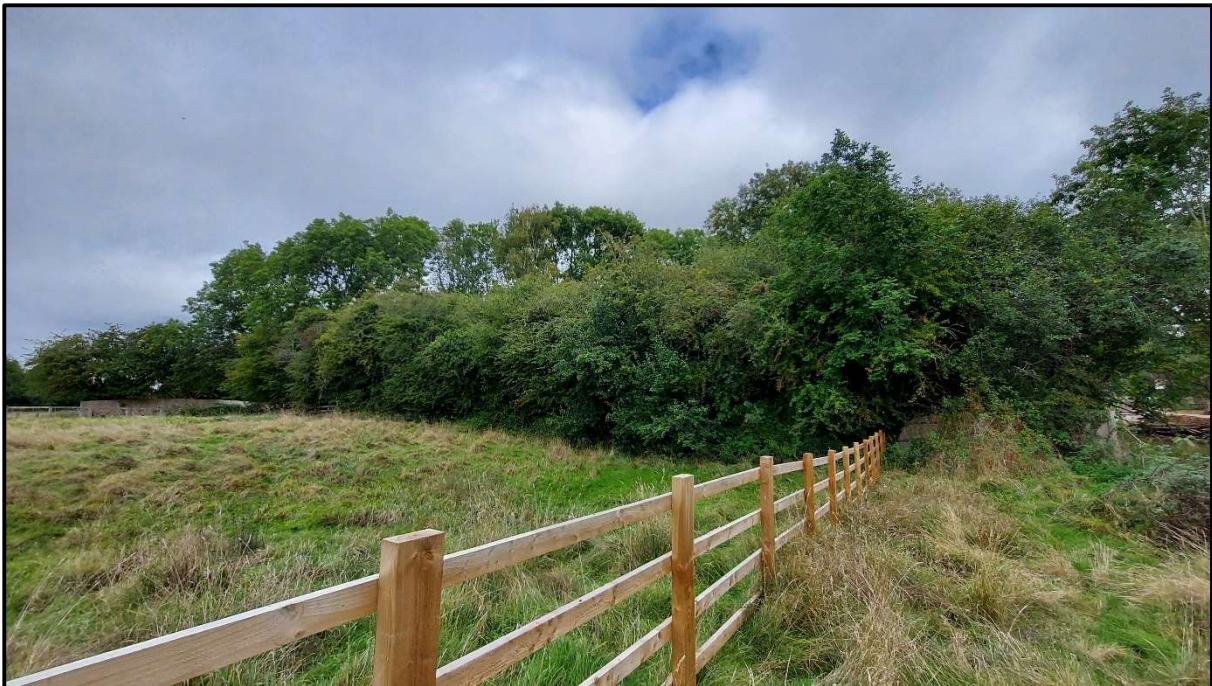
Photograph 6. Overview of G10, mixed species. Viewed looking towards the north-east from the central part of the eastern site boundary.

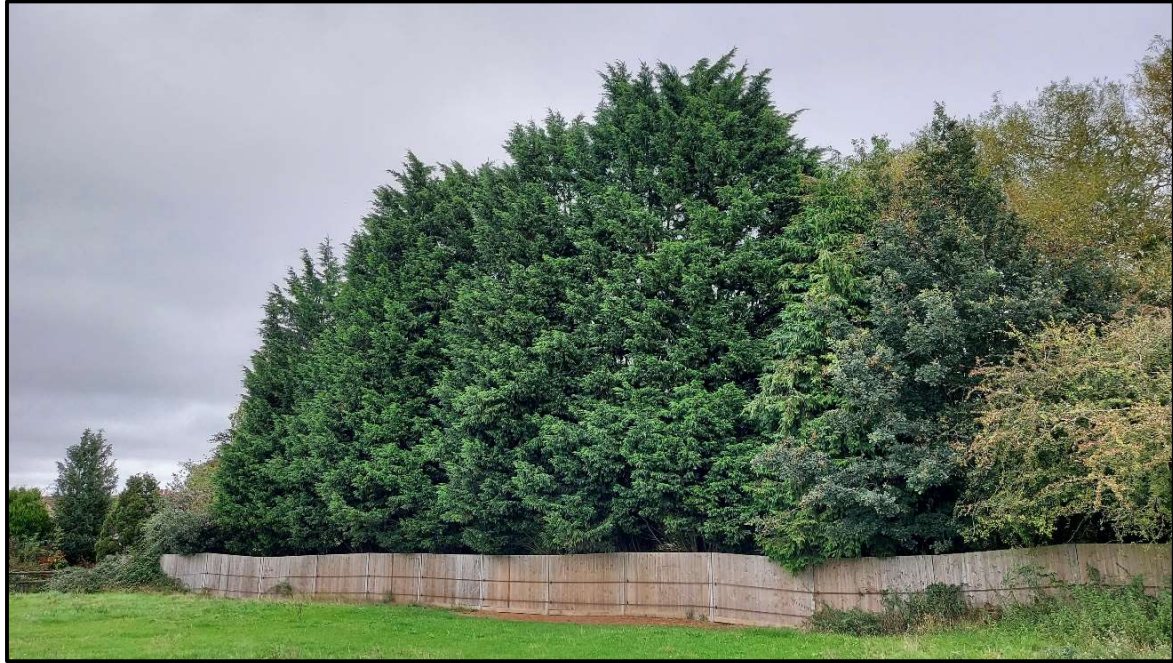
Photograph 7 (above). G12, Leyland cypress, located to the north of the eastern boundary. Viewed looking towards the northeast.

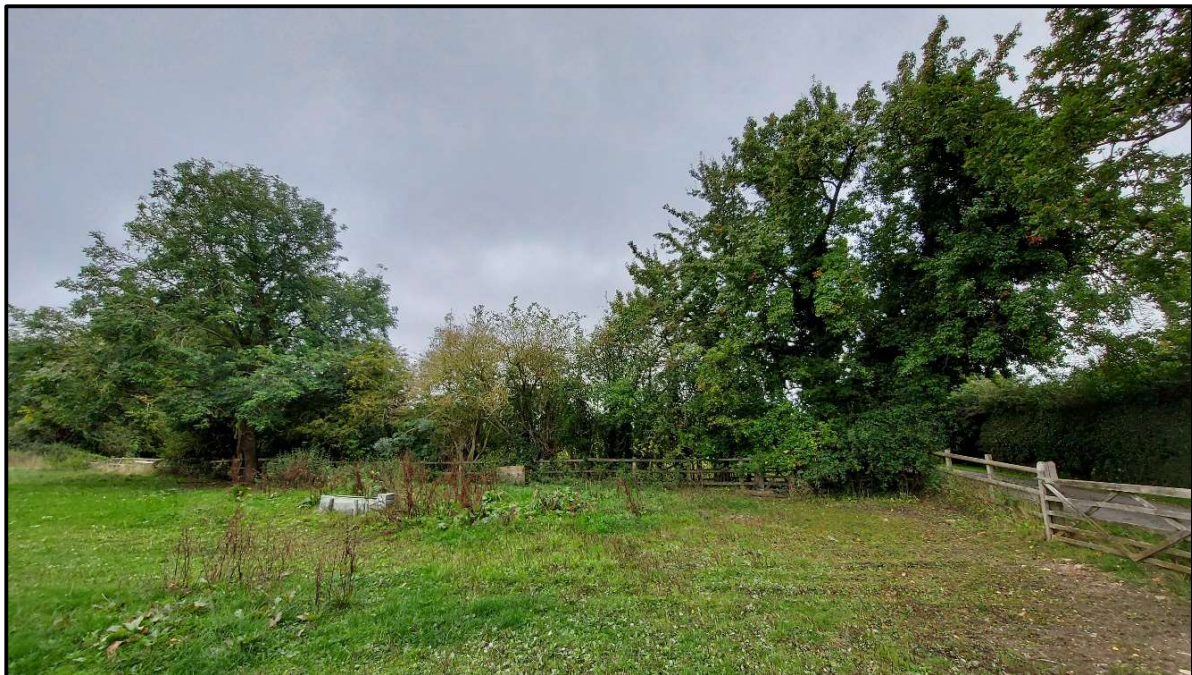
Photograph 8. T15, high quality apple (right) and northern section of G17 (left). Viewed looking towards the west.

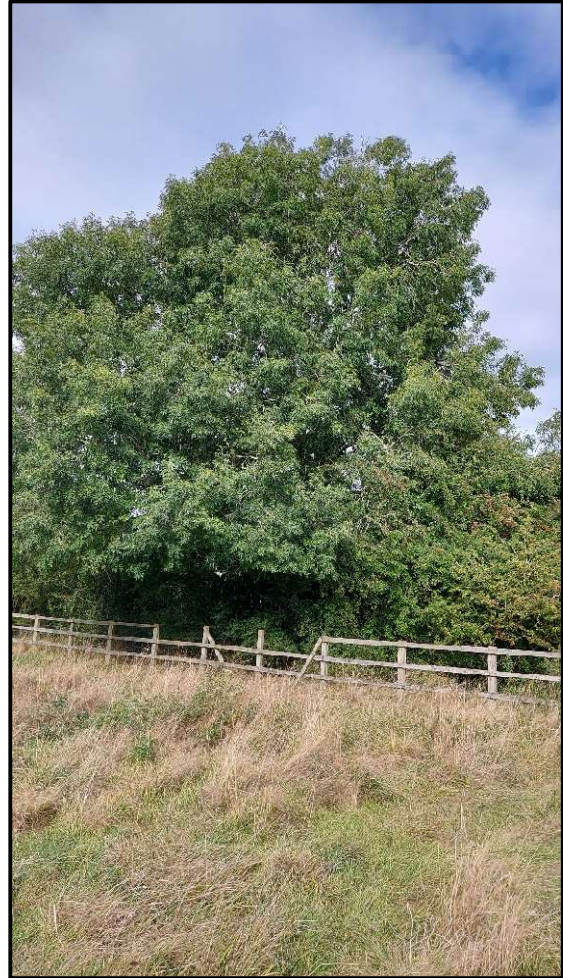
Photograph 9 (right). T22, ash. Viewed looking towards the northeast.

T22	Ash	M	720	18 (0)	-	10	12	10	10	Good	Dominant tree. Forms two stems at 3m with normally formed union.	No work recommended	40+	B1	8.6	234	
G23	Hawthorn Elder oak (Quercus robur) Lime (Tilia sp.) maple (Acer campestre)	English Field	M	360	6 (0)	-	5.0	5.0	5.0	5.0	Fair	Group with mutual crown formation. Maximum diameter recorded.	No work recommended	20+	C2, 3	4.3	59
G24	Ash Hawthorn	M	500	14	-	6.0	6.0	6.0	6.0	Fair	Group with mutual crown. Estimated maximum diameter recorded.	No work recommended	40+	B2,3	6.0	113	
T25	Ash	M	490 540	16 (2)	3 W	10	10	10	10	Good	Dominant tree. Forms two stems at ground level. V-shaped union and bulging. Good extension growth and crown density.	No work recommended	40+	A1	8.8	241

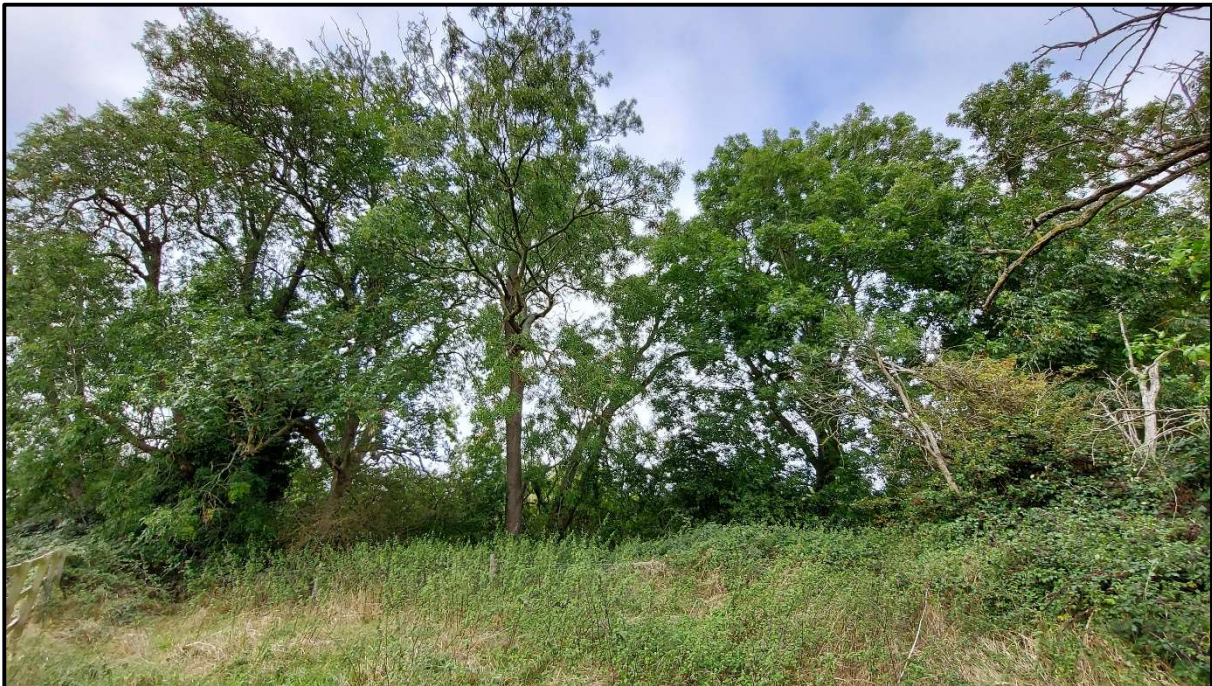
Photograph 10 (below). G26, ash. Viewed looking towards the northwest.

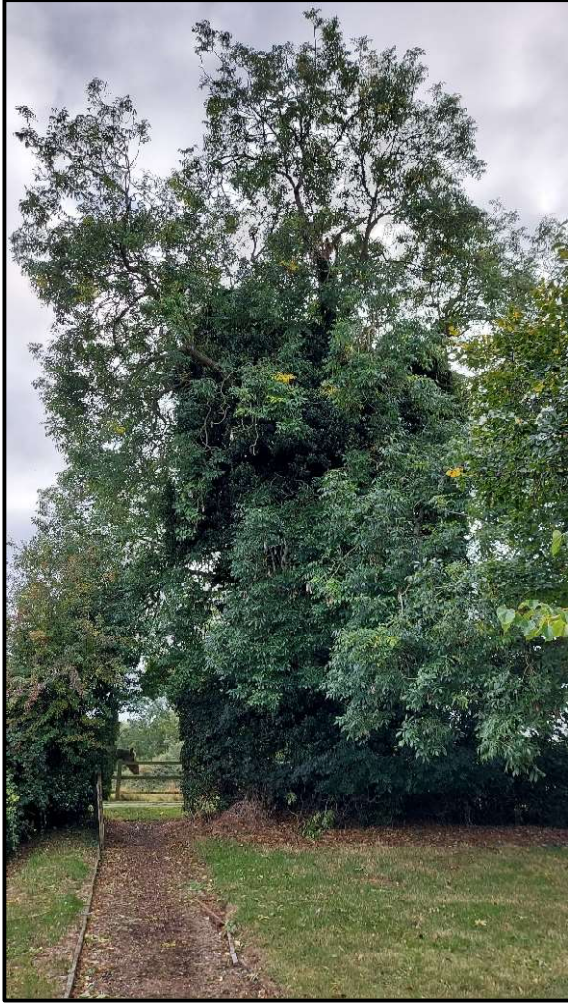
Photograph 11. T37, ash. Viewed looking towards the south.

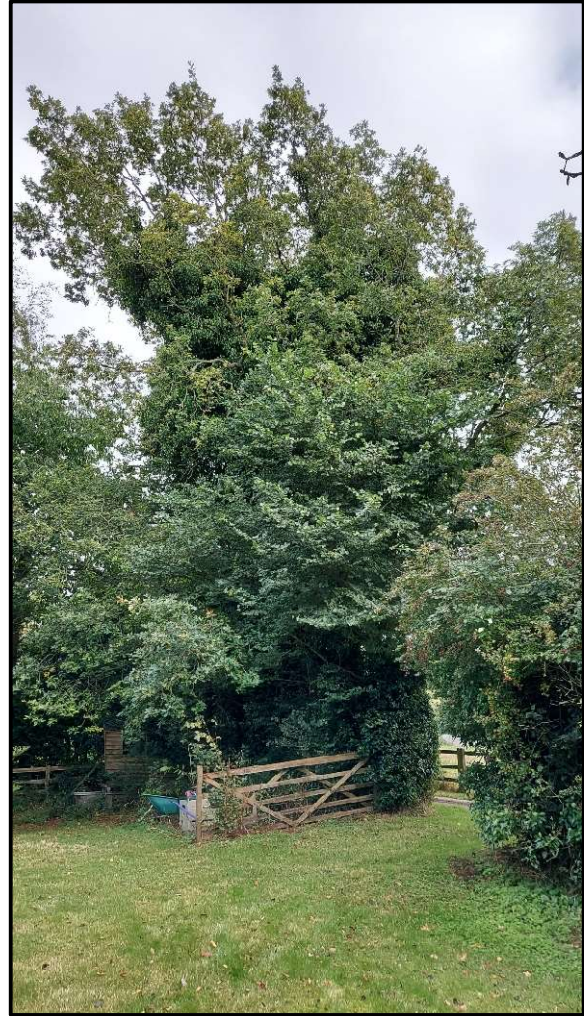
Photograph 12. T39, English oak. Viewed looking towards the southeast.

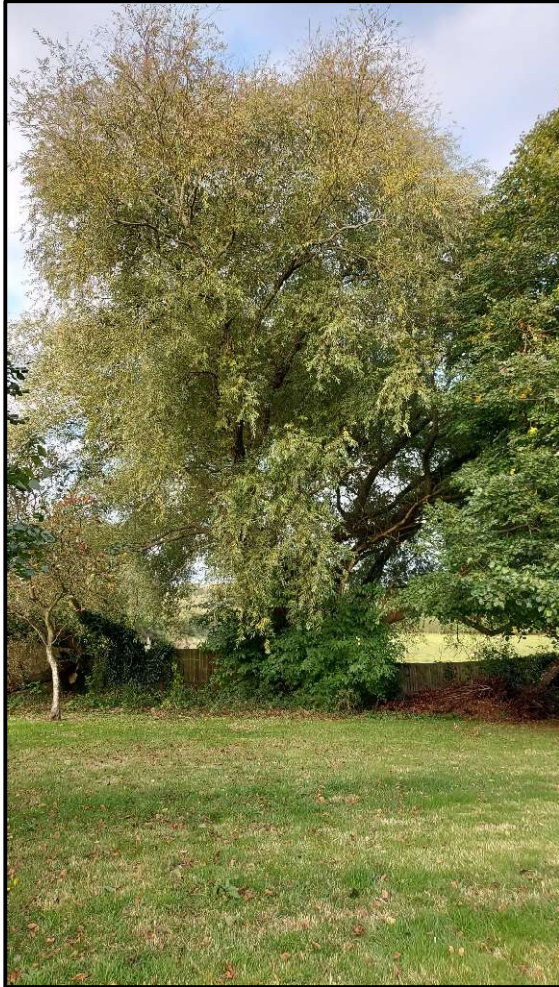
Photograph 13. T56, white willow. Viewed looking towards the north from the centre of the northern boundary.

- 6.10 Parking spaces and hard surfacing encroach into the precautionary root protection area (RPA) of T70, mature silver birch.
- 6.11 Parking spaces encroach into the RPA of T56, a mature white willow.
- 6.12 Due to the construction of hard surfacing running beneath the crown of the tree a cellular confinement system will be used to form a “tabletop” which will then be finished with permeable block pavers or other porous wear layer.
- 6.13 Edges will consist of staked railway sleepers to avoid any excavation for kerbs within the RPA.
- 6.14 A small area to the west of T62’s RPA will be excavated to install hard surfacing and construct building foundations. The risk of root damage in such a small area is considered to be negligible provided the excavation and construction is carried out under supervision.

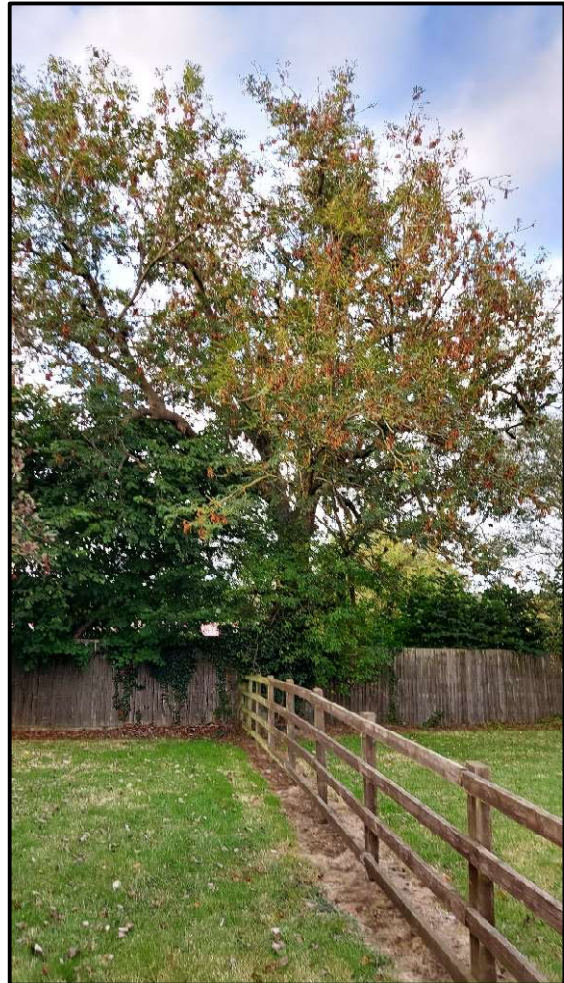
Photograph 14. T62, ash. Viewed looking towards the north.

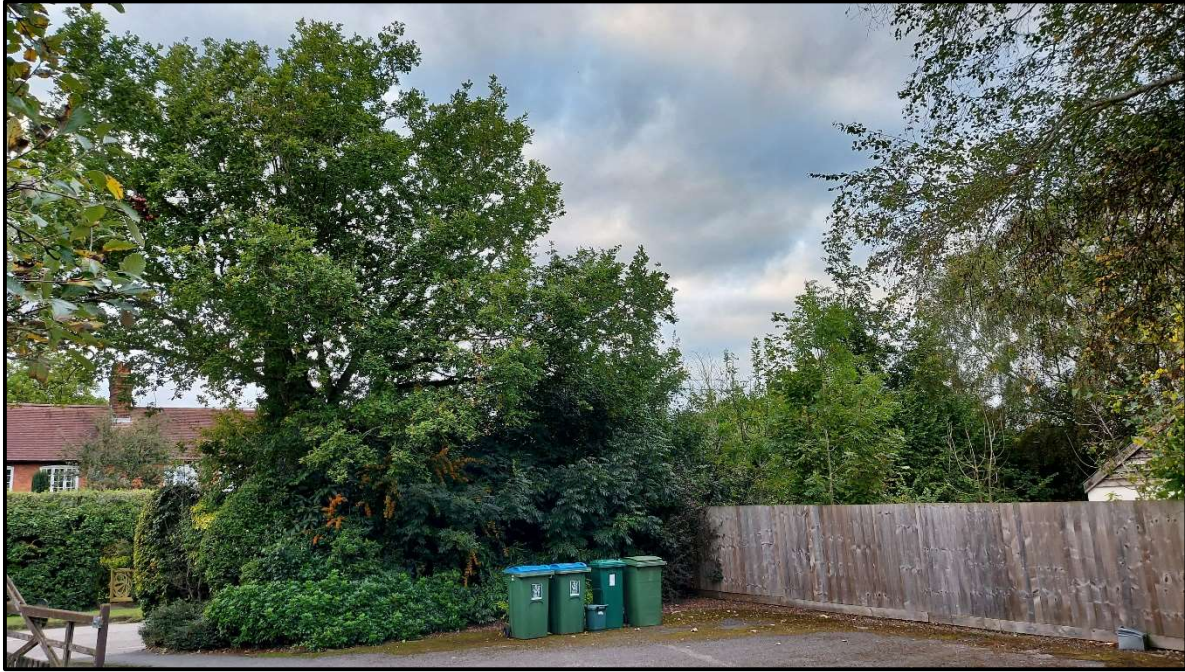
Photograph 15 (above). T69, English oak.
Viewed looking towards the northwest from
the existing site entrance.

- 6.15 Existing hard surfacing will be removed from within the root protection area of the semi-mature English oak, T69, adjacent to the entrance to the site to create an open space, parking spaces and a new footpath alongside the access road.
- 6.16 As the area is already covered by hard, non-permeable, surfacing the likelihood of finding major roots in this area is expected to be low.
- 6.17 The removal of hard surfacing will be undertaken using hand tools, including pneumatic drills, removed in sections down to the sub-base and working backwards away from the trees. This will ensure the risk of root damage is minimised.
- 6.18 Excavations within RPAs of T37, T38 and T39 will be carried out under the direct supervision of the appointed arboricultural consultant, and the following measures will be undertaken to minimise the risk of root damage.

- 6.19 Excavations will be carried out manually using appropriate hand tools OR using an air lance to expose tree roots to minimise the potential for root damage.
- 6.20 Where roots **below** 25mm diameter are encountered, pruning will only be carried out by the arboricultural consultant, using sharp, sterile tools suitable to the size of the root to be cut i.e., sharp hand saw or secateurs (if appropriate). Where possible roots will be pruned cleanly back to a side branch.
- 6.21 If roots **exceeding** 25mm in diameter are encountered, no severance must take place without first consulting the project arboriculturist, to assess any potential impact of removal on tree health and stability.

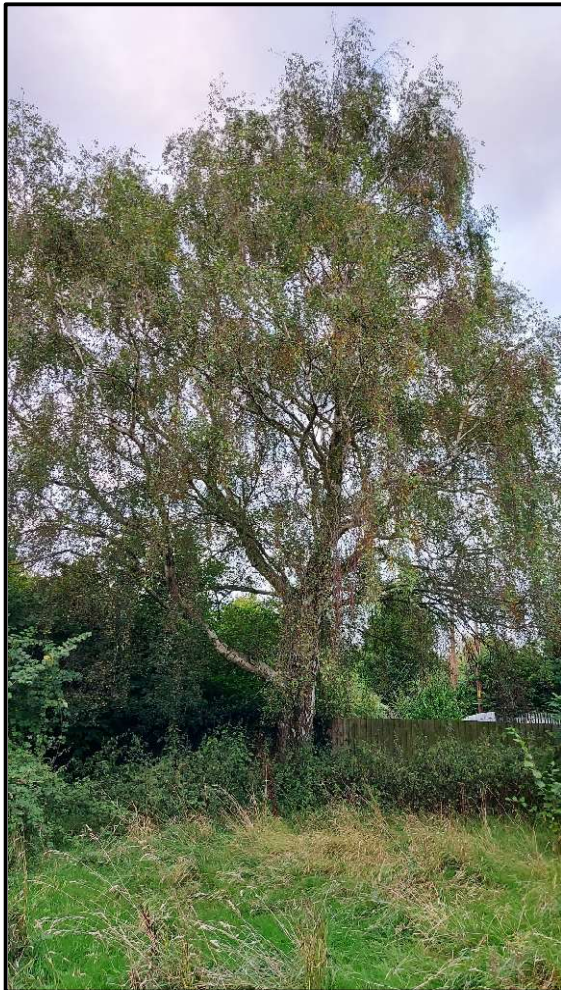
Photograph 16 (left). T70, silver birch.
Viewed looking towards the north from the
north-west corner of the site.
