Arboricultural Impact Assessment

Old Brickyard Farm, Great Horwood Road, Winslow

Bloor Homes South Midlands

JBA 21/303 AR01 Issue D

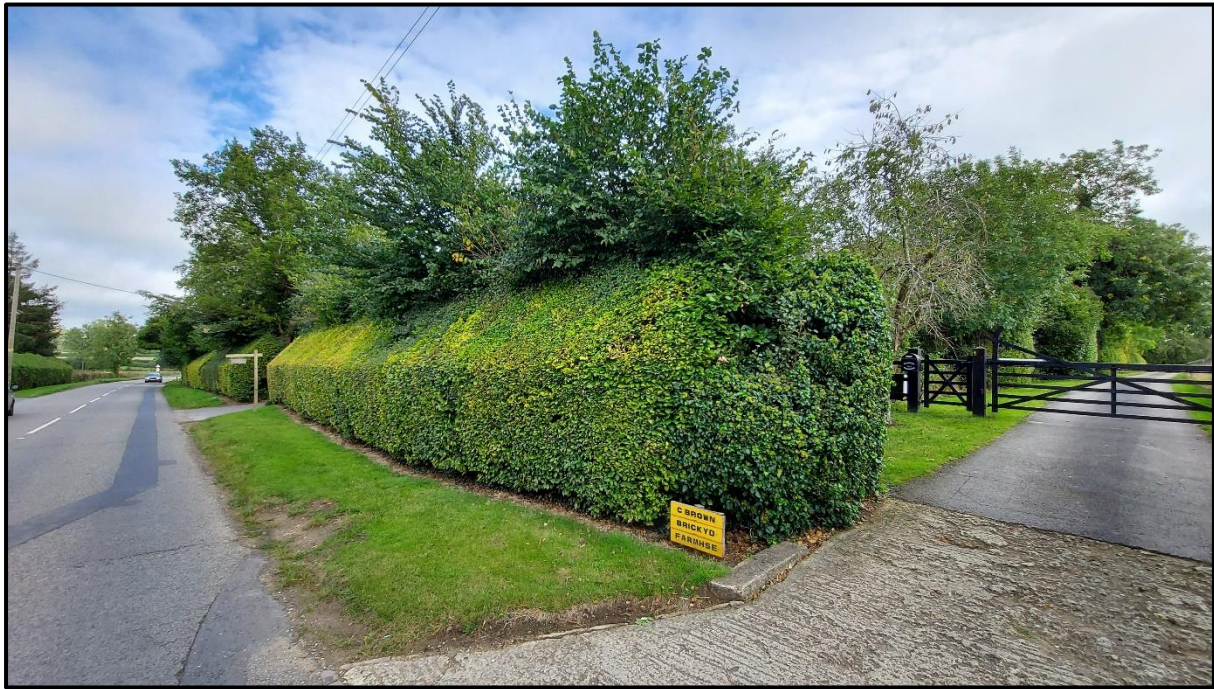
Photograph 1 (above). H1, mixed species (centre), located to the north of the main site entrance. Viewed looking towards the north-east.

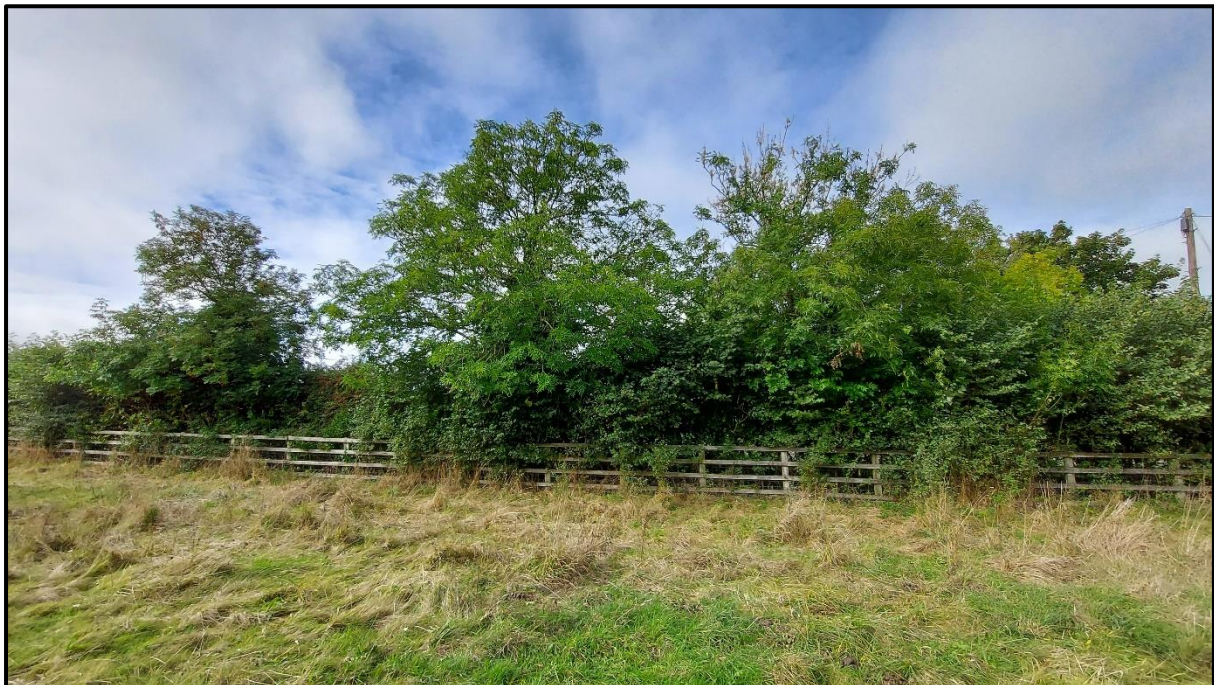
Photograph 2. G3, ash, located to the north of H2, elm, ash, hazel and blackthorn. Viewed looking towards the south-west.

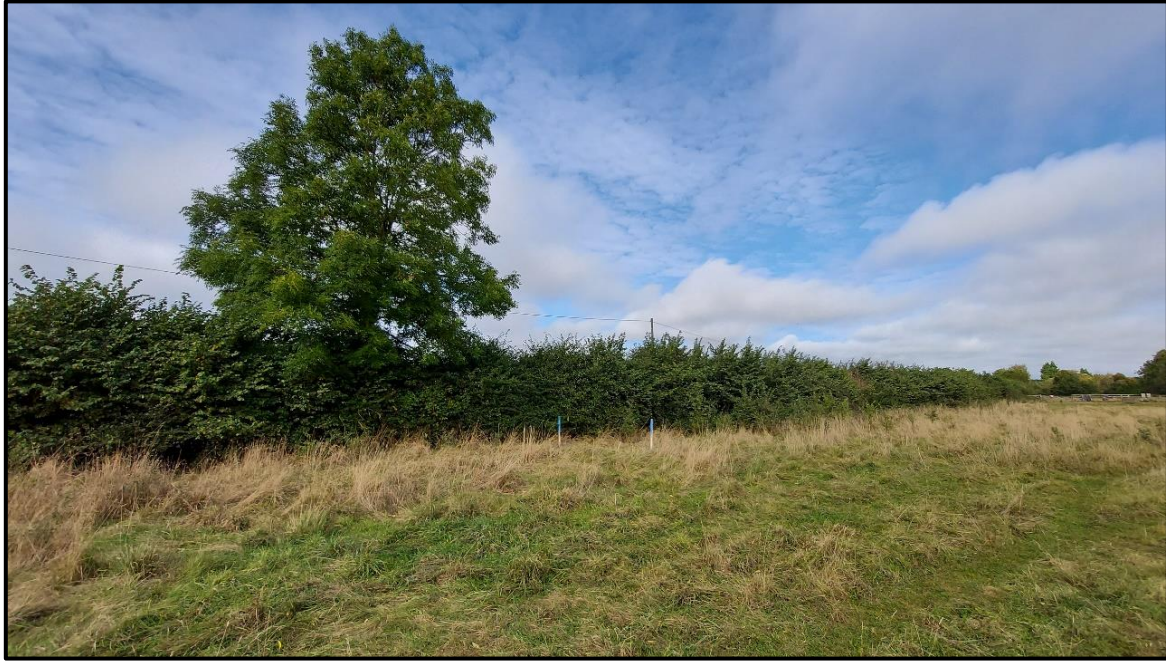
Photograph 3 (above). T4, ash, located to the south of H2. Viewed looking towards the north-west.

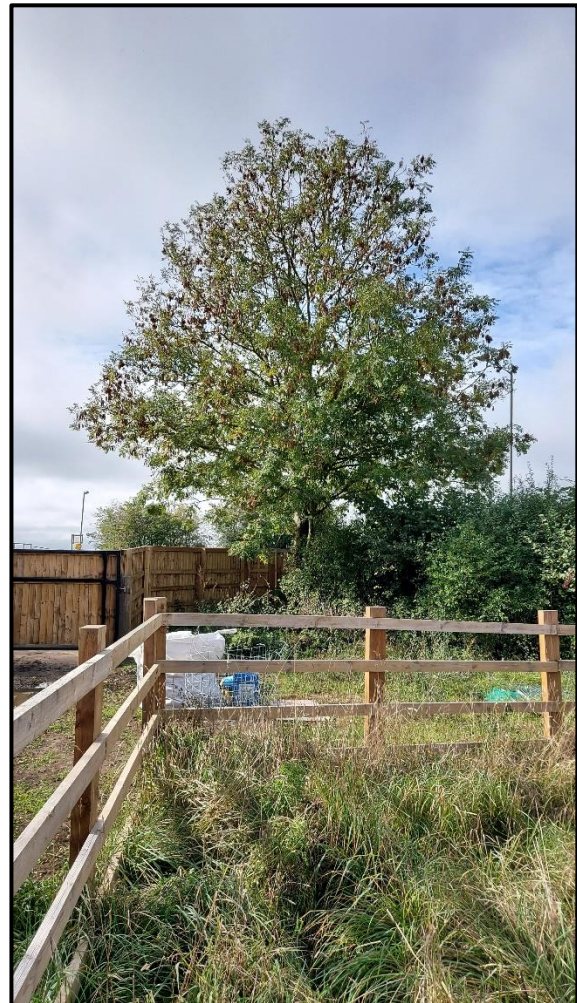
Photograph 4 (right). T6, ash, located in the southwest corner of the site. Viewed looking towards the west.

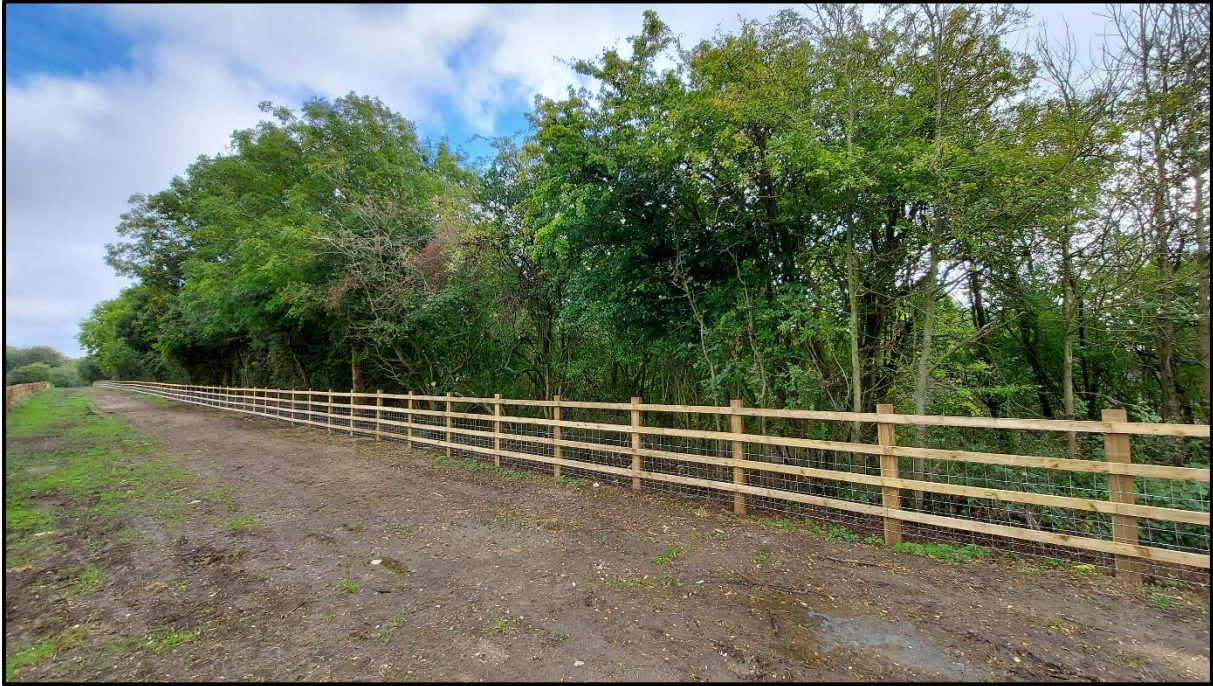
Photograph 5 (above). Woodland W7, mixed species, located along the southern boundary, showing T8, ash, (centre). Viewed looking towards the east from the far south of the site.

- 6.18 Excavations within RPAs of T8, T9, T37, T38, and T39 will be carried out under the direct supervision of the appointed arboricultural consultant, and the following measures will be undertaken to minimise the risk of root damage.

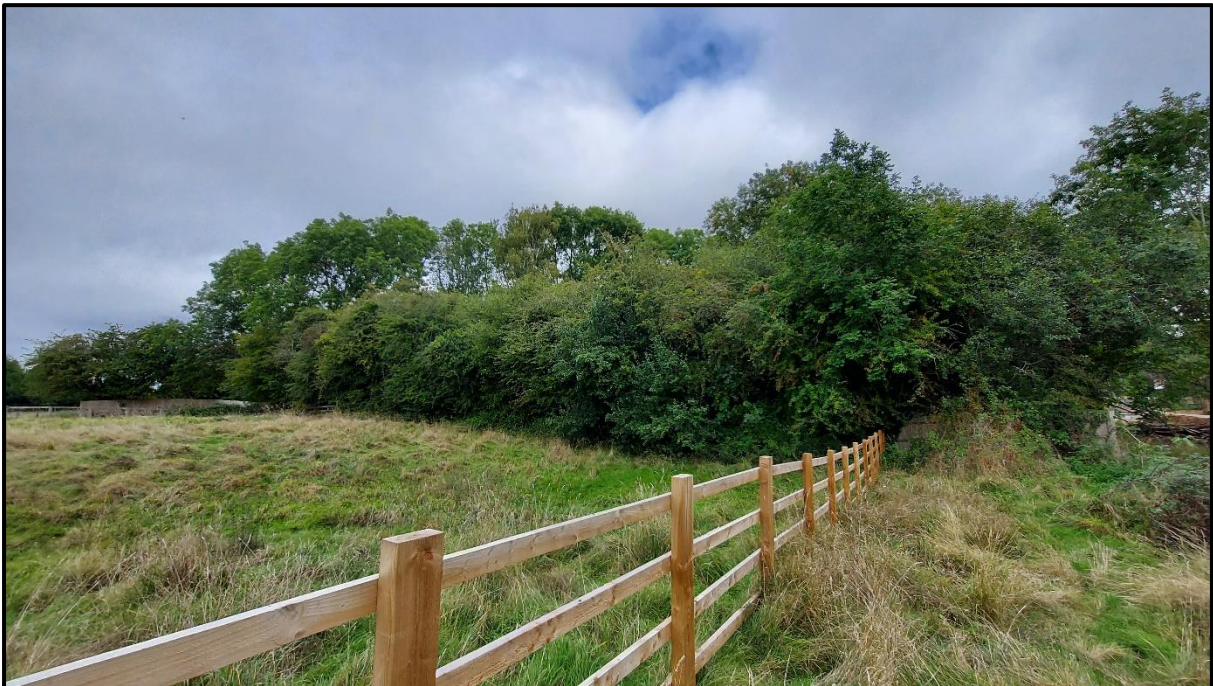
Photograph 6. Overview of G10, mixed species. Viewed looking towards the north-east from the central part of the eastern site boundary.

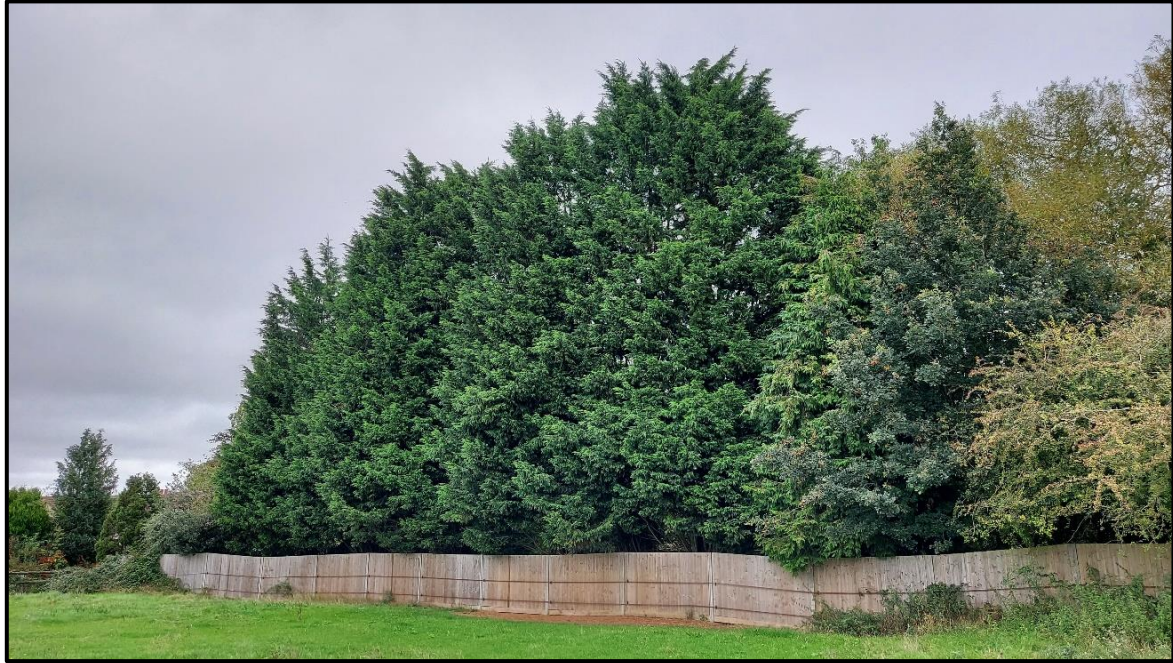
Photograph 7 (above). G12, Leyland cypress, located to the north of the eastern boundary. Viewed looking towards the northeast.

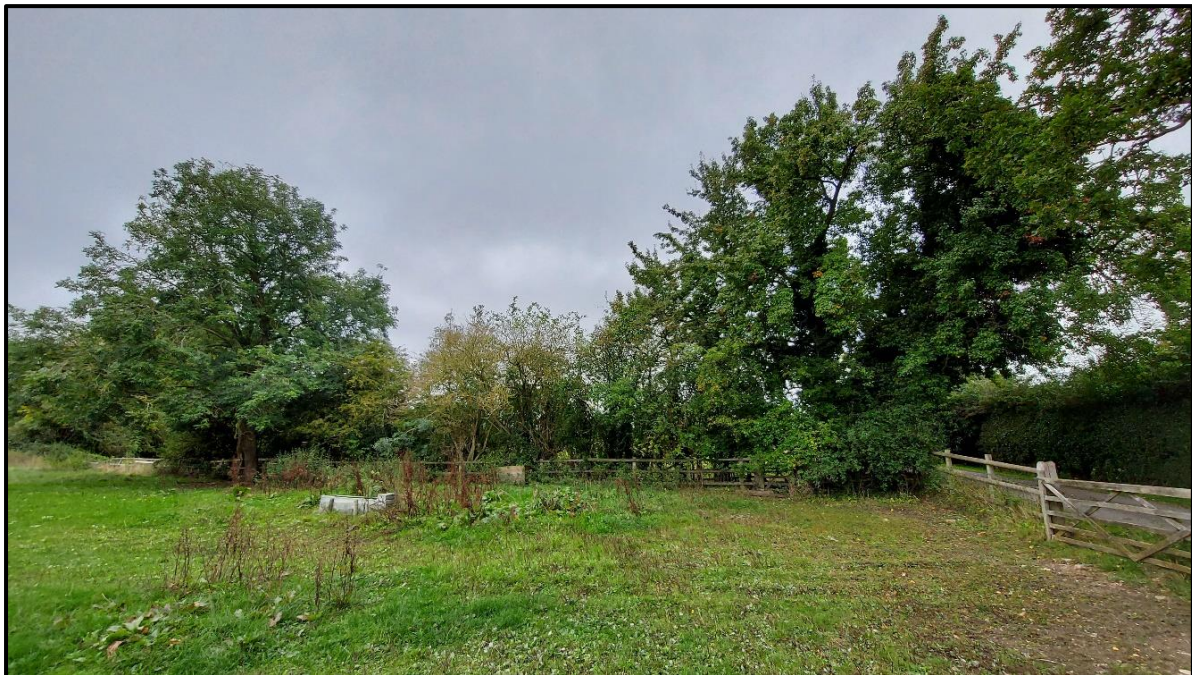
Photograph 8. T15, high quality apple (right) and northern section of G17 (left). Viewed looking towards the west.

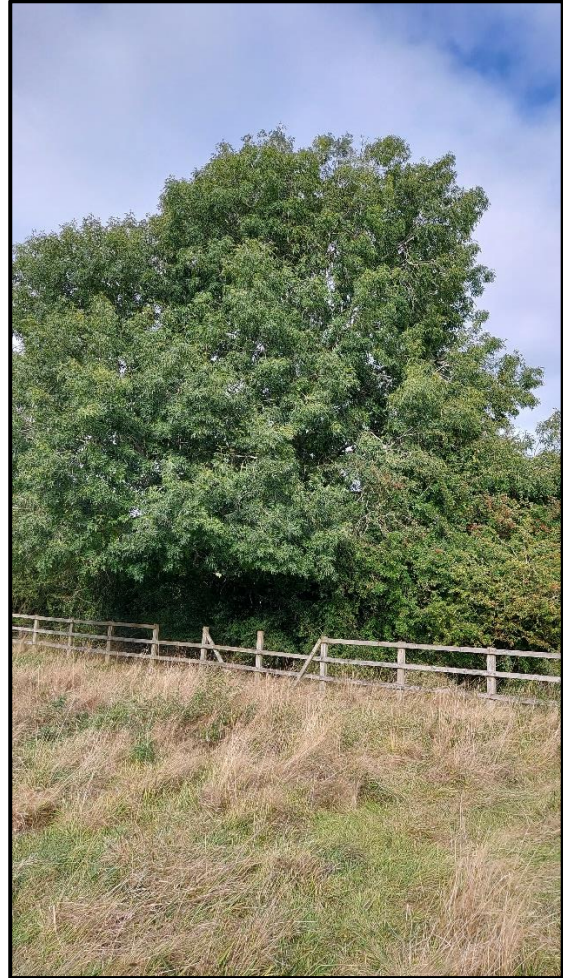
Photograph 9 (right). T22, ash. Viewed looking towards the northeast.

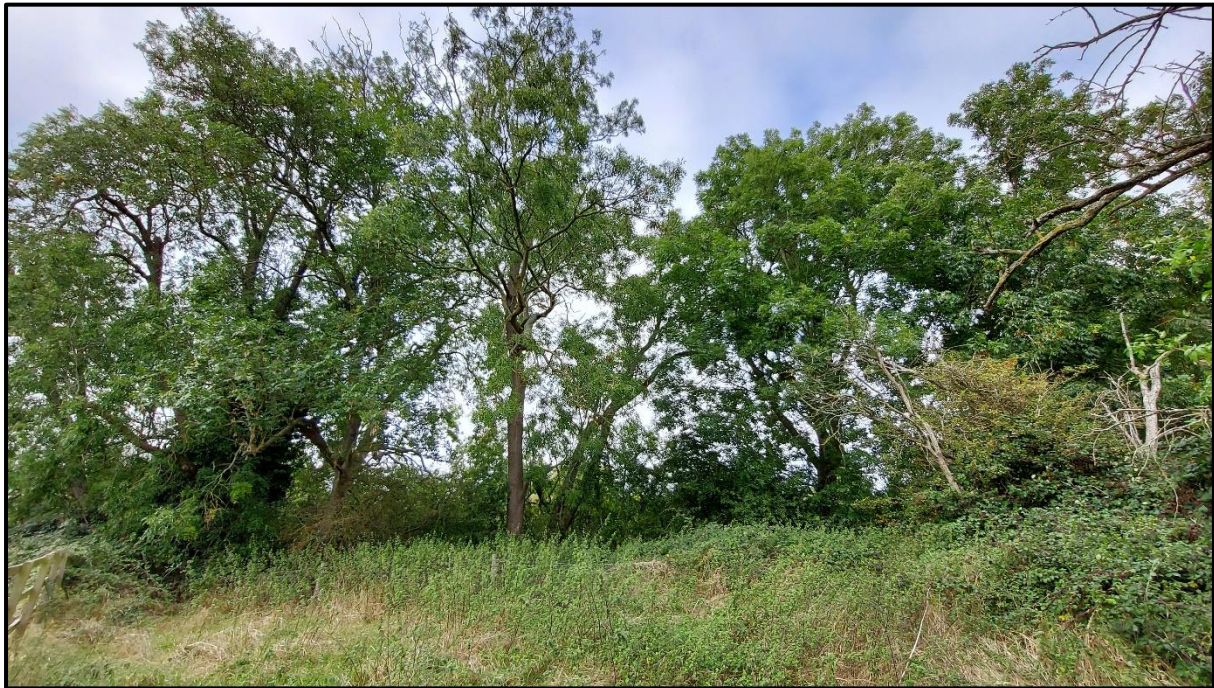
Photograph 10 (below). G26, ash. Viewed looking towards the northwest.

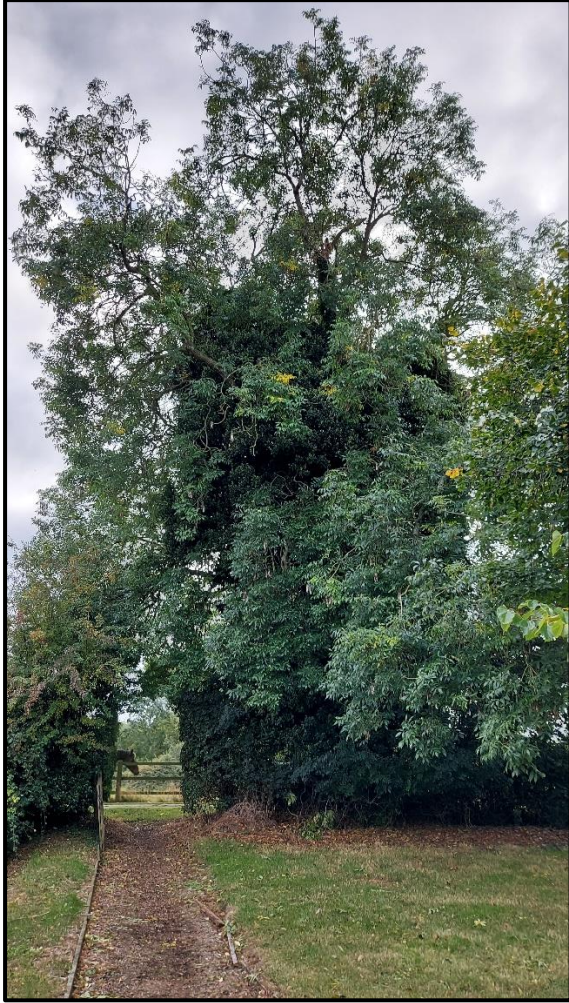
Photograph 11. T37, ash. Viewed looking towards the south.

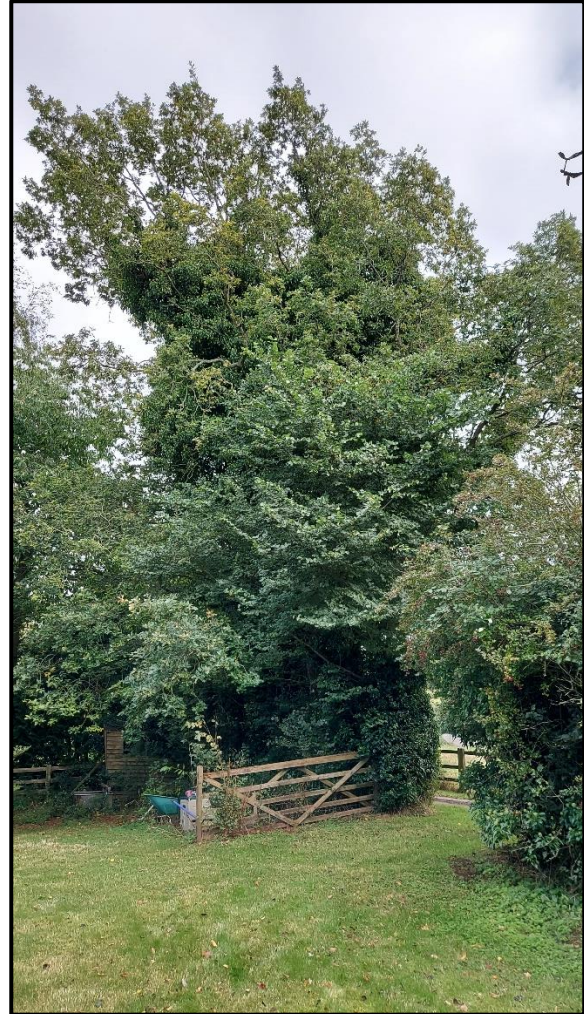
Photograph 12. T39, English oak. Viewed looking towards the southeast.

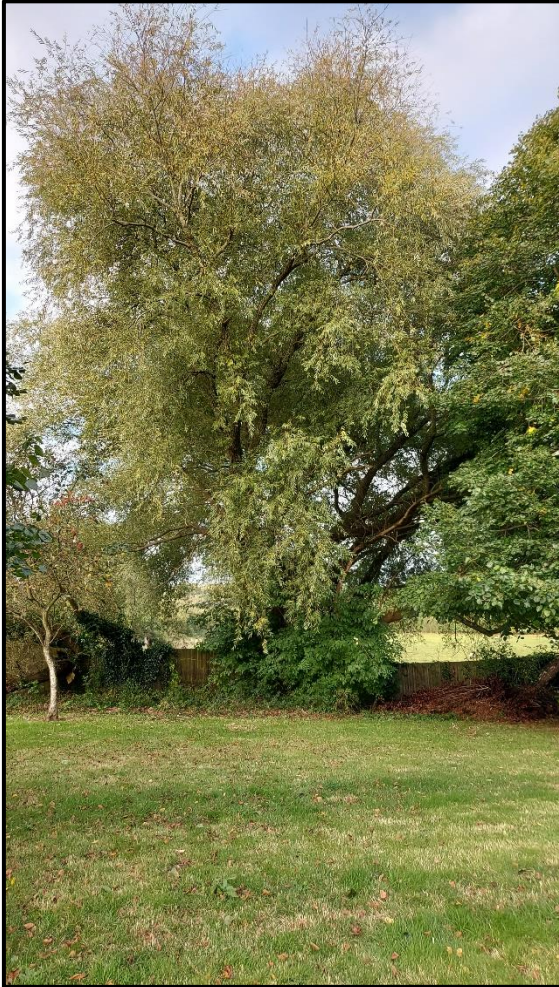
Photograph 13. T56, white willow. Viewed looking towards the north from the centre of the northern boundary.

- 6.10 Parking spaces and hard surfacing encroach into the precautionary root protection area (RPA) of T70, mature silver birch.
- 6.11 Parking spaces encroach into the RPA of T56, a mature white willow.
- 6.12 Due to the construction of hard surfacing running beneath the crown of the tree a cellular confinement system will be used to form a “tabletop” which will then be finished with permeable block pavers or other porous wear layer.
- 6.13 Edges will consist of staked railway sleepers to avoid any excavation for kerbs within the RPA.
- 6.14 A small area to the west of T62’s RPA will be excavated to install hard surfacing and construct building foundations. The risk of root damage in such a small area is considered to be negligible provided the excavation and construction is carried out under supervision.

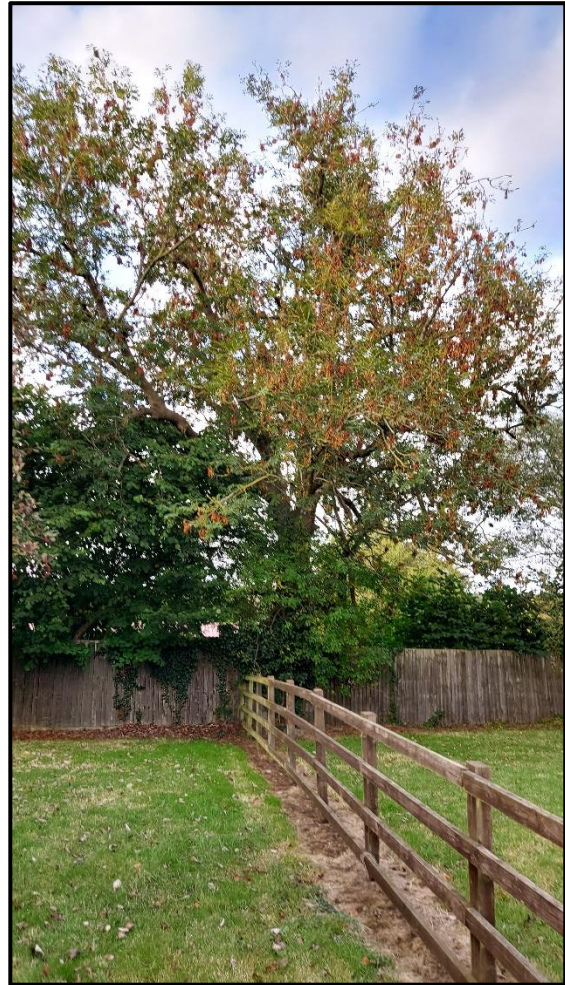
Photograph 14. T62, ash. Viewed looking towards the north.

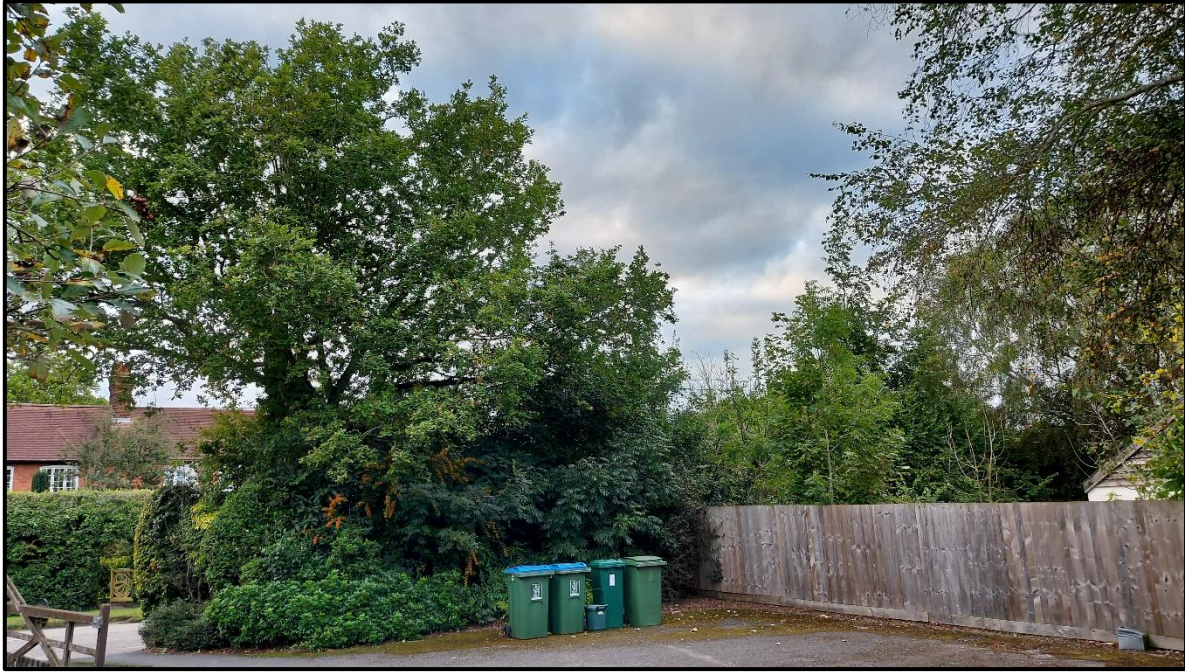
Photograph 15 (above). T69, English oak.
Viewed looking towards the northwest from
the existing site entrance.

- 6.15 Existing hard surfacing will be removed from within the root protection area of the semi-mature English oak, T69, adjacent to the entrance to the site to create an open space, parking spaces and a new footpath alongside the access road.
- 6.16 As the area is already covered by hard, non-permeable, surfacing the likelihood of finding major roots in this area is expected to be low.
- 6.17 The removal of hard surfacing will be undertaken using hand tools, including pneumatic drills, removed in sections down to the sub-base and working backwards away from the trees. This will ensure the risk of root damage is minimised.

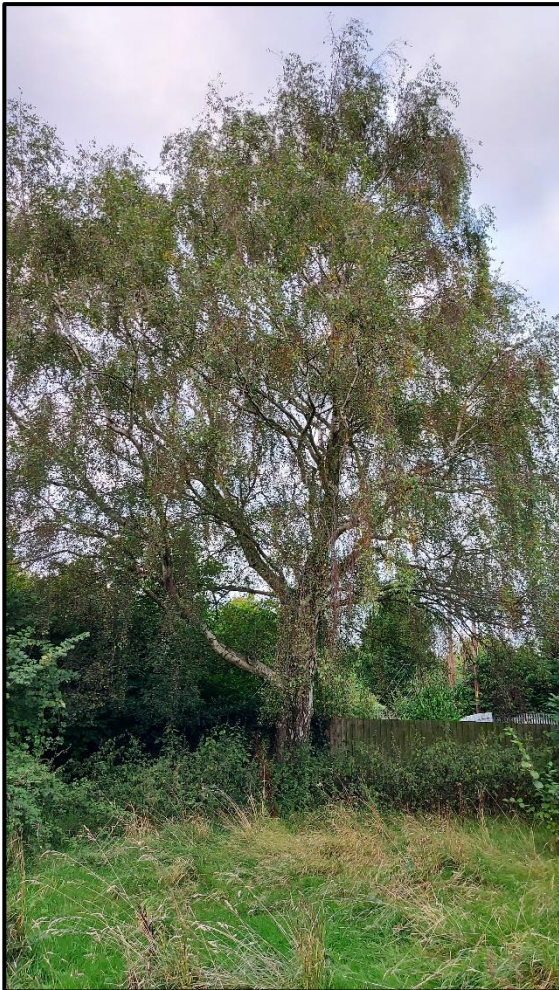
Photograph 16 (left). T70, silver birch.
Viewed looking towards the north from the
north-west corner of the site.
