Heritage and Design and Access Statement

89 Strand Street, Kent

Date: 23rd February 2024

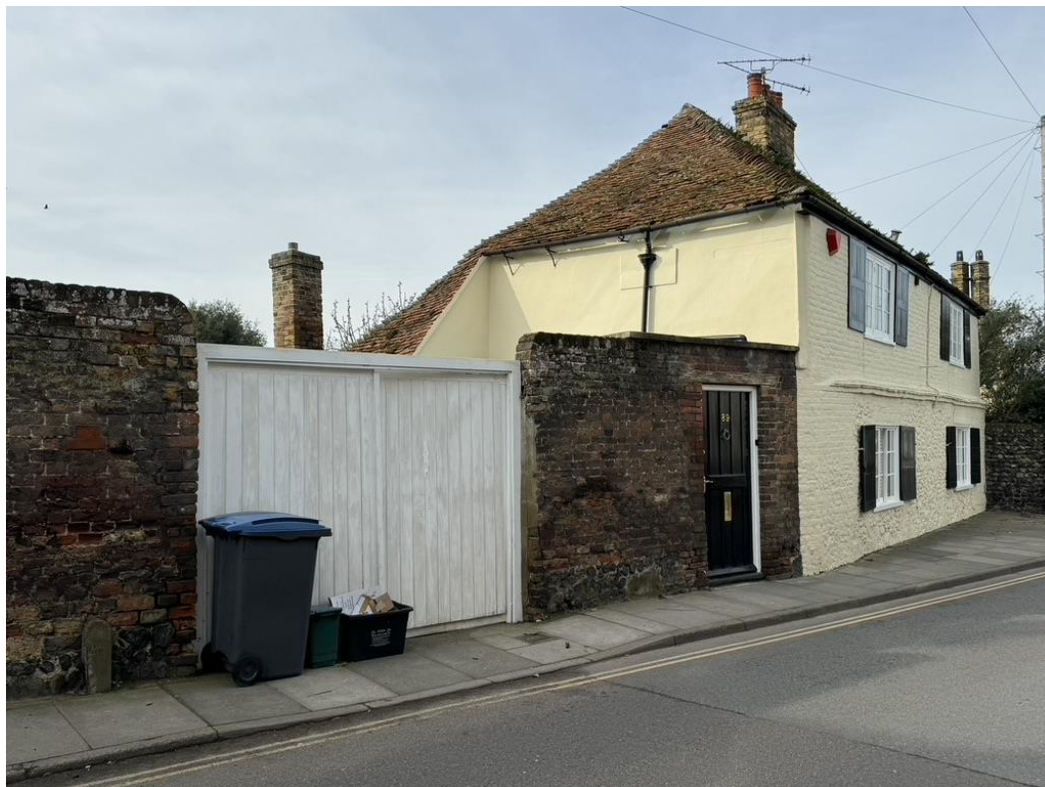
Photo (i) – Front elevation with gates

It is proposed to replace the existing gates, (photos i and vii), with new gates as shown in photo (viii). The existing gates are modern replacement gates which are rotten at the bottom, and they no longer close. It is therefore proposed to replace them with timber gates, similar to those used in nearby properties and as shown in photo vii.

The existing double gates are fairly modern and therefore of no significance. The gates are now beyond repair and replacement will enhance the property's appearance.

The proposed replacement gates are necessary in order to secure the rear area, as the existing gates no longer close properly.

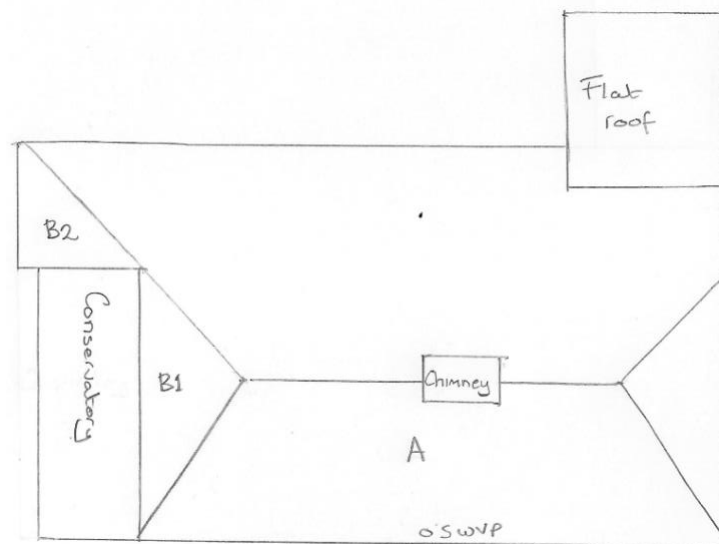
The main roofs are covered in Kent peg tiles. The rear elevation roofs have previously been recovered, incorporating a modern felt underlay and are still in a good condition, (photos iii & iv). However, the front and side gable end roofs, (roofs A, B1 and B2 – see fig (i)), have reached the end of their life, and are heavily covered in plant growth, (photos v and vi). It is therefore proposed to fully strip these roofs, setting aside the sound tiling for reuse and making up any deficiency using good quality second-hand Kent peg tiles to match the existing. It is anticipated that 80% of the tiling can be reused. It is also proposed to upgrade the current roof insulation in order to meet part L of the building regulations as far as possible. In summary the proposed works are as follows:

Fig (ii) – plan of roof

- Carry out repairs to roof structure if found necessary, using timbers to match existing;
- recovering of the front elevation and side gable end roofs, (roofs A, B1 and B2 shown in the plan below);

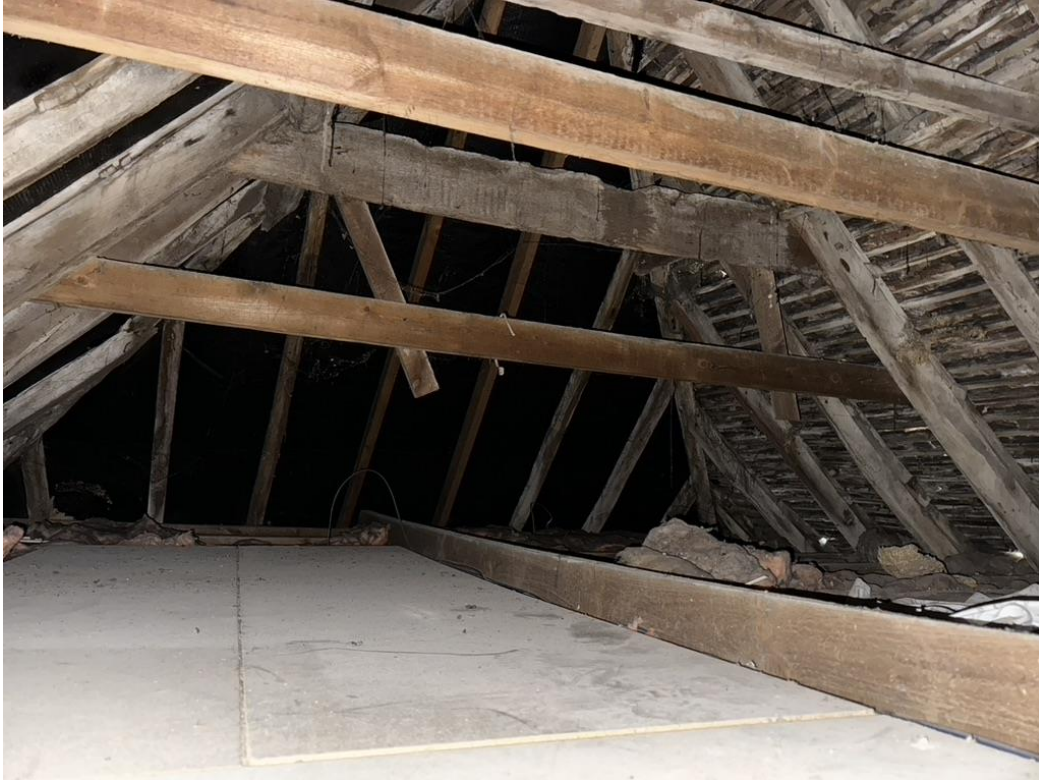
Photo (iv) – roof void showing rear and one gable having been recovered, with felt beneath

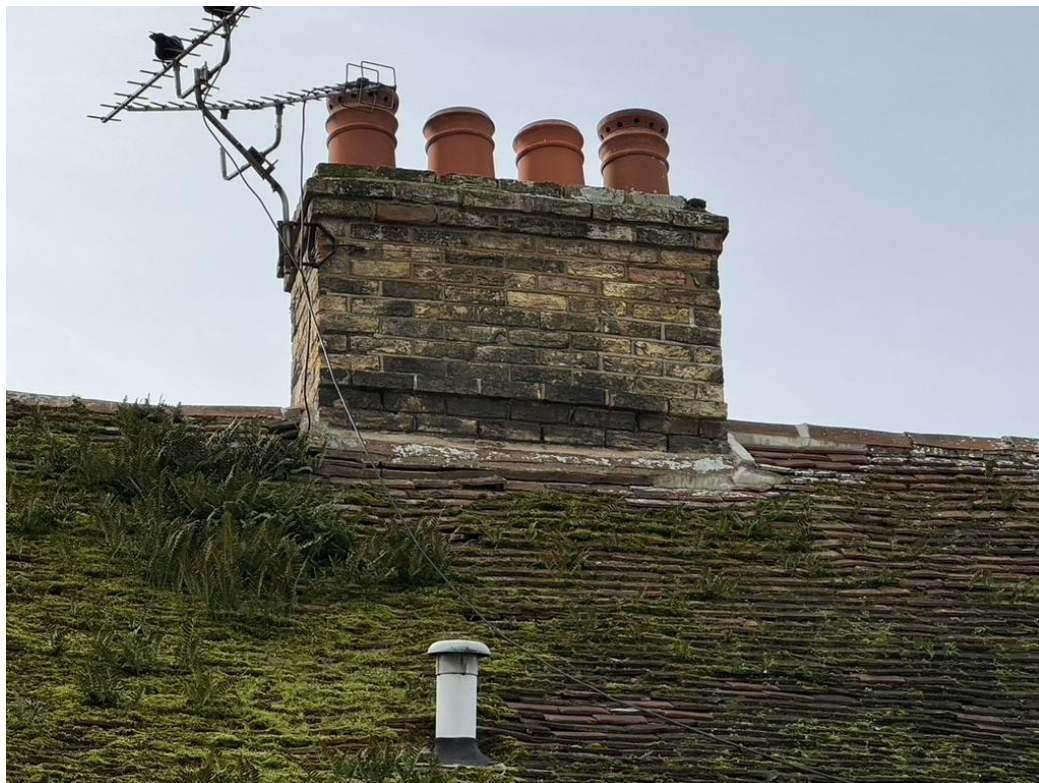
Photo (v) – chimney stack

- patch repointing to chimney stack, (photo v), in an NHL 3.5 lime mortar, where the pointing has completely eroded, together with re-flaunching if required, with pointing finished to a neat flush joint to match the original.

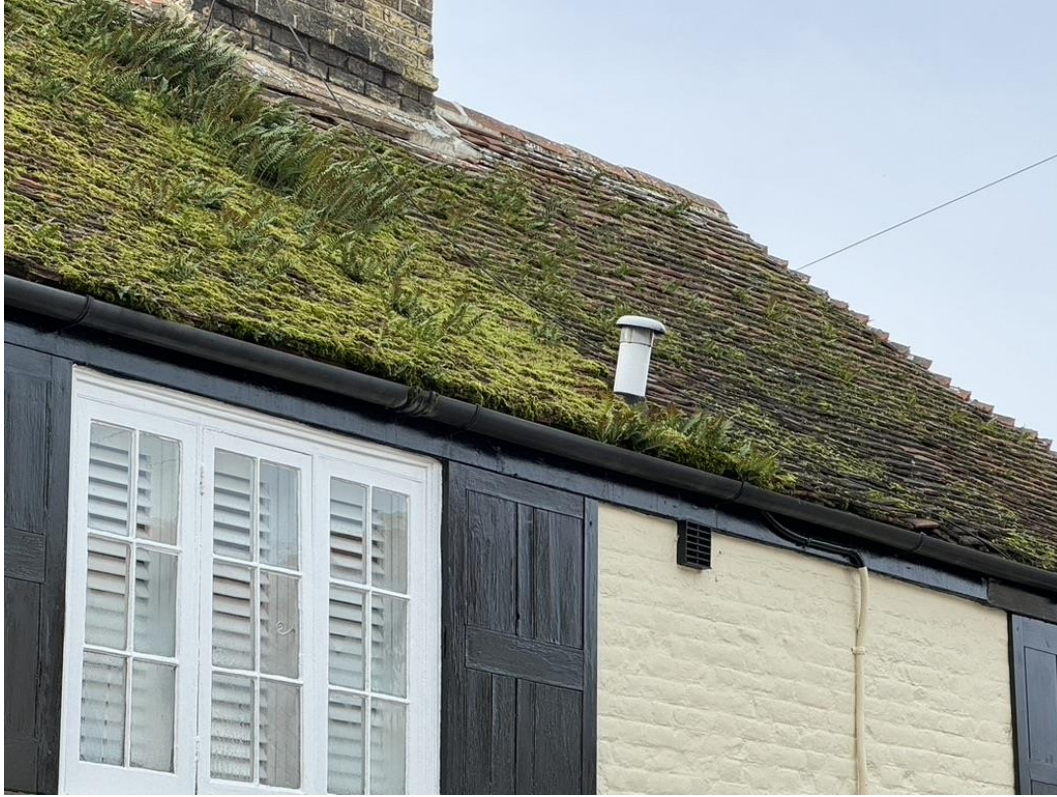
Photo (vi) – severe moss/plant growth to front elevation roof

The roof recovering to the front and gable end is necessary due to the roof coverings having reached the end of their life, and in order to protect the fabric of the building. Where possible as many of the original tiles will be reused, making up the deficiency with secondhand Kent peg tiles to match the original. There will be very little impact on the appearance of the property as the materials will all match the existing, including re-use of the existing sound tiles.

- peg tiles to be hung on 40mm allow peg drops, on pre treated timber battens on breathable felt;
- ridge and hip tiles to be neatly pointed in lime mortar;

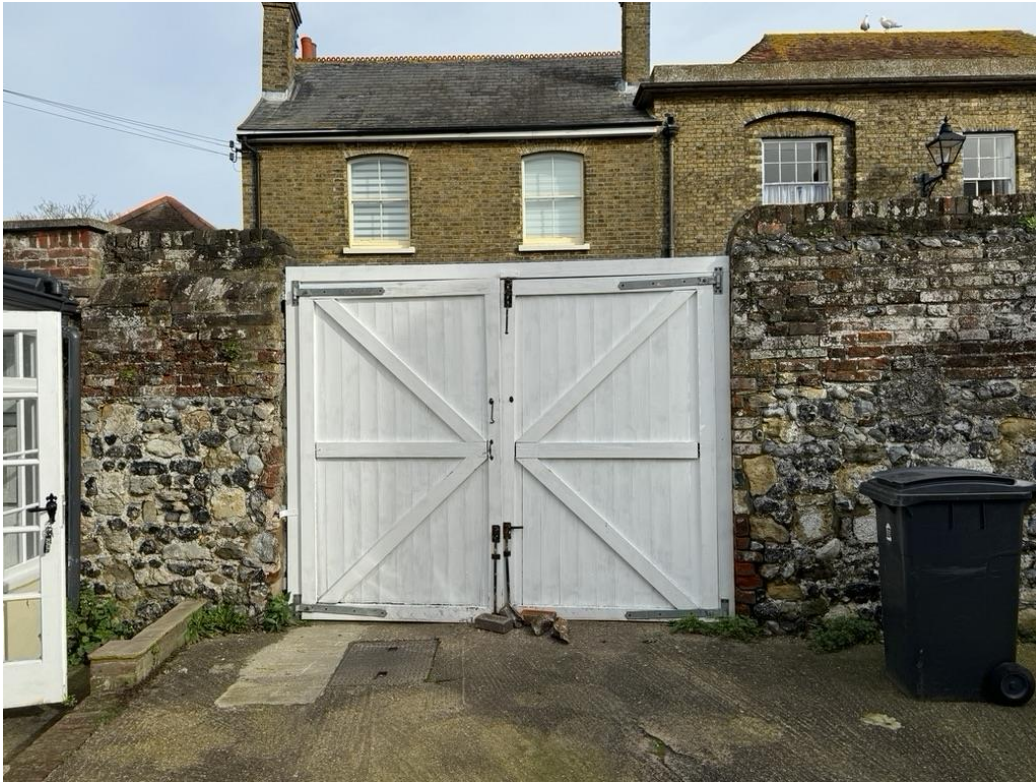
Photo (vii) – view of gates from inside garden courtyard

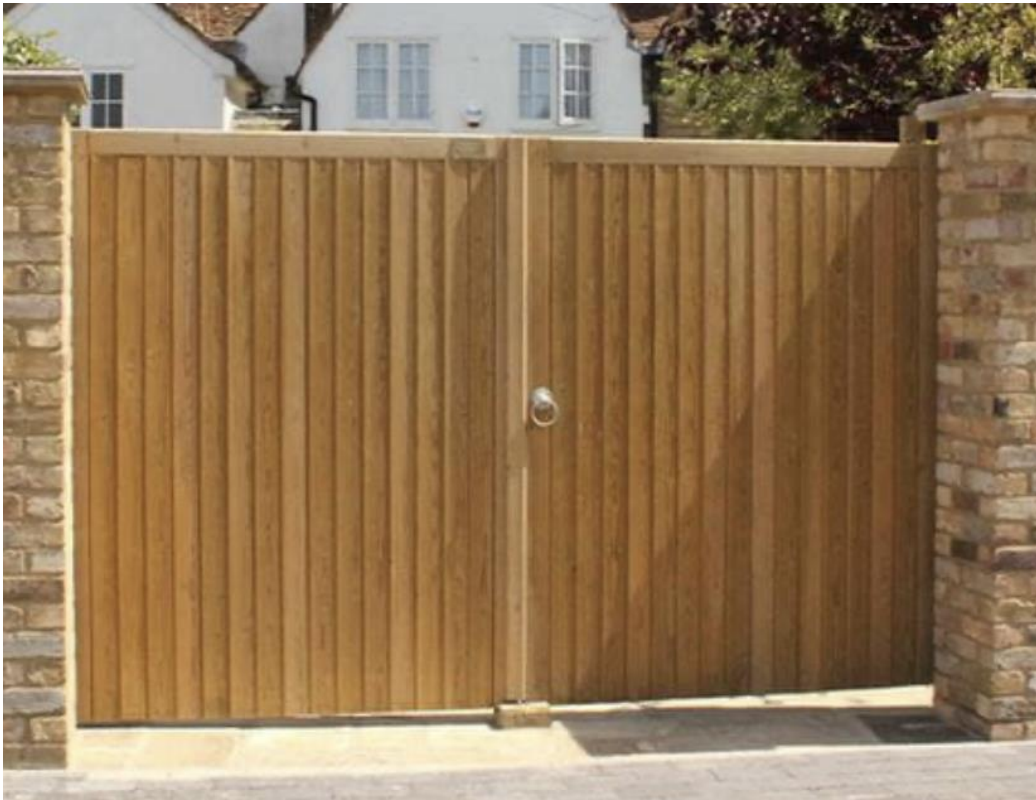
Photo (viii) – proposed gates
