Whitfield Court, Littlewick Road,
Knaphill, Woking. GU21 2JU
Heritage Statement

Woking Borough Council
April 2022

Heritage Statement

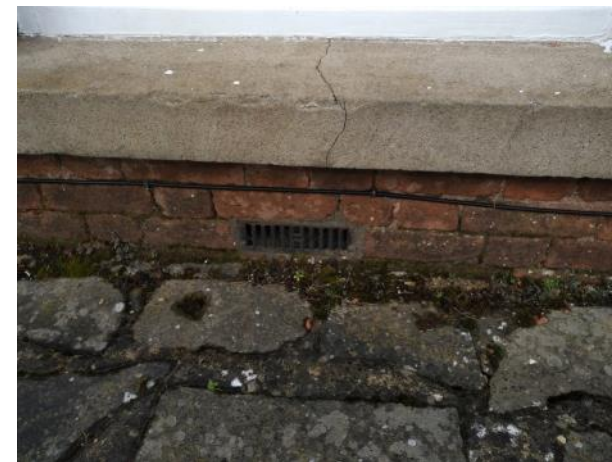
Figure 5.26: Showing the airbrick below the canted bay window. Also note that the concrete cill to the central window is cracked.

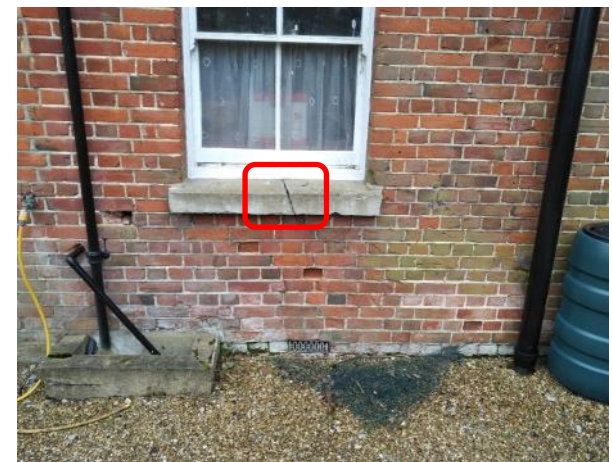
Figure 5.46: Showing the cracked concrete cill to the Victorian Extension's western ground floor window.

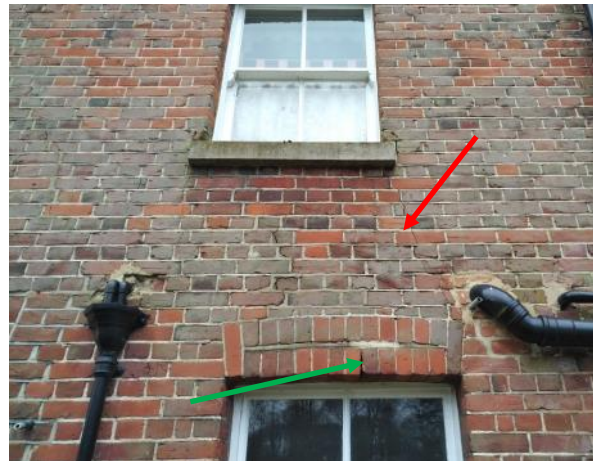
As discussed there is a crack (marked in red at Figure 5.47) leading from the central ground floor window’s head to the cill of the first floor window.

Figure 5.47: Showing the crack from the ground floor central window’s head to the first floor window cill. Also showing the cementitious mortar surrounding many SVPs and overflow pipes.

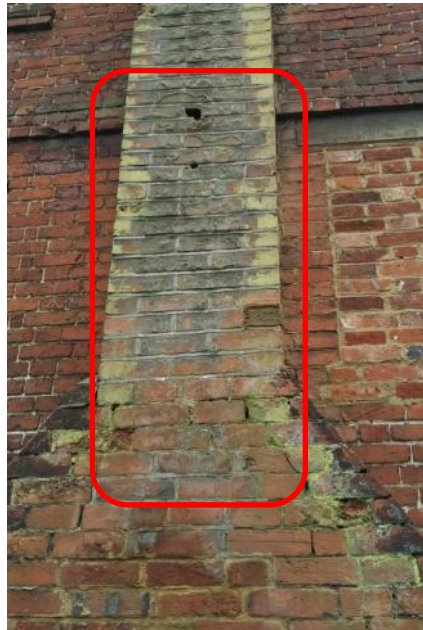
Figure 5.3 from 1830 does not show this element and the stack is therefore post 1830. It has also been discoloured to its northern side by the large steel flue shown in Figure 5.10 (1978), which has since been removed. There are no chimneypots to the apex of the stack. This stack has a number of large holes in the brickwork that pass all the way through, indicating disrepair. It might be that this has been caused by the failure to install a ventilation grille when the fireplace was capped off internally in the late 1970s. Many of the brick faces have delaminated also.

Between the stack and the 'boiler house' many bricks have similarly become delaminated and require replacement.

Figure 5.62: Showing the various cracks and holes to the northern chimneystack.

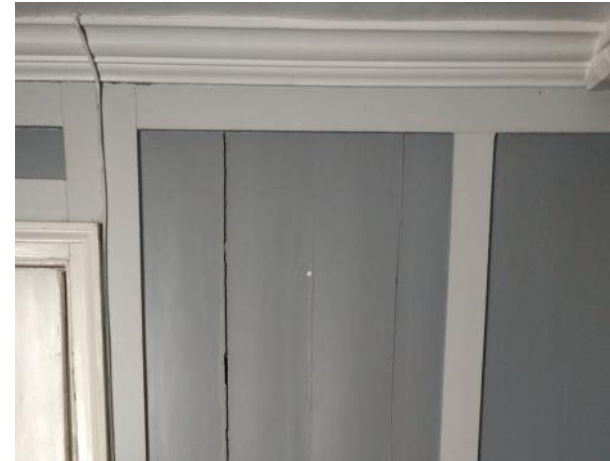
The timber frame to this part of the building is entirely concealed by 18th century full height panelling. The panelling has cracks to the occasional panel that needs minor repairs.

Figure 5.102: Showing a section of cracked panelling to the Music Room and a section of cornice above.

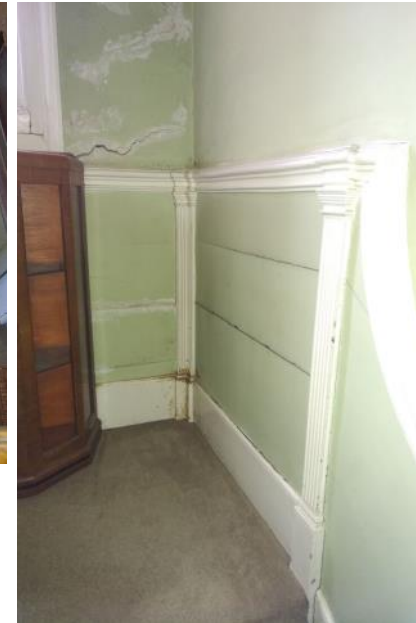
The walls to the stairs have skirting boards, a ramped dado rail, and fluted Doric pilasters from skirting boards to dado rails. Some of the panelling between skirting board level and dado level has cracked or separated due to the structural movement in the staircase.

Figure 5.119: Showing cracking to the northern staircase wall and separation of the panelling.

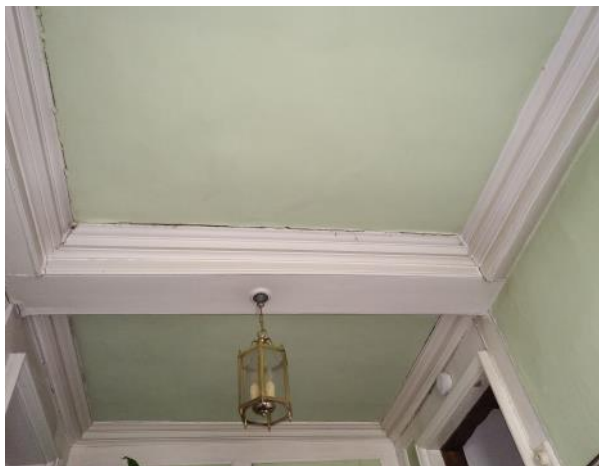
At ceiling level is a prominent, deep timber cornice that has also cracked and/or become separated from the walls in a number of places due to structural movement. There is also cracking evident on the northern wall of the stair

Figure 5.120: Showing the cornice to the ceiling and the cracking that is evident.

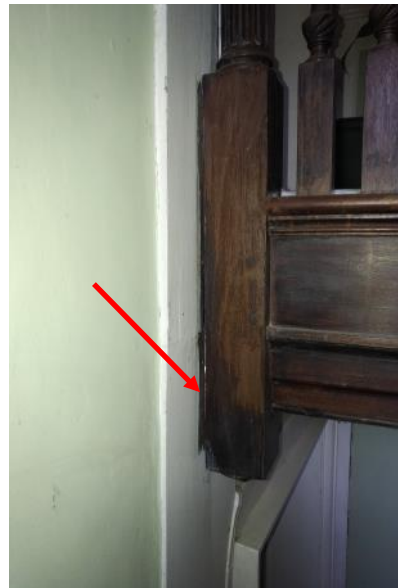
Figure 5.121: Showing the balustrade to the first floor staircase landing where it has become loose from the wall (marked in red).

The staircase balustrade on the first floor landing has also partially moved away from its fixings due to structural movement. Several balusters are also damaged at first floor level and the balustrade itself is partially loose.

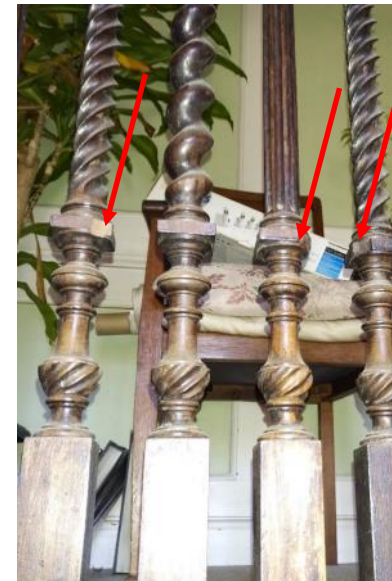
Figure 5.122: Showing the areas (marked in red) of the first floor Main Staircase balustrade where damage has occurred.

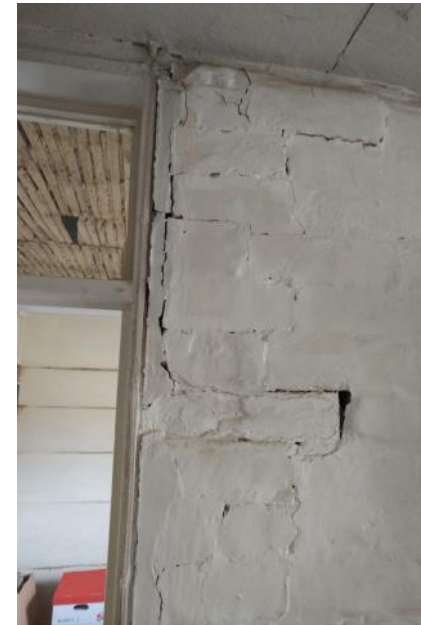
The room at present has a concrete floor of no heritage value. The floor is cracked, as are large parts of all the walls in the room showing the structural movement in this part of the building.

Figure 5.136: Showing an example area of cracking to the W.C..

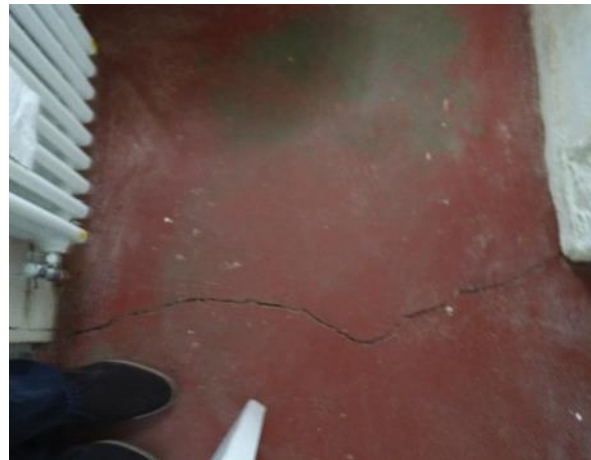
Figure 5.137: Showing the cracked concrete floor to the W.C..

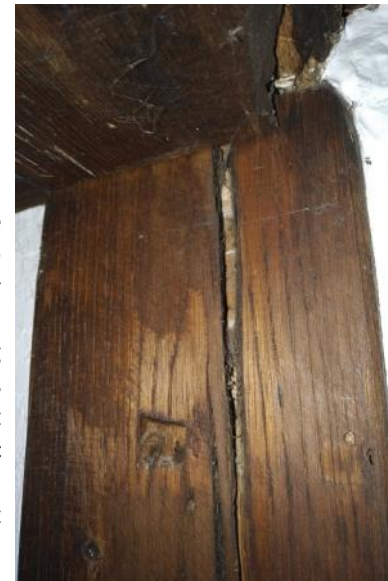
Figure 5.150: Showing a cracked modern timber member and the wall is visible behind indicating the shallow depth of the timber member.

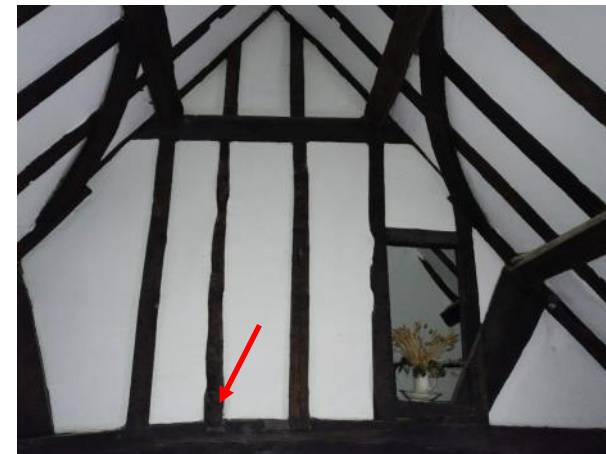
Figure 5.190: Showing the smoking bay doorway (on the right hand side) on the southern end of the Master Bedroom. The loose post is marked in red.

Above the fireplace is a smoking bay historically used to smoke meats. One of the posts to this bay has become dislodged and is loosely held in place by nails, but requires repair to be pegged back in place.
