Turnbridge Farmhouse
116 Low Road, Burwell

Appendix C – Window and External Door Schedule

Revision 1 (25 January 2024)

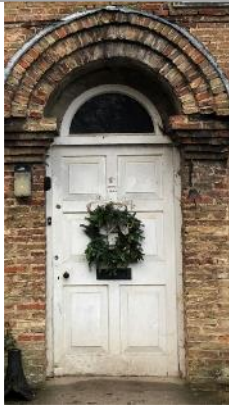
Reference	Photo	Description	Notes
DE-01

White-painted timber entrance door and single-glazed fanlight.	Retained, refurbished and repainted (white).

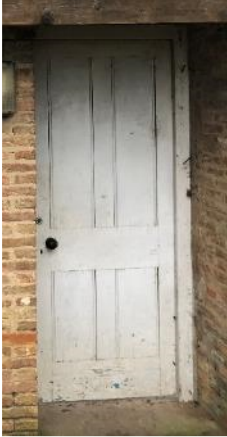
DE-02

White painted timber rear door.	Replaced with new double-glazed timber framed door.
DE-03

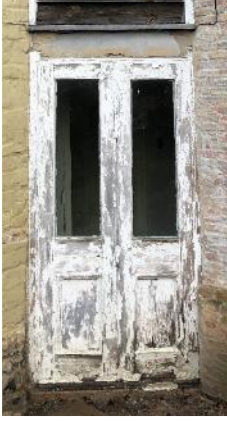
White painted timber double doors, single-glazed and fixed shut with radiator to internal face.	Poor condition. Door will be removed as part of proposed extension works.
