Arboricultural Impact Assessment

116 Low Road, Burwell

OAS 24-023-AR01

February 2024

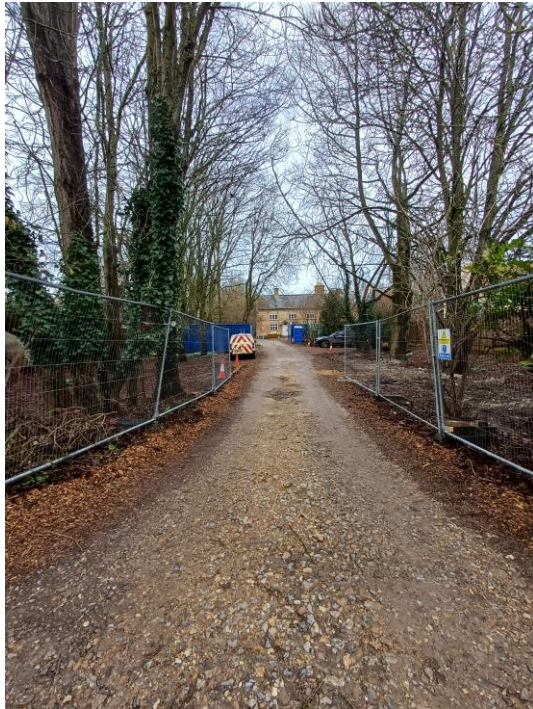
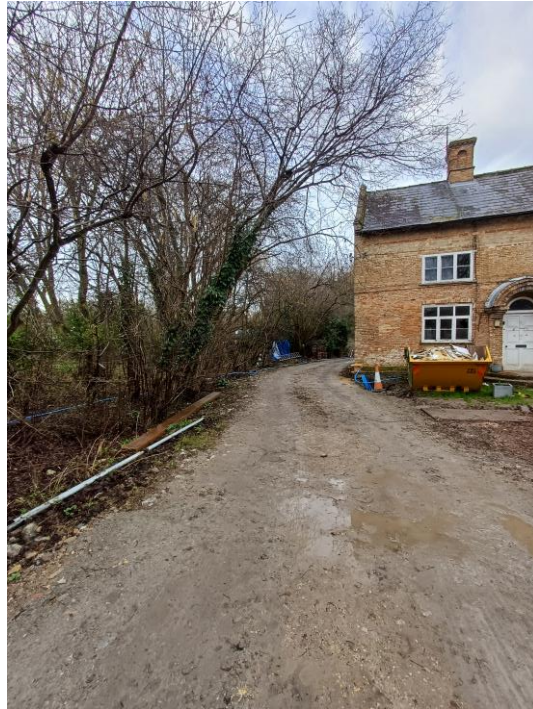
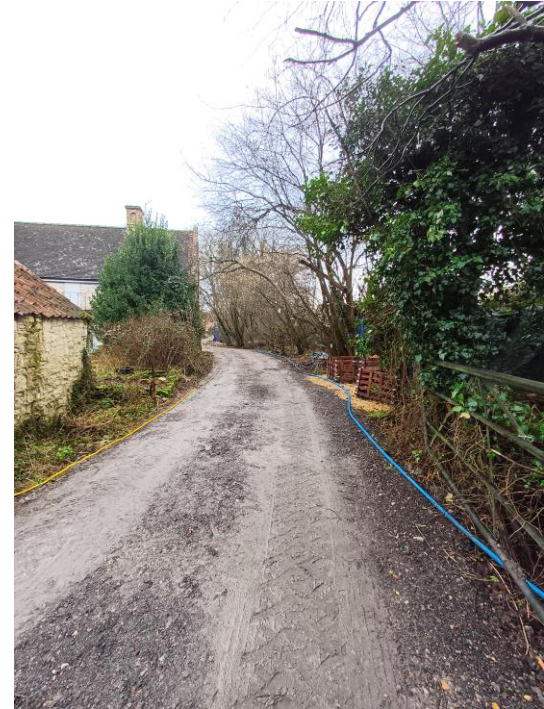
2.2.2 T1- T3 are located to the area of proposed construction and are all of low overall value due to being dominated by ivy and in poor condition, particularly T1, all are Category C. Both groups are existing trees to the main driveway to the main access of Low Road and to the side of the main house. Both groups are established and of good value Category B.

Exiting access drive and G1/ G2

3.3.1 Access would be via the existing access drive and would have no effect on G1 or G2. The new constructed access would have no effect T2 or T3.

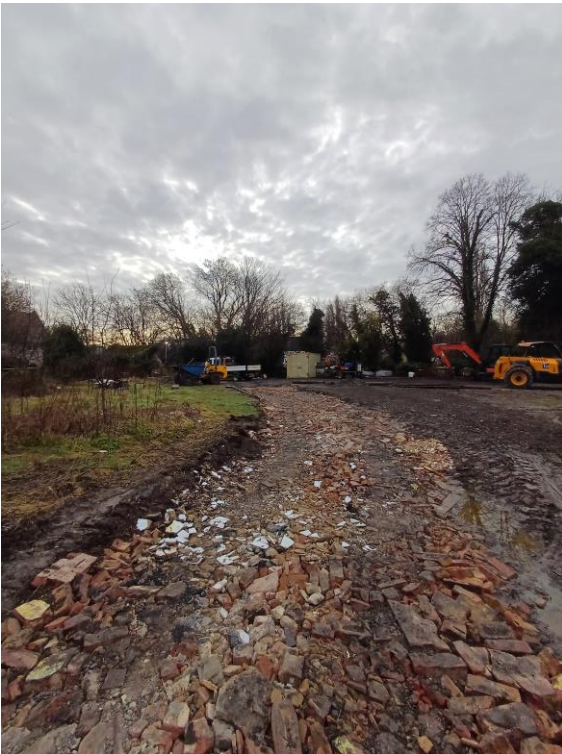
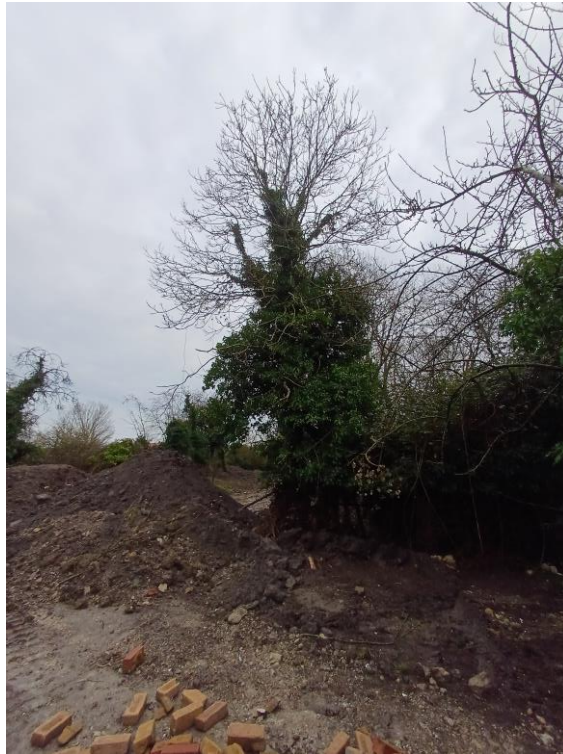
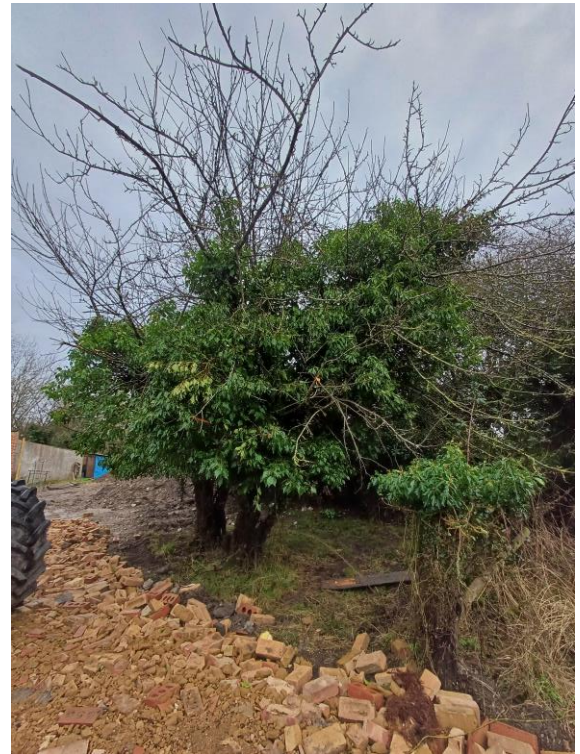
Access from main drive and T1- T3

3.1.2 The proposal will see the removal of T1 to accommodate the layout. Of low value this should not be considered a constraint however there is ample space within the site boundary to mitigate its loss via replacement planting. Any replanting is recommended to be of native species such as Oak and or Field Maple
