Design, Access and Heritage Statement to support a Listed Building Application for Alterations to Layham House

## DESIGN, ACCESS AND HERITAGE STATEMENT

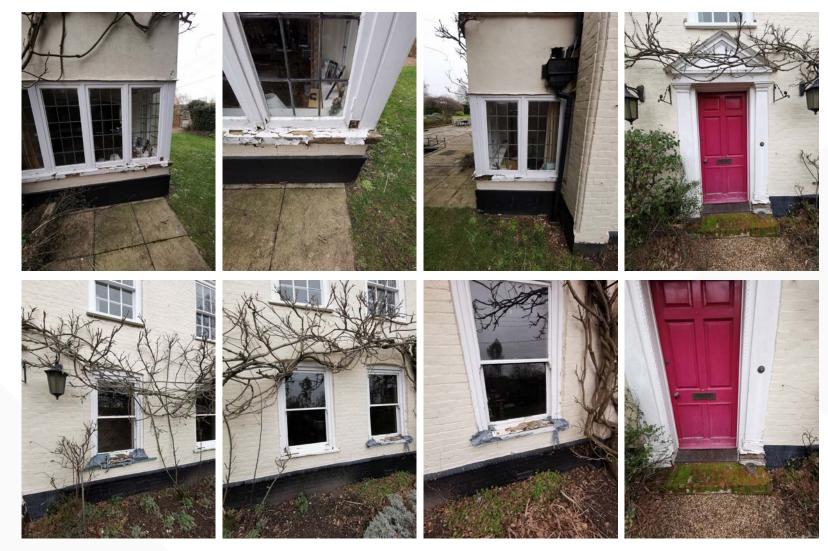
Photographs showing rotten timber cills and pilasters requiring repair. See Appendix A for details.

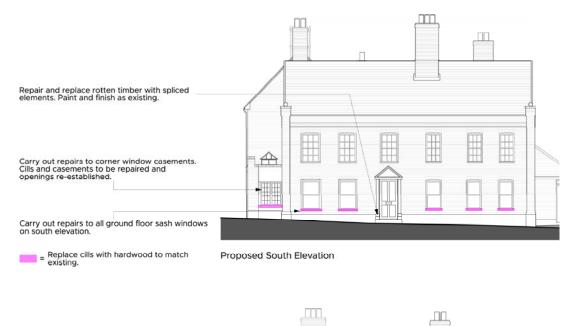
Carry out repairs to highlighted sash windows. Replace cills with hardwood =

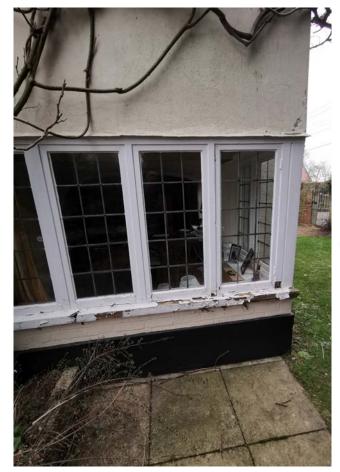
Photographs showing rotten cill on corner window to the west and south elevations. Repairs required to cill and casements, and openings to be re-established.

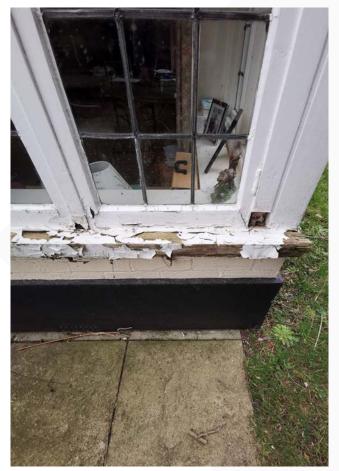
Photographs showing rotten cill on corner window to the west and south elevations. Repairs required to cill and casements, and openings to be re-established.

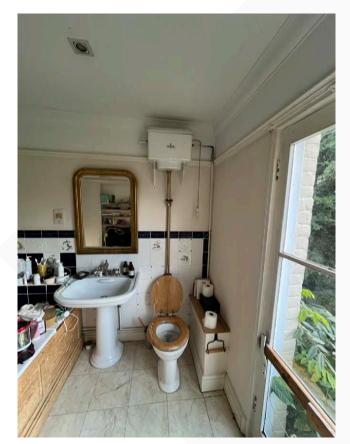
Photograph of existing free standing sink to be replaced by new vanity unit with built-in cupboards and sink.

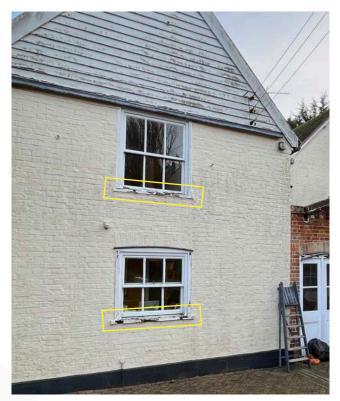
Photograph of north elevation showing both windows requiring repair.

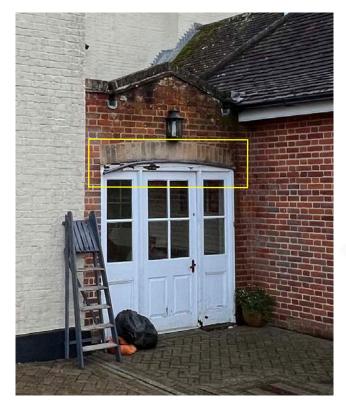
Photograph of entrance door requiring repair.

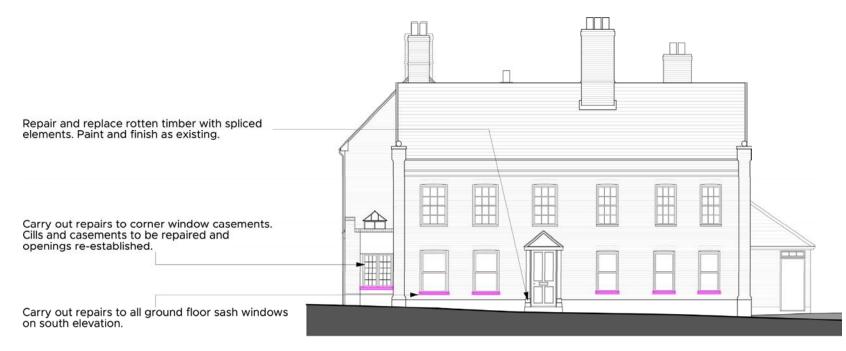
= Replace cills with hardwood to match existing.
