Tree Survey and Arboricultural Constraints

UNIVERSITY OF STIRLING GOLF PAVILION

UNIVERSITY OF STIRLING

21 February 2024

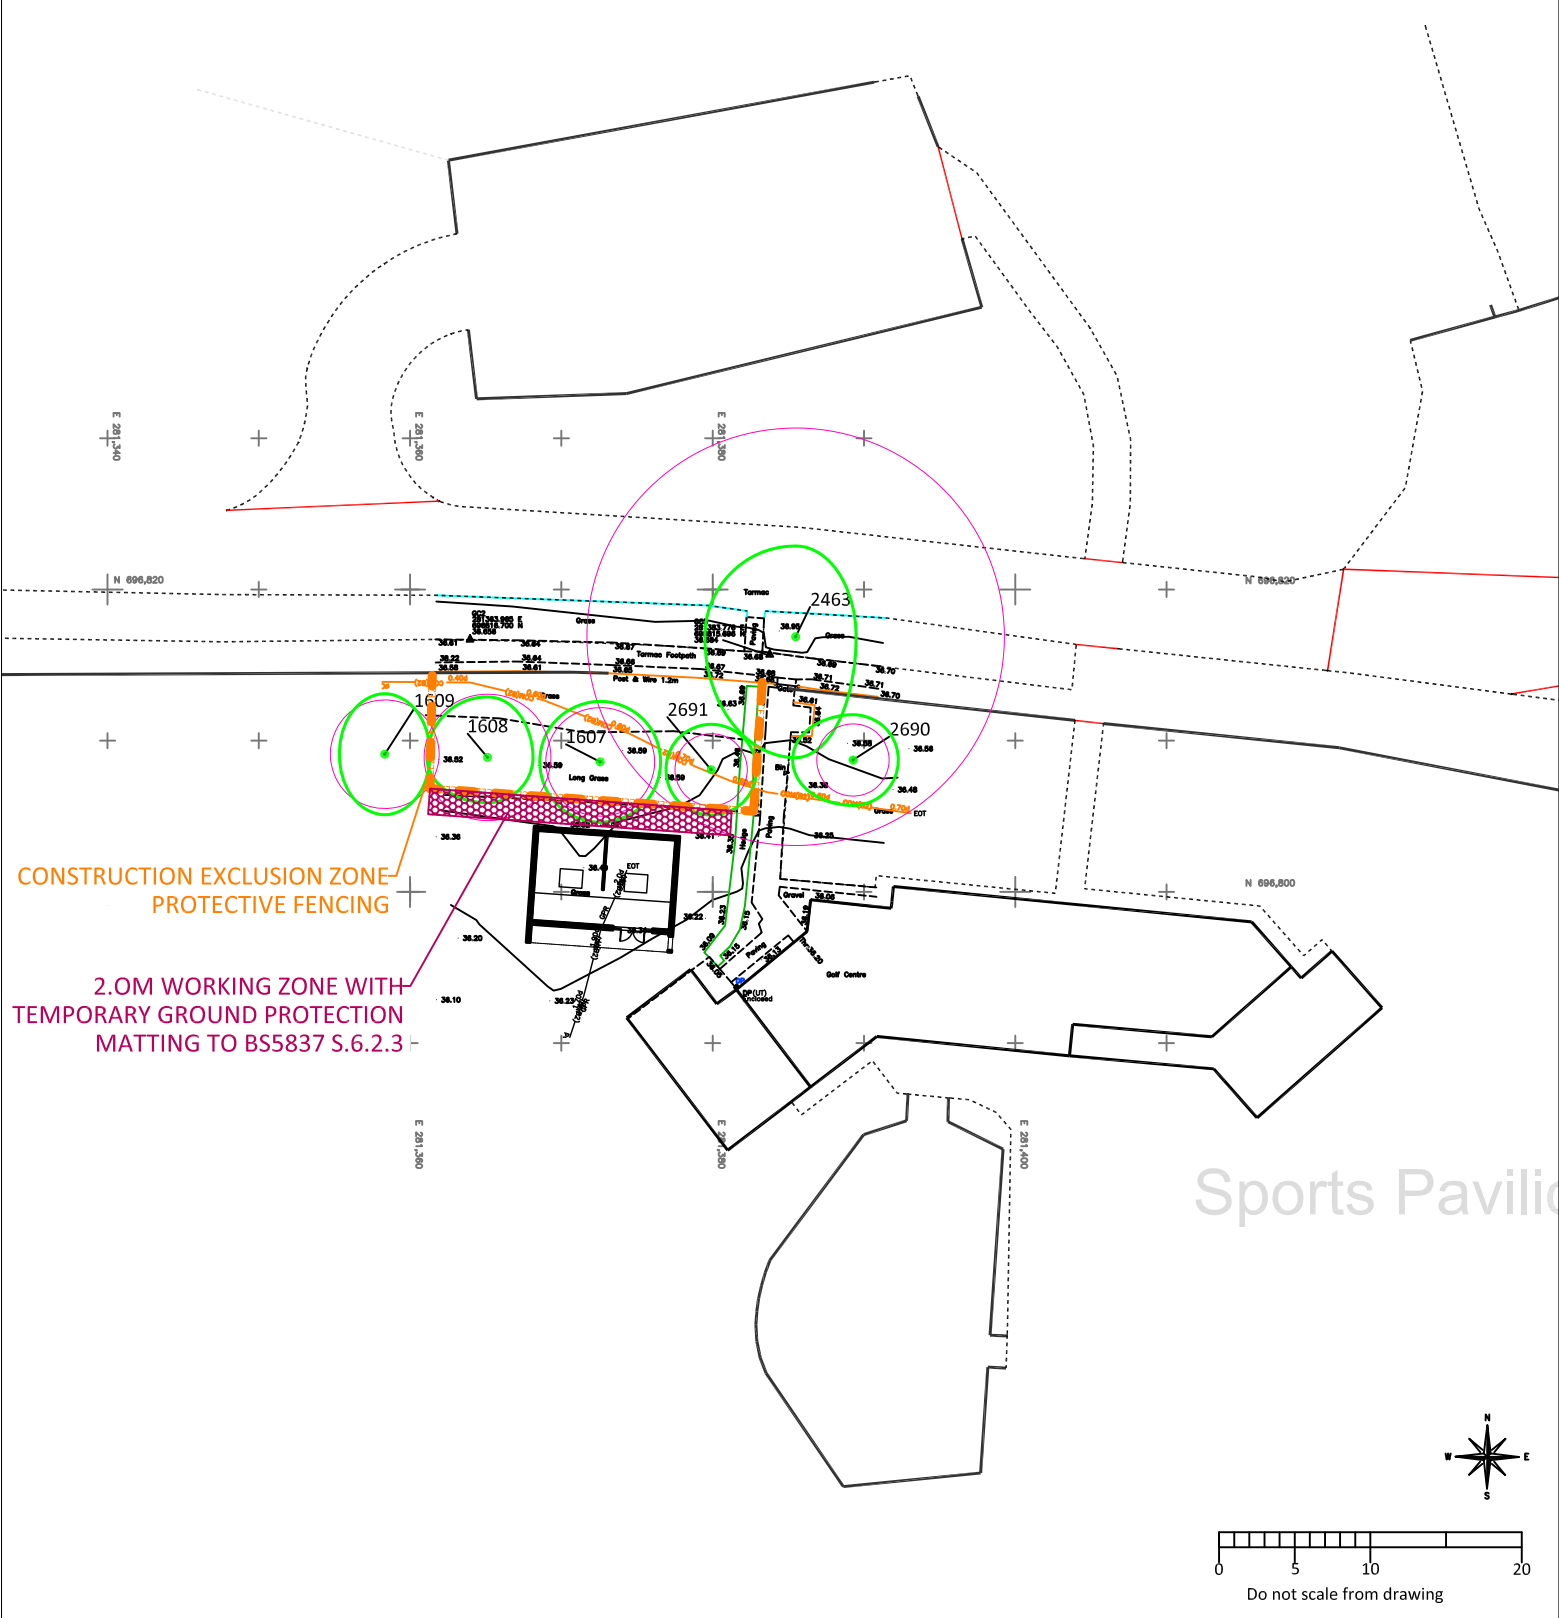
CLIENT: University of Stirling		
PROJECT: Swing Studio		
DRAWING TITLE: Tree Protection Plan		
DRAWING No: TP-01		
DATE: 21-2-24	SCALE: 1:500 at A4	REV:

- 7.1. The proposed site development involves the construction of a new 10m x 8m building to house a swing studio. The new building is proposed within an existing grass area immediately to the west of the existing pavilion.
- 7.2. The row of semi-mature lime trees is located north of the proposed building at a distance of 4.5m. Tree canopies extend 3-4m towards the proposed building.
- 7.3. The proposed building is located beyond the recommended RPA of the adjacent trees, although working space would encroach slightly. The installation of appropriate temporary ground protection measures would minimise the risk of ground compaction and any detriment to the trees, which are young and of high vigour.
- 7.4. Some crown-lifting of tree number 1607 would be required to permit construction access.

- 8.4. Construction access will require the installation of ground protection measures, in accordance with Section 6.2.3.3 of BS5837:2012. Where construction working space or temporary construction access is required and justified within the RPA, temporary ground protection should be installed as part of the implementation of physical tree protection measures prior to work starting on site. This should be capable of supporting any traffic entering or using the site without being distorted or causing compaction of underlying soil. For pedestrian movements only, a single thickness of scaffold boards placed either on top of a driven scaffold frame, so as to form a suspended walkway, or on top of a compression-resistant layer (e.g. 100 mm depth of woodchip), laid onto a geotextile membrane is recommended.

NOTE: All trees designated for retention to be protected by the erection of fencing in accordance with Section 6.2 and Figure 3 of BS5837:2012 (Construction Exclusion Zone). Within Root Protection Area delineated by hatching there shall be no construction operations without the installation of ground protection measures in accordance with Section 6.2.3 of BS5837:2012. Protective fencing and ground protection measures must be installed prior to all construction operations, including demolition works. There shall be no alterations in ground levels, excavations, storage of materials, or access by machinery within the Construction Exclusion Zone through the duration of the works.
