| Client: | Richard Leak |
| Address: | 10 Rowan Garth, Skidby, HU165TT |
| Date: | 10 th February 2024 |
| Туре: | BS5837;2012 |

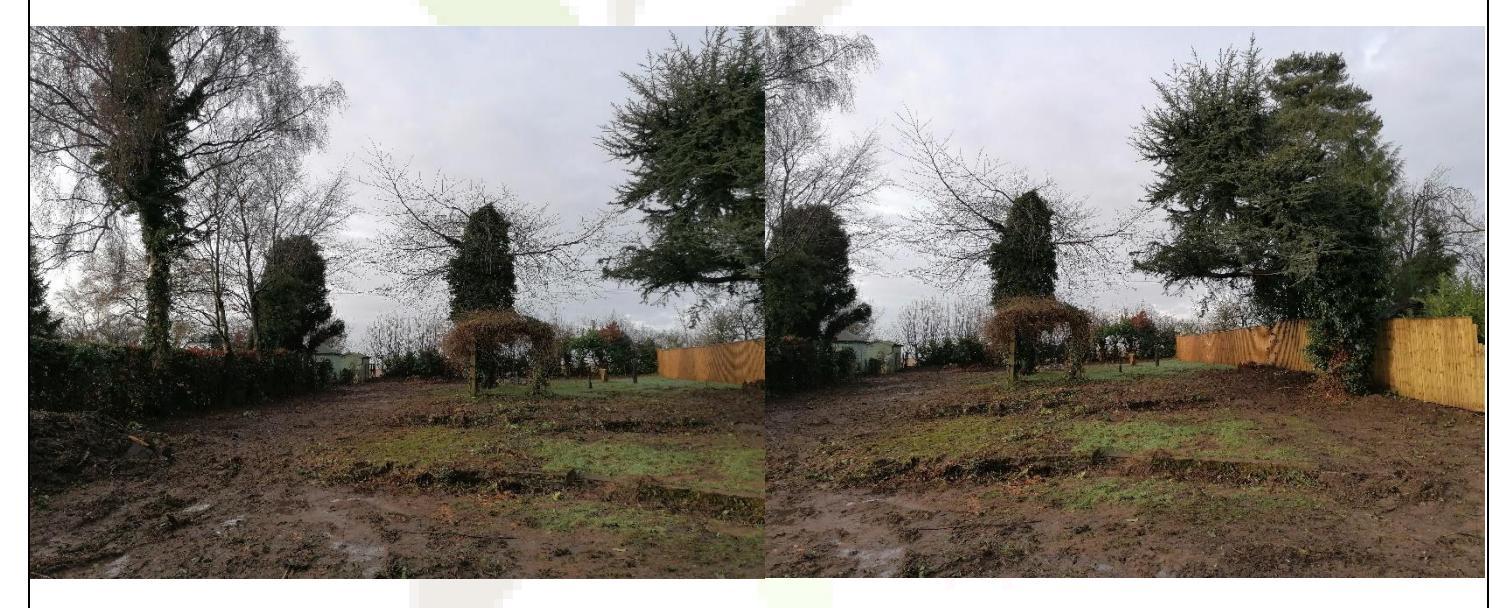
| No | Species | Height | DBH | RPA | Crow <mark>n</mark> spread | | <mark>SU</mark> LE | Grade | Physiological condition | Cutting requirements | | |
|---|---|---|---|---|---|---|---|---|---|---|--|--|
| 1 | Birch | 18 | 50 | 6.00 | 7 | 7 | 3 | 3 | 20 | C1 | Single straight stem Slight east lean Covered in Ivy | Recommend to fell for development although not essential |
| 2 | Beech | 12 | 24 | 2.88 | 2 | 4 | 4 | 1 | 20 | C1 | Poor form Part of existing Beech hedge | Recommend to Reduce to form level hedge although not essential |
| 3 | Beech | 12 | 50 | 6.00 | 4 | 2 | 5 | 3 | 20 | C1 | Poor form Part of existing Beech hedge | Recommend to Reduce to form level hedge although not essential |
| 5 | Cherry | 8 | 40 | 4.80 | 6 | 6 | 6 | 6 | 5 | U | History of pollarding at 7m or severely storm damaged and in poor form Covered in Ivy | Fell for development |
| 7 | Cedar | 6 | 90 | 10.80 | 0 | 5 | 6 | 5 | 5 | U | Poor form with either storm damage or severe hard crown reduction work Covered in Ivy | Fell although not essential for development |

Image 1: Looking SW showing T1-5

Image 2: Looking NW showing T5-7

T1 should ideally be felled for development as any construction work in this tree's RPA will likely render the tree unsafe. If the tree is to be retained then an adequate final design of the driveway and materials used will need to be considered.

T2 and T3 ideally should be reduced down to form a level hedge as these will also be rendered unsafe.

T5 is proposed to be removed as this tree is unworthy of retention.
