**PROJECT**  
**Scotland England Green Link 2**

**TITLE**  
**Figure 2**  
**Otter Habitat Assessment & Survey**

**REFERENCE**  
 SEGL2\_T\_WVO\_2\_v3\_20220209

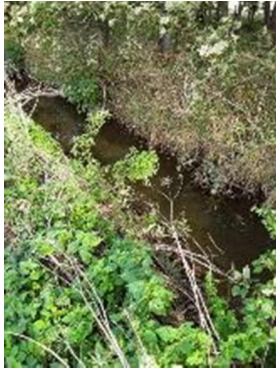
Watercourse Reference (and name if applicable)	Survey start & end points (OS Grid Reference)	Survey date	Description of watercourse	Evidence of Water Vole Found?	Evidence of otter found?	Comments	Photograph (representative of habitat)
WC126	N/A	N/A	N/A	N/A	N/A	Ditch not surveyed, but it is connected directly to WC1. Therefore, water vole potentially present. Within the planning application boundary.	N/A
WC1 (Auburn Beck)	TA 16401 63406 & TA 16430 63531	14.10.21	A slow flowing ditch with steep earth banks vegetated with brambles and common nettles. The channel is approximately 30cm deep and typically 1m in width. The eastern reach of the ditch becomes wider with shallower less steep banks with a reduction in vegetation cover. In channel vegetation is limited with the ditch under recent maintenance.	Yes – latrine and feeding remains.	No	Water vole present. Ditch likely to yield an increase in field signs during optimal survey window (April – September). Otter likely absent.

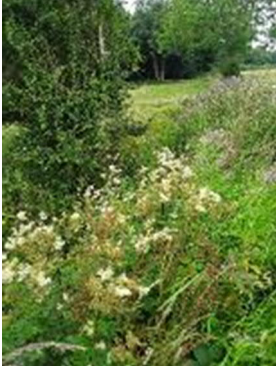
Watercourse Reference (and name if applicable)	Survey start & end points (OS Grid Reference)	Survey date	Description of watercourse	Evidence of Water Vole Found?	Evidence of otter found?	Comments	Photograph (representative of habitat)
WC3	TA 15034 62753	27.7.21	A slow flowing ditch with earth banks and dense bankside vegetation on steep earth banks including meadowsweet, great willowherb, common nettle, cocksfoot and false oat-grass. The channel is typically 1m wide with a depth of around 10cm with negligible in-channel vegetation due to amount of shading from brambles and great willowherb which dominate at times. Channel is likely to fluctuate by up to +/- 10cm during heavy rain and drought conditions. The ditch had been recently managed, with the base and one side having a marked reduction in vegetation. In-channel vegetation includes duckweed and starwort.	No	No	Ditch considered sub-optimal habitat for water vole, scoped out from further assessment and water vole considered likely absent. Stoat scat recorded. Otter considered likely absent.

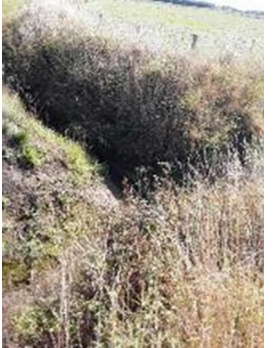
WC4 (Carr Dike)	N/A	N/A	Slow running ditch with steep earth banks. Channel has been recently managed along with northern bank leaving it devoid of vegetation. Channel is typically 1m wide with a depth not greater than 10cm.	No	No	Ditch considered sub-optimal habitat for otter and water vole and scoped out from further assessment.

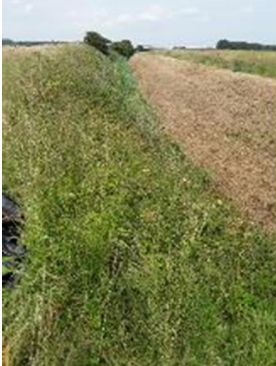
Watercourse Reference (and name if applicable)	Survey start & end points (OS Grid Reference)	Survey date	Description of watercourse	Evidence of Water Vole Found?	Evidence of otter found?	Comments	Photograph (representative of habitat)
WC7 (Burton Drain)	TA 13511 60434 to TA13460 60534	27.7.21	A field ditch typically 10cm deep with a width of 1m. It has steep earth banks and limited shading from trees. Tussocky grasses are present with great willowherb, meadowsweet and occasional common reed throughout the channel. The eastern bank had been recently managed.	No	No	Feeding remains and droppings of small vole (bank or field) recorded. Water vole and otter considered to be likely absent and scoped out from further assessment.

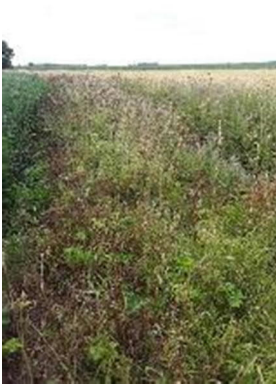
WC8	TA 12952 60453 to TA 12919 60372	27.7.21	A ditch up to 2m wide with a maximum depth of 10cm, but much of the channel was dry at the time of the survey. Steep 45 degree vegetated banks to 3m high, which are overgrown and unmanaged with tall ruderal vegetation and scattered bramble. Sparse aquatic vegetation and bare earth in small stretches. Species present include meadowsweet, greater willowherb, cocksfoot, false oat grass, hogweed and common nettle.	No	No	Water vole and otter considered likely absent and scoped out from further assessment.

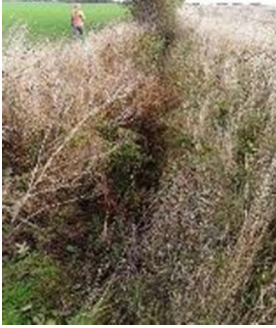
Watercourse Reference (and name if applicable)	Survey start & end points (OS Grid Reference)	Survey date	Description of watercourse	Evidence of Water Vole Found?	Evidence of otter found?	Comments	Photograph (representative of habitat)
WC103	N/A	N/A	A ditch just inside route boundary, not accessed.	N/A	N/A	Further assessment required, no access. Ditch inside Working Width Rev08.	N/A
WC104	N/A	N/A	A dry ditch just outside the route corridor.	N/A	N/A	Scoped out from further assessment.	N/A
WC105	N/A	N/A	A shallow drainage ditch adjacent to hedgerow, 2m wide with steep banks 2m high. Few stands of common reed in channel, earth substrate and turgid water up to 15cm deep. No macrophytes in channel, with bankside vegetation of rank grasses and tall ruderals.	N/A	N/A	Requires further assessment.

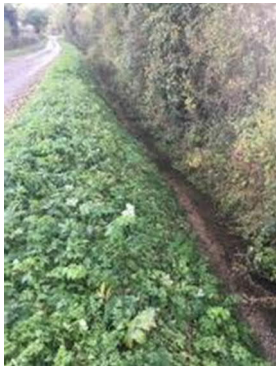
WC14	N/A	N/A	Steep trackside verge with associated running ditch approximately 1.0m wide with a shallow depth up to 10 cm deep. Limited vegetation for water vole and adjacent hedgerow does provide sub-optimal conditions through shading.	N/A	N/A	Requires further assessment.

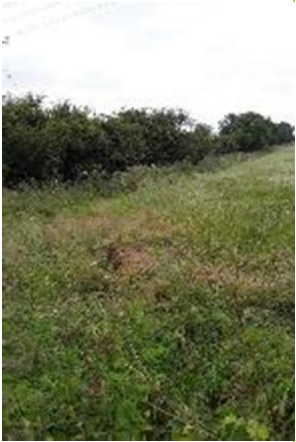
Watercourse Reference (and name if applicable)	Survey start & end points (OS Grid Reference)	Survey date	Description of watercourse	Evidence of Water Vole Found?	Evidence of otter found?	Comments	Photograph (representative of habitat)
			survey with a depth up to 40cm, and a width not exceeding 2m.				
WC110	N/A	N/A	N/A	N/A	N/A	No impact – scoped out.	N/A
WC111	N/A	N/A	N/A	N/A	N/A	No impact – scoped out.	N/A
WC16	TA 07615 58526 to TA 07636 58567	14.7.21	Steep earth banks suitable for burrowing and plenty of food plants and cover for water vole; suitable as commuting habitat for otter. The ditch is approximately 1m wide and 15cm deep with a slow flow. It is shaded on northern side by an adjacent hedgerow. Dense bankside vegetation on tall steep banks. Recently dredged.	Yes, latrine.	No, likely present at times.	Water vole confirmed. Impacted section not surveyed, but water vole likely to be present due to signs located c.200m upstream. Access/ egress difficult, survey halted once water vole confirmed. Grass snake recorded.

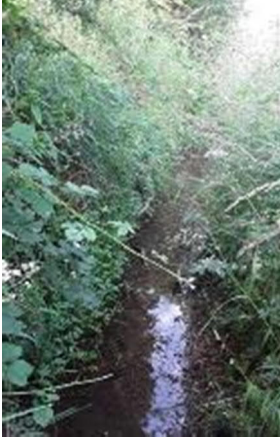
Watercourse Reference (and name if applicable)	Survey start & end points (OS Grid Reference)	Survey date	Description of watercourse	Evidence of Water Vole Found?	Evidence of otter found?	Comments	Photograph (representative of habitat)
WC17 (White Dike)	TA 07651 58175 to TA 07625 58209	14.7.21	A farm ditch approximately 0.5m wide with a maximum depth of 5cm. No flow at the time of the survey. The ditch is shaded by adjacent trees and shrubs leading to limited in-channel vegetation. The ditch is well-maintained, probably on a bi-annual basis with a recently dredged bare channel base. Dense brambles and dog rose crossing span of ditch. Cocksfoot and false oatgrass, cow parsley, perennial ryegrass and hogweed also present.	No	No	Water vole and otter considered likely absent, low water depth and limited food and cover. Scoped out from further assessment.

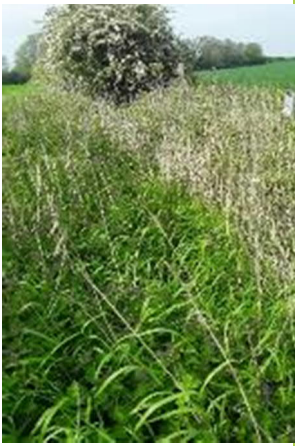
Watercourse Reference (and name if applicable)	Survey start & end points (OS Grid Reference)	Survey date	Description of watercourse	Evidence of Water Vole Found?	Evidence of otter found?	Comments	Photograph (representative of habitat)
WC18	TA 07385 57792	14.7.21	Ditch did not hold water at the time of the survey. Vegetation present included common nettle, meadowsweet, hogweed, bulrush, perennial ryegrass, hogweed and occasional brambles.	No	No	Water vole and otter considered likely absent due to lack of suitable habitat (water depth). Scoped out from further assessment.

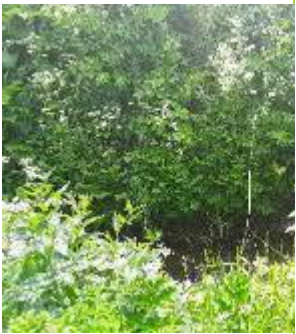
WC19 (Nafferton Highland Stream)	TA 07167 57693 to TA 07228 57588	14.7.21	Steep sided earth banks bind an approximately 2m wide stream between two arable fields. Vegetation present includes perennial ryegrass, red fescue, brambles, cow parsley, hogweed, common nettle, creeping buttercup, creeping Jenny, dandelion, creeping thistle, curled dock, cocksfoot, meadowsweet, crosswort, ribwort plantain, field horsetail, herb Robert and ground ivy.	No	No	Water vole considered likely absent. Potential for commuting otter. Scoped out from further assessment.

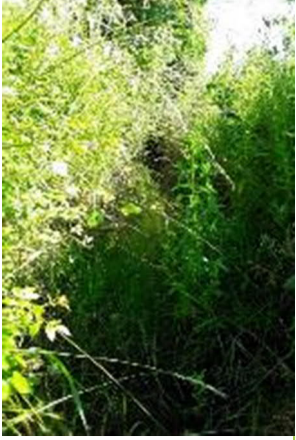
Watercourse Reference (and name if applicable)	Survey start & end points (OS Grid Reference)	Survey date	Description of watercourse	Evidence of Water Vole Found?	Evidence of otter found?	Comments	Photograph (representative of habitat)
WC20	TA 06974 57516 to TA 06962 57540	14.7.21	Dry Ditch with occasional standing water and sloping vegetated sides suitable for water vole. Vegetation includes but is not limited to creeping thistle, common comfrey, perennial rye grass and red campion.	No	No	Water vole and otter likely absent due to lack of sufficient water depth. Scoped out from further assessment.

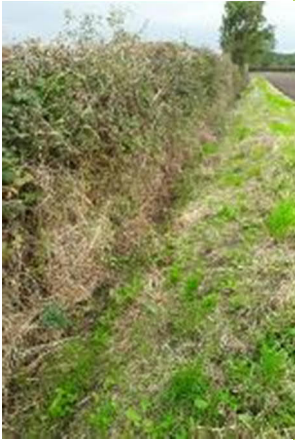
WC21	TA 06762 57459	13.10.21	A dry ditch associated with an adjacent hawthorn dominated hedgerow.	No	No	Ditch scoped out from further assessment as habitat is unsuitable for riparian species.

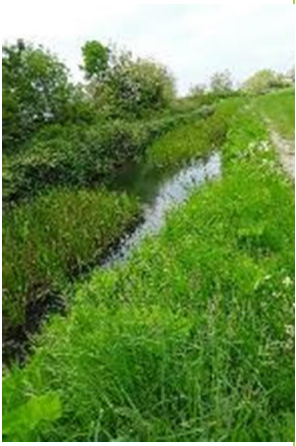
Watercourse Reference (and name if applicable)	Survey start & end points (OS Grid Reference)	Survey date	Description of watercourse	Evidence of Water Vole Found?	Evidence of otter found?	Comments	Photograph (representative of habitat)
WC22 (Nafferton Beck)	N/A	13.10.21	A substantial beck up to 6 m wide with a maximum depth of 40cm. Vegetated earth banks suitable for burrowing with perennial ryegrass, cow parsley, rosebay willowherb, butterbur, and occasional in-channel patches of bullrush.	N/A	N/A	Survey found no signs, but undertaken at sub-optimal time. Further assessment required. Otter potentially present.

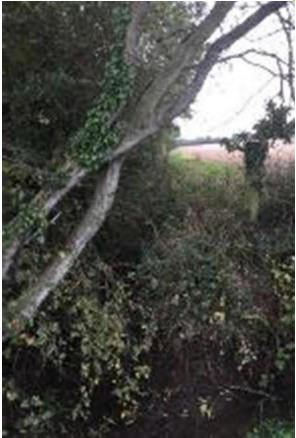
WC23	N/A	19.10.21	A wet ditch approximately 1m in width with shallow water not exceeding 10cm in depth. Shaded banks with vegetation limited to occasional common nettle, rosebay willowherb and curled dock. Macrophytes present include locally abundant fool's watercress.	N/A	N/A	Water vole and otter considered likely absent due to lack of sufficient water depth. Scoped out from further assessment.

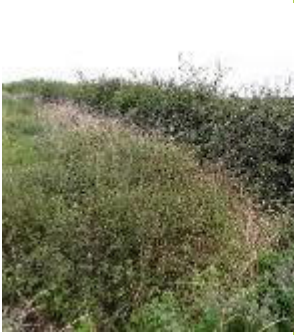
Watercourse Reference (and name if applicable)	Survey start & end points (OS Grid Reference)	Survey date	Description of watercourse	Evidence of Water Vole Found?	Evidence of otter found?	Comments	Photograph (representative of habitat)
WC24	TA 05908 56972 and TA 05681 56499	27.8.21	Dry ditch associated with a hawthorn-dominated hedgerow found to be dry at the time of survey.	No	No	Lack of suitable habitat for riparian mammals, scoped out from further assessment.

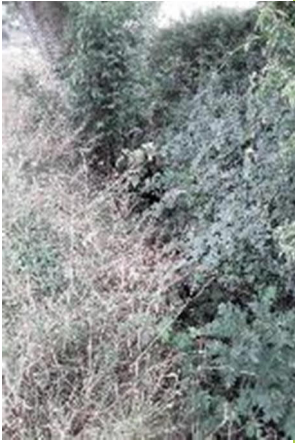
Watercourse Reference (and name if applicable)	Survey start & end points (OS Grid Reference)	Survey date	Description of watercourse	Evidence of Water Vole Found?	Evidence of otter found?	Comments	Photograph (representative of habitat)
WC129	N/A	N/A	Mapped as a (shaded) dry ditch in Phase 1.	N/A	N/A`	Remotely mapped as a dry ditch; would require field verification. Ditch within the planning application boundary.

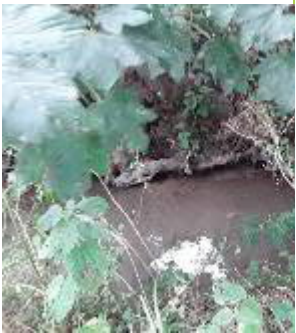
WC29	TA 04324 55633	25.8.21	Shaded ditch, 0.5m wide with shallow standing water not exceeding 5cm in depth in ditch adjacent to improved pasture land.	No	No	Ditch considered too isolated from wider ditch network, too shallow and too shaded. Water vole and otter considered likely absent. Scoped out from further assessment.

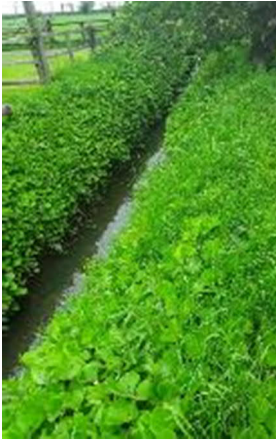
Watercourse Reference (and name if applicable)	Survey start & end points (OS Grid Reference)	Survey date	Description of watercourse	Evidence of Water Vole Found?	Evidence of otter found?	Comments	Photograph (representative of habitat)
WC130	N/A	N/A	Limited field notes from Phase 1, 2 photos on Field Mapper, 1 of which looks good for water vole with water depth and cover/ food plants. Second photo habitat is poor (gone with better here). Shallow ditch to 30cm deep and 1.5m in width with meadow foxtail, bracken and perennial ryegrass.	N/A	N/A	Needs verification via field survey as ditch in the planning application boundary.

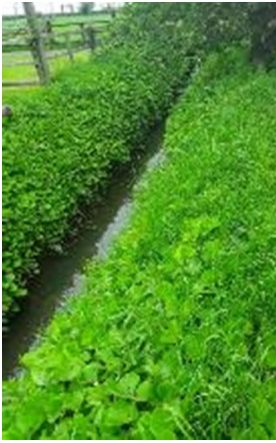
WC30	N/A	N/A	A running ditch approximately 30cm deep with a width of 1.5m. Earth banks and a silty substrate wide ditch, silt bottom and steep vegetated sides with meadow foxtail, bracken, perennial rye grass, rosebay willowherb, common nettle and coltsfoot.	N/A	N/A	Further assessment required.

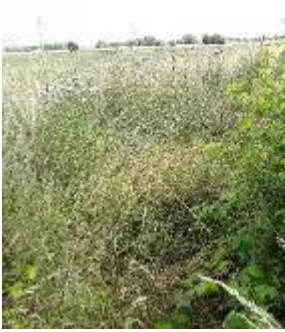
Watercourse Reference (and name if applicable)	Survey start & end points (OS Grid Reference)	Survey date	Description of watercourse	Evidence of Water Vole Found?	Evidence of otter found?	Comments	Photograph (representative of habitat)
WC116	TA 03487 54689		Dry ditch with common knapweed, false oat-grass and occasional brambles and dog rose.	N/A	N/A	Scoped out from further assessment due to unsuitable habitat.

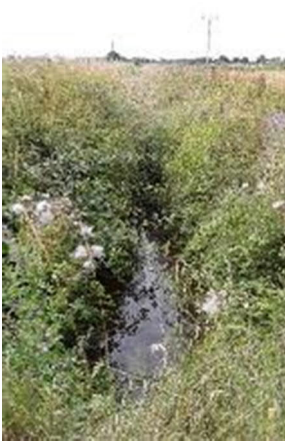
WC117	TA 03275 54374 to TA 03301 54531	15.10.21	Well vegetated ditch with dominant common reed, cocksfoot and false oat-grass. Wide field margins with tufted vetch, tufted hair grass, cocksfoot, meadow vetchling and ribwort plantain. Ditch approximately 1m in width with a depth in excess of 10cm.	N/A	N/A	Late survey, cannot confirm water vole absence. Further assessment required. Potential for otter as linkages to WC33 (Knorka Dike).

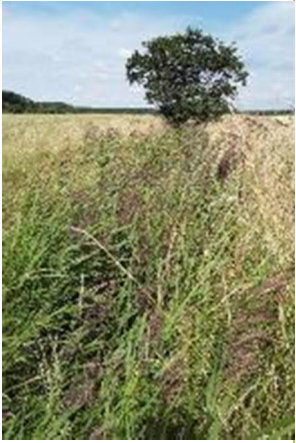
Watercourse Reference (and name if applicable)	Survey start & end points (OS Grid Reference)	Survey date	Description of watercourse	Evidence of Water Vole Found?	Evidence of otter found?	Comments	Photograph (representative of habitat)
WC32	TA 03104 54308 to TA 03081 54361	15.10.21	Densely veg ditch dominated by common reed with false oat-grass and cocksfoot. Channel approximately 40cm wide, with a depth not exceeding 15cm.	No	No	No impact – scoped out.

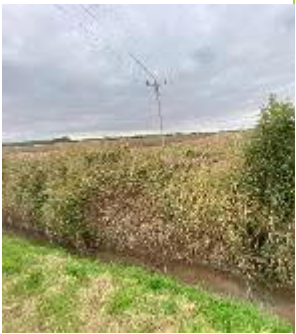
WC33 (Knorka Dike)	TA 03053 54314 to TA 03253 54251	15.10.21	Running ditch up to 2m in width with a depth no greater than 20cm. Gravel substrate with earth banks with occasional common reed in channel with meadowsweet, false oat-grass, creeping thistle, common nettle and brambles.	No	No	Water vole considered potentially present as late survey. Needs reassessing in optimal window. Otter potentially present as linked to WC35 Northfield Beck.

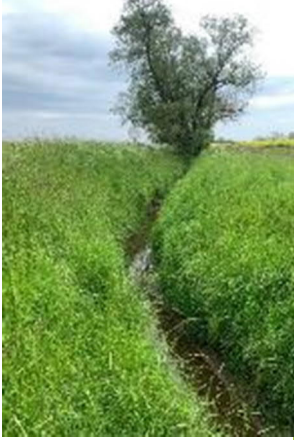
Watercourse Reference (and name if applicable)	Survey start & end points (OS Grid Reference)	Survey date	Description of watercourse	Evidence of Water Vole Found?	Evidence of otter found?	Comments	Photograph (representative of habitat)
WC35 (Northfield Beck)	TA 02277 53881 to TA 02425 53911	3.6.21	Flowing ditch up to 1.5m wide with a depth typically of 10cm, with occasional deeper areas to 30cm. Tall tussocky grasses present on bankside including timothy with red campion, crosswort, false oat-grass and Yorkshire fog. Ditch is managed.	Yes, latrines, burrows and feeding remains	Yes, print.	Numerous water vole latrines recorded throughout ditch. Otter present.

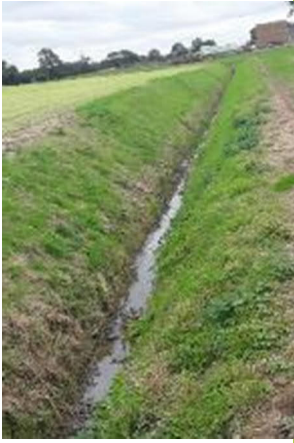
Watercourse Reference (and name if applicable)	Survey start & end points (OS Grid Reference)	Survey date	Description of watercourse	Evidence of Water Vole Found?	Evidence of otter found?	Comments	Photograph (representative of habitat)
WC39	TA 01122 52931 to TA 01228 52703	19.10.21	A ditch with a 1m wide channel that is approximately 20cm deep with silt bottom. Sloped vegetated banks 2.m tall dominated by perennial ryegrass with occasional common nettle and creeping thistle.	No	No	Water vole likely absent, but would require further survey in optimal window to confirm.Otter likely absent, isolated ditch.

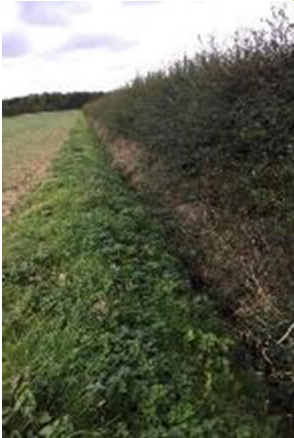
WC40	TA 00684 52902 to TA 00470 52785	19.10.21	A wet ditch approximately 1m in width and depth of 5cm. Limited food plants for water vole.	No	No	Unsuitable habitat, scoped out from further assessment. Now outside the planning application boundary.

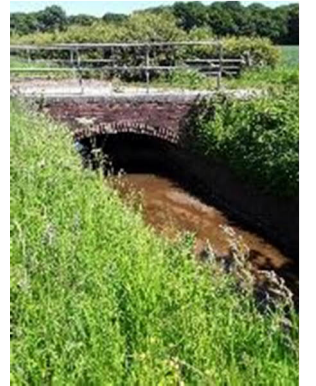
WC51 (Back Delfin)	SE 85044, 37295 to SE 84331, 36903	9.6.21	A managed watercourse approximately 2m wide and up to 50cm in depth, although typically much shallower than this. Earth banks with occasionally tussocky vegetation with a silty substrate.	Potential burrow	Yes, otter prints.	Otter present, and water vole potentially present. Further assessment required.

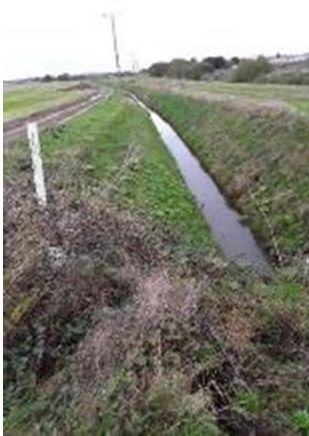
WC52 (Egremont Drain)	N/A	N/A	A 1m wide channel with a depth of approximately 20cm. Steep vegetated banks of poor semi-improved grassland.	N/A	N/A	Further assessment required to scope out water vole. Otter potentially present given proximity of WC51 Beils Beck.

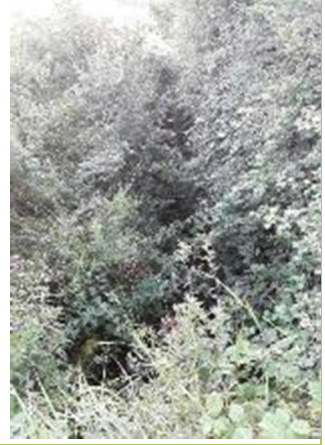
Watercourse Reference (and name if applicable)	Survey start & end points (OS Grid Reference)	Survey date	Description	Evidence of Water Vole Found?	Evidence of otter found?	Comments	Photograph
WC55	N/A	5.8.21	A running ditch approximately 1m wide with a depth not greater than 20cm. The ditch is shaded by an adjacent hedgerow limiting in-channel vegetation growth and to a lesser extent bankside vegetation, with mugwort, common nettle and creeping thistle.	No	No	Unsuitable habitat for water vole, otter potentially present given linkages to wider watercourse network WC52 & WC51.

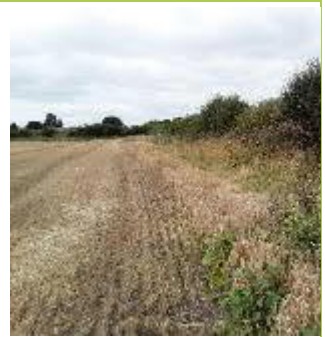
WC56	N/A	26.8.21	Dry ditch adjacent to managed hawthorn hedgerow.	No	No	Unsuitable habitat for water vole; likely absent. Scoped out from further assessment.

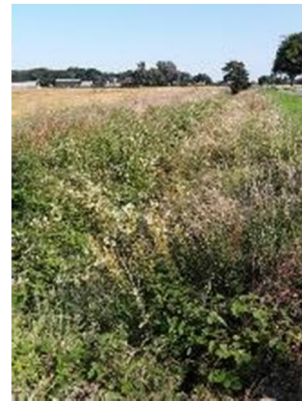
WC59 (Main Drain)	SE 81503 35411 to SE 81537 35382; SE 81714 35215 to SE 81757 35176.	21.7.21	A well vegetated flowing ditch up to 1.2m in width with a depth not greater than 0.3m deep. Occasional dense in-channel vegetation with reed canary grass, false oatgrass, meadowsweet, common knapweed. Bankside vegetation includes comfrey, cocksfoot, Yorkshire fog. Subject to some management, and banks occasionally reinforced with timber shoring.	Yes	No	Water vole latrines, feeding remains and burrows where ditch opens out beyond mature boundary. Ditch is being avoided through HDD, but haul road may impact.

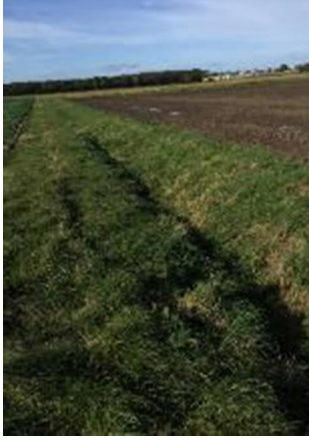
Watercourse Reference (and name if applicable)	Survey start & end points (OS Grid Reference)	Survey date	Description	Evidence of Water Vole Found?	Evidence of otter found?	Comments	Photograph
WC61	SE 81208 35026	21.10.21	Dry ditch forming a field boundary dominated by perennial rye grass with occasional hogweed and common nettle.	No	No	Unsuitable habitat, scoped out from further assessment.

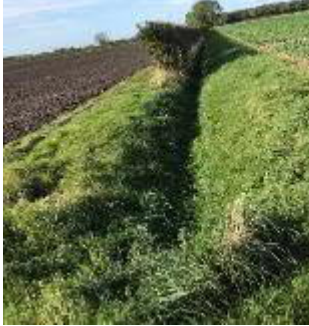
WC62	SE 81028 34888	21.10.21	Dry ditch with associated hawthorn hedgerow. Perennial rye grass dominated with occasional common nettle and hog weed.	No	No	Unsuitable habitat, scoped out from further assessment.

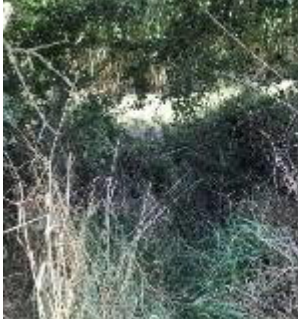
WC64	SE 80268 34307	8.9.21	Dry ditch associated with hawthorn hedgerow.	N/A	N/A	Unsuitable habitat, scoped out from further assessment.

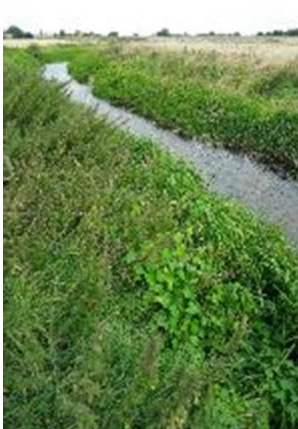
WC66 (River Foulness)	N/A	18.8.21	A main river up to 4m in width with a depth exceeding 1m. Well vegetated earth banks with flote grass, reed canary grass and redshank.	N/A	Yes	Not surveyed as considered too deep to survey safely. Otter confirmed in immediately adjacent WC65; water vole potentially present.

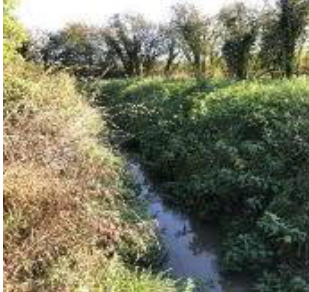
Watercourse Reference (and name if applicable)	Survey start & end points (OS Grid Reference)	Survey date	Description	Evidence of Water Vole Found?	Evidence of otter found?	Comments	Photograph
WC67	SE 79311, 32414 to SE 79405, 32510	21.10.21	Well vegetated earth banks with false oatgrass, cocksfoot and common nettle. Channel approximately 1.5m wide with a depth not greater than 30cm.	No	No	Further assessment required to scope out. Otter potentially present.

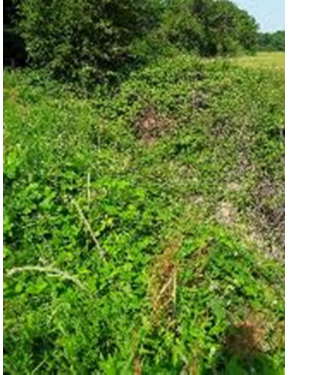
WC68	N/A	22.7.21	Dry ditch overgrown with bramble, rosebay willowherb and teasel.	No	No	Scoped out from further assessment.

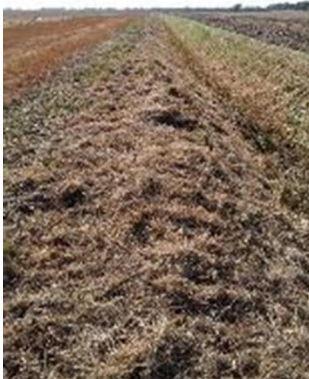
WC140	N/A	9.08.21	Managed vegetated ditch, predominantly dry with occasional wet areas to 10cm in depth.	N/A	N/A	Water vole and otter scoped out given absence of continual water of a sufficient depth. Ditch within the planning application boundary.

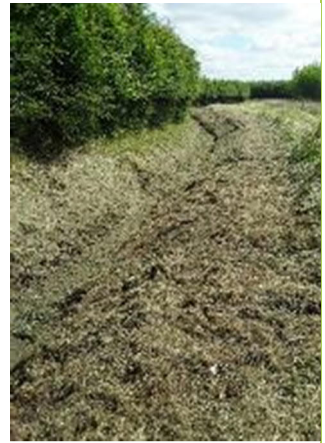
Watercourse Reference (and name if applicable)	Survey start & end points (OS Grid Reference)	Survey date	Description	Evidence of Water Vole Found?	Evidence of otter found?	Comments	Photograph
WC79	SE 72563 29637	15.7.21	A shallow 10cm deep ditch along a field boundary adjacent to a hedgerow, bordered by improved grassland with common nettle, perennial ryegrass, marsh marigold and hogweed.	N/A	N/A	Ditch flailed immediately prior to planned survey – choked with flailed vegetation so any signs hidden or obliterated. Further assessment for water vole is required if haul road used to cross as ditch is subject to HDD. Otter likely absent.
