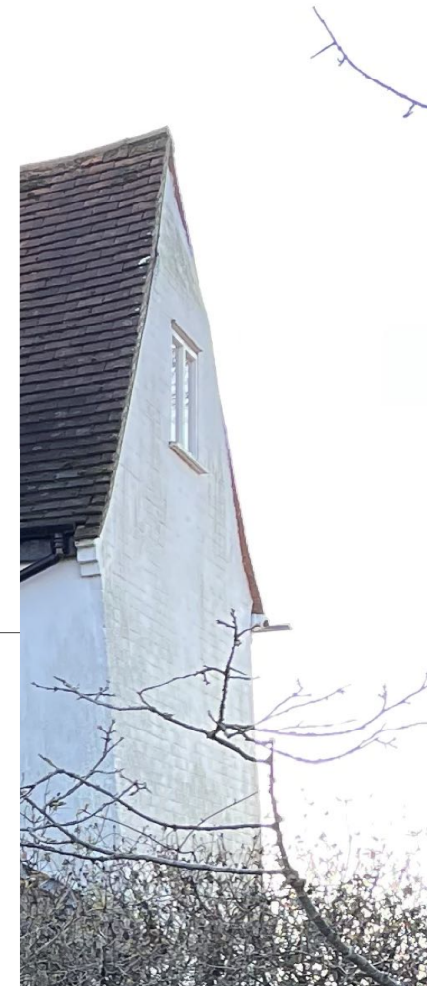
EXISTING WEST ELEVATION
Scale: 1:100

The west brick gable currently bows outwards, past the roof boundary line at second floor level. This needs to be rectified.

Covered UPVC basement window to be replaced with a more appropriate timber window well.
